# Albion Square War Memorial Condition Report

Date: 13.04.2026

Document ID: 140-05-CR03

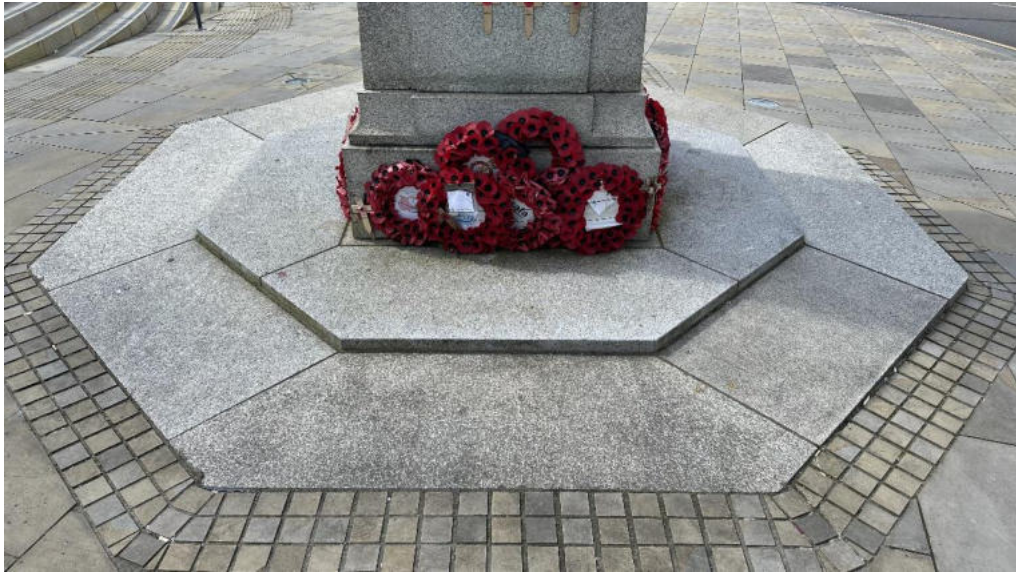
| <b>4.1</b> | <p>The base consists of granite slabs laid in two steps in an octagonal shape around the plinth. The lower labs are laid with a fall away. Joints are tight and slabs are level. There is some atmospheric dirt on the surface that could be cleaned. Cleaning should be considered with an appropriate biocide. If results are not satisfactory a superheated steam system could be considered. No abrasive or high-pressure methods should be employed. <b>STONE CLEANING</b></p> | <b>4</b> |

| 3 | STONE CLEANING | 4.1, 4.5, | C,L |

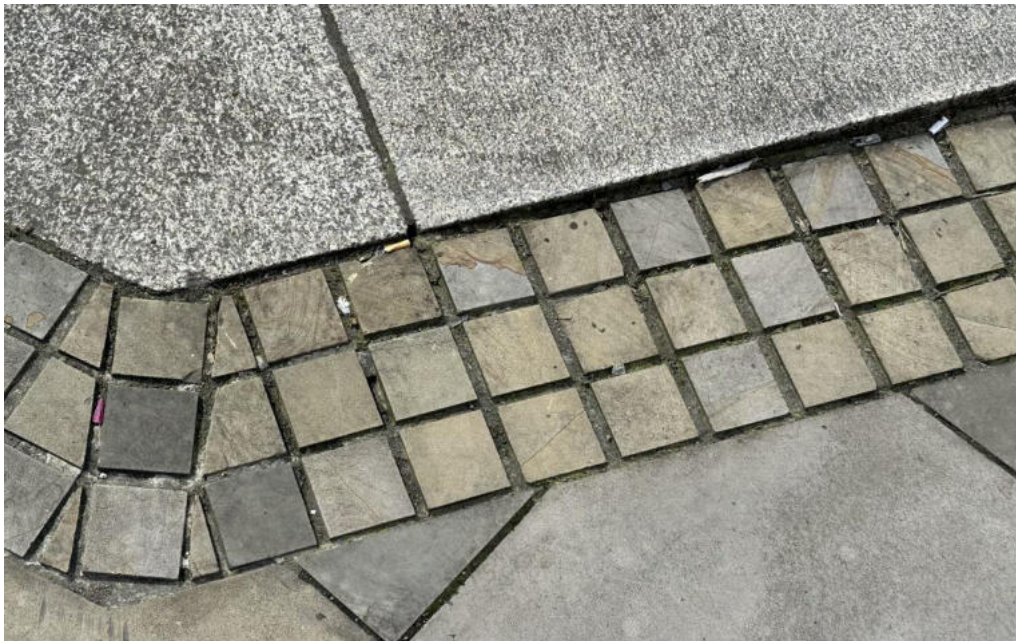
| <b>4.2</b> | <p>There are Yorkstone setts surrounding that have recessed joints that trap litter. Regular clearing of litter is needed. <b>LITTER CLEARANCE</b></p> | <b>4</b> |

| 4 | LITTER CLEARANCE | 4.2, | C,V |

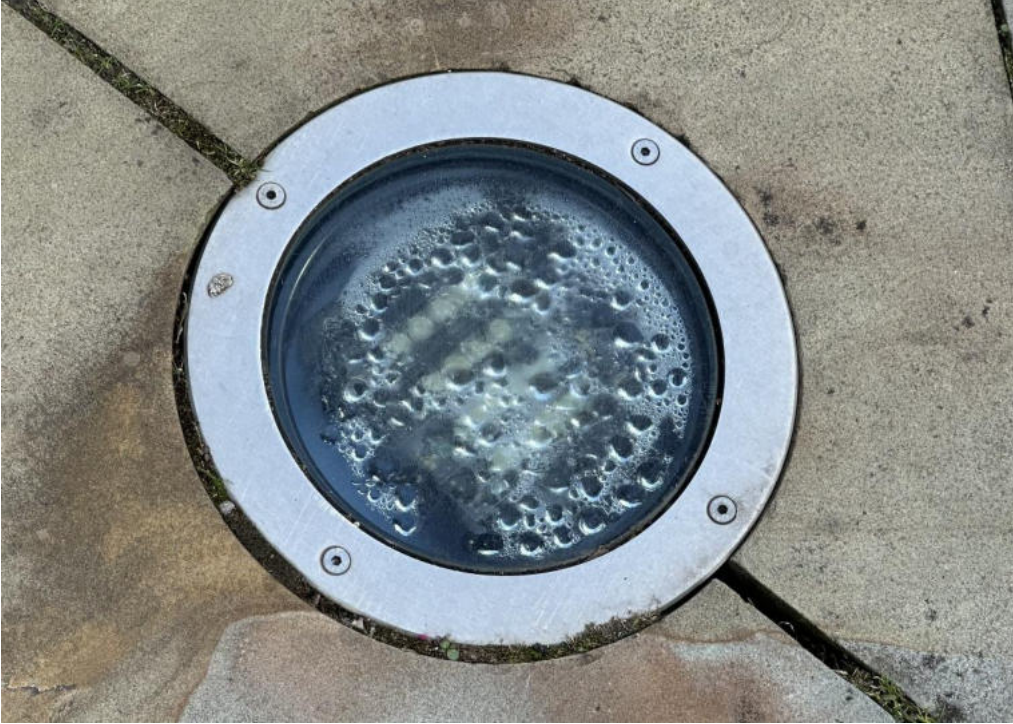
| 4.4 | <p>There are spotlights fitted into the slabs. Some have water ingress inside the glass and seals should be checked. It should be checked that this does not impede their operation. <b>CHECK AND CLEAN LIGHT GLASS</b></p> | 4 |

| 5 | OVERHAUL/REPLACE LIGHT FITTINGS | 4.4, | |

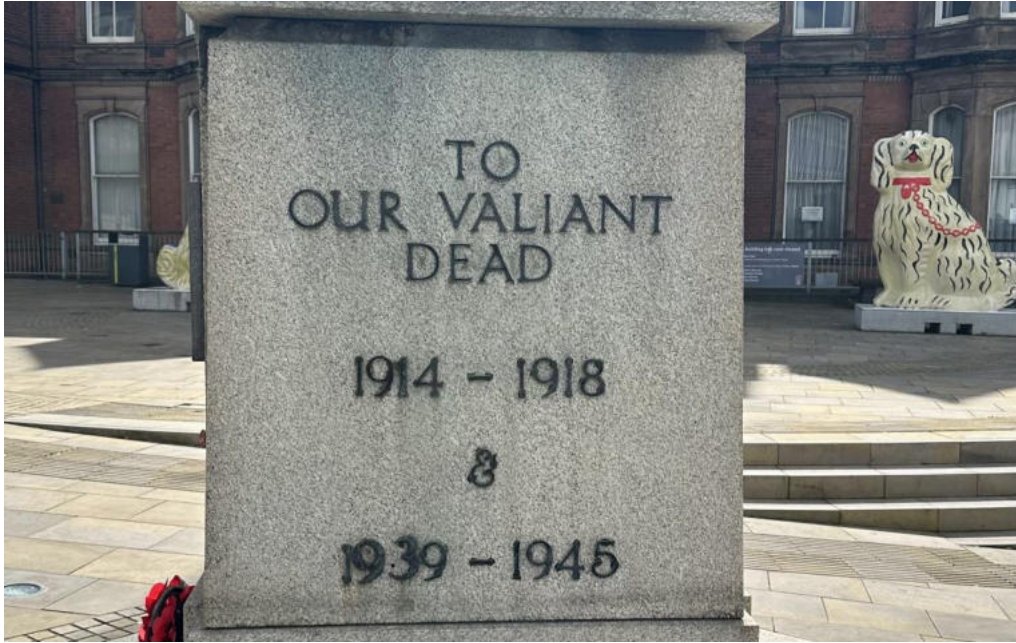
| <b>4.5</b> | <p>The square plinth is of a cream granite. There is staining from water run-off. Cleaning should be considered with an appropriate biocide. If results are not satisfactory a superheated steam system could be considered. No abrasive or high-pressure methods should be employed. <b>STONE CLEANING</b></p> | |

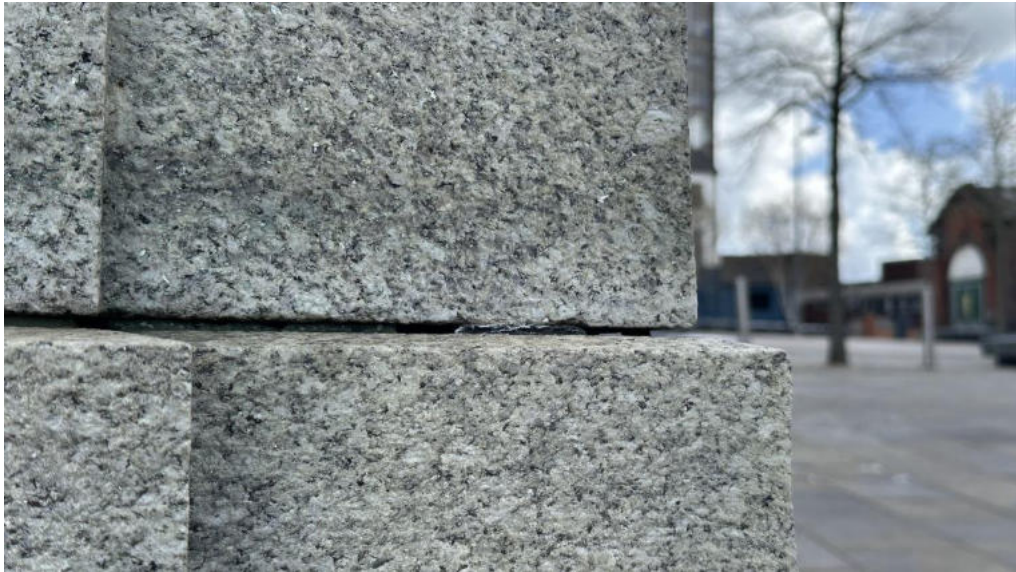
| <b>4.6</b> | <p>Joints between blocks are recessed but mostly appeared well filled. On the southwest corner mortar has recessed further and daylight visible. The joint needs carefully repointing. <b>REPOINTING</b></p> | <b>3</b> |

| 1 | REPOINTING | 4.6, | |

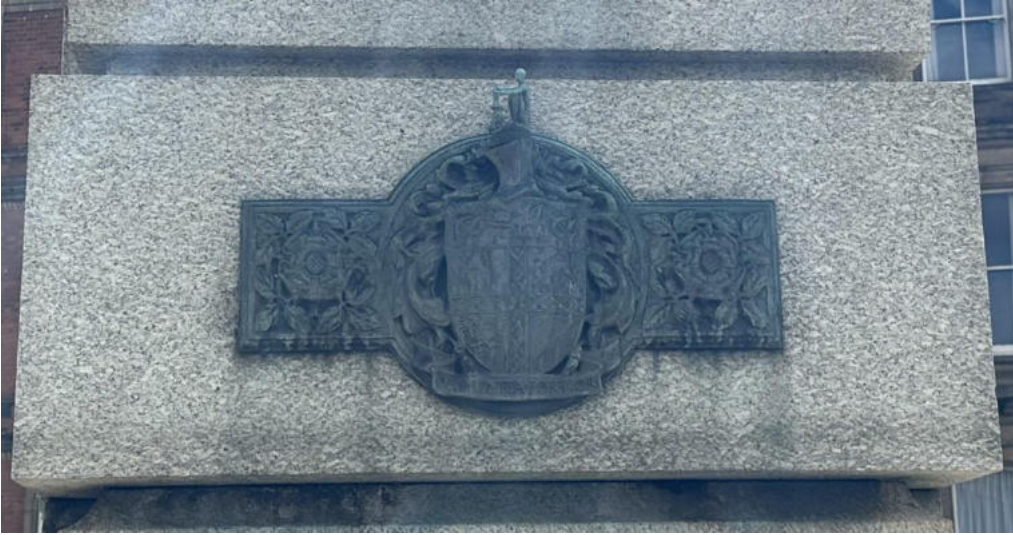
| 4.7 | <p>Above the inscription there is a bronze panel with roses to each side of the Stoke on Trent coat of arms. The bronze has weathered and oxidized to a verdigris patina. The visual effect is relatively pleasant but the appropriateness of oxidation of memorials is subjective. It would be undesirable to attempt to remove the patination but a hot or cold wax coating could be considered for application over the existing patina. <b>CONSIDER WAX COATING OF BRONZE</b></p> | 4 |

| 6 | WAX COATING OF BRONZE | 4.7, 4.9, 4.11, 4.13, | L |

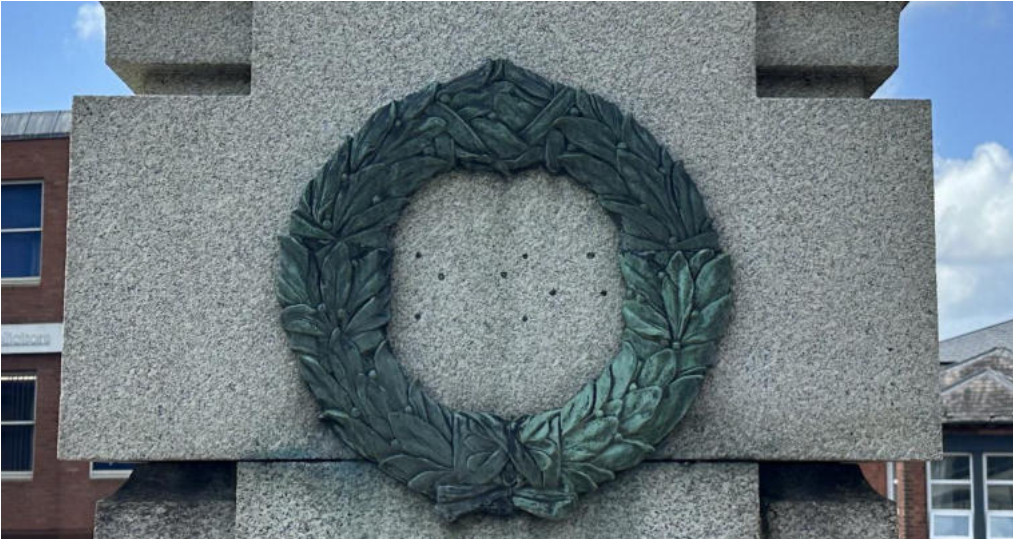
| 4.9 | <p>Above the plaque is a bronze wreath. The bronze has weathered and oxidized to a verdigris patina. The visual effect is relatively pleasant but the appropriateness of oxidation of memorials is subjective. It would be undesirable to attempt to remove the patination but a hot or cold wax coating could be considered for application over the existing patina. <b>CONSIDER WAX COATING OF BRONZE</b></p> | 4 |
| 4.10 | <p>There are drill holes in the centre of the wreath that should be filled. <b>STONE REPAIRS</b></p> | 3 |

| 2 | STONE REPAIRS | 4.10, 4.12, | L |

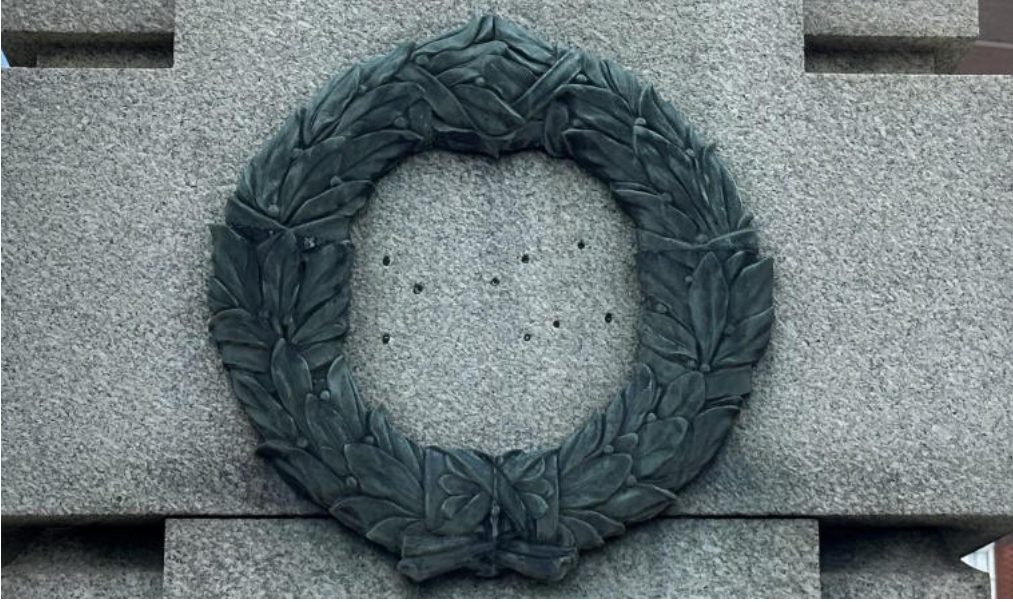
| <p><b>4.11</b></p> | <p>There is a similar bronze wreath on the west face. The bronze has weathered and oxidized to a verdigris patina. The visual effect is relatively pleasant but the appropriateness of oxidation of memorials is subjective. It would be undesirable to attempt to remove the patination but a hot or cold wax coating could be considered for application over the existing patina. <b>CONSIDER WAX COATING OF BRONZE</b></p> | <p><b>4</b></p> |
| <p><b>4.12</b></p> | <p>There are similar drill holes in the centre of the wreath that should be filled. <b>STONE REPAIRS</b></p> | <p><b>3</b></p> |

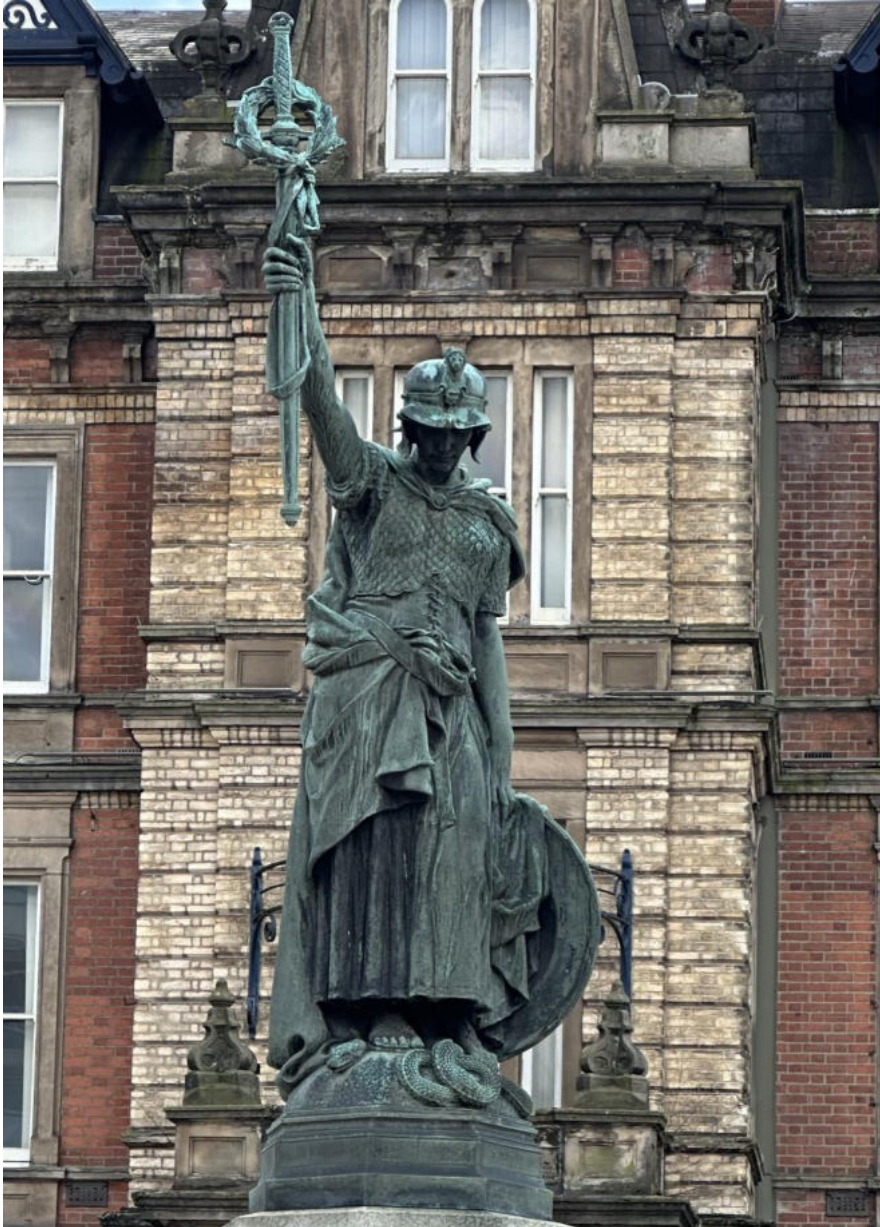
| <b>4.13</b> | <p>The bronze has weathered and oxidized to a verdigris patina. The visual effect is relatively pleasant but the appropriateness of oxidation of memorials is subjective. It would be undesirable to attempt to remove the patination, but a hot or cold wax coating could be considered for application over the existing patina. <b>CONSIDER WAX COATING OF BRONZE</b></p> | <b>4</b> |

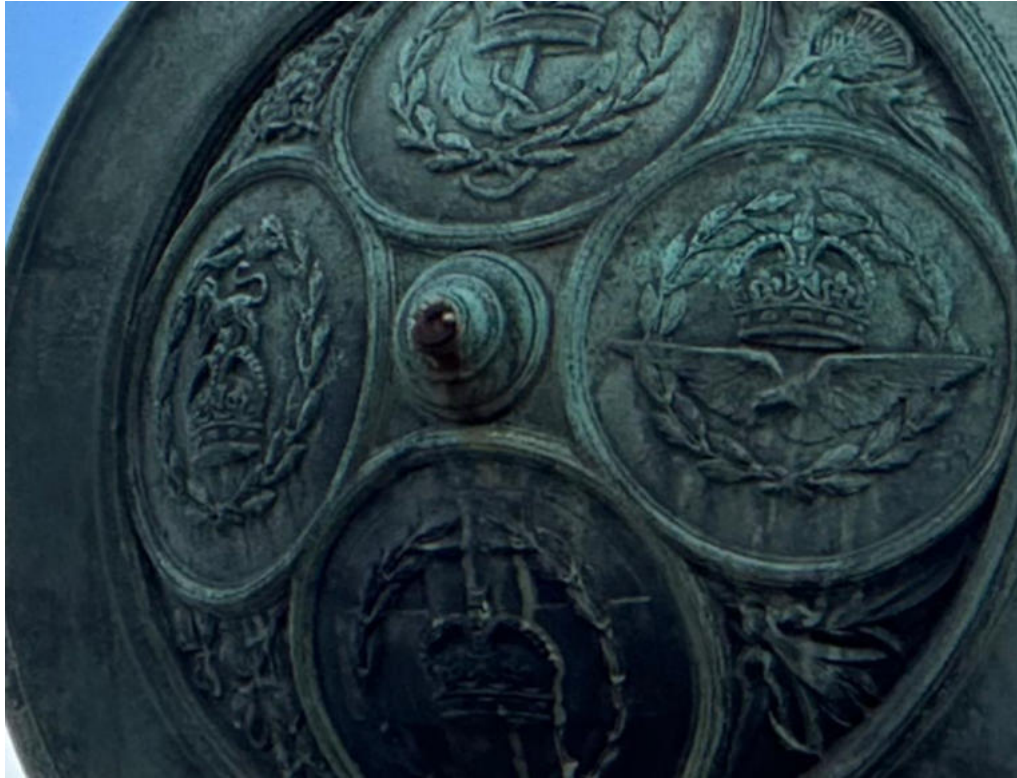
**4.14**

No holing could be identified within the bronze casting however there is some brown oxidization to the centre of the shield, suggesting a ferrous metal core pins left in the bronze at the time of casting, or armatures still present within the hollow bronze. This can be removed with the localized use of chemical poultices. **REMOVE FERROUS STAINING**

| 7 | REMOVE FERROUS STAINING | 4.22 | |
