# Bucknall War Memorial

## Condition Report

Document ID: 140-05-CR07

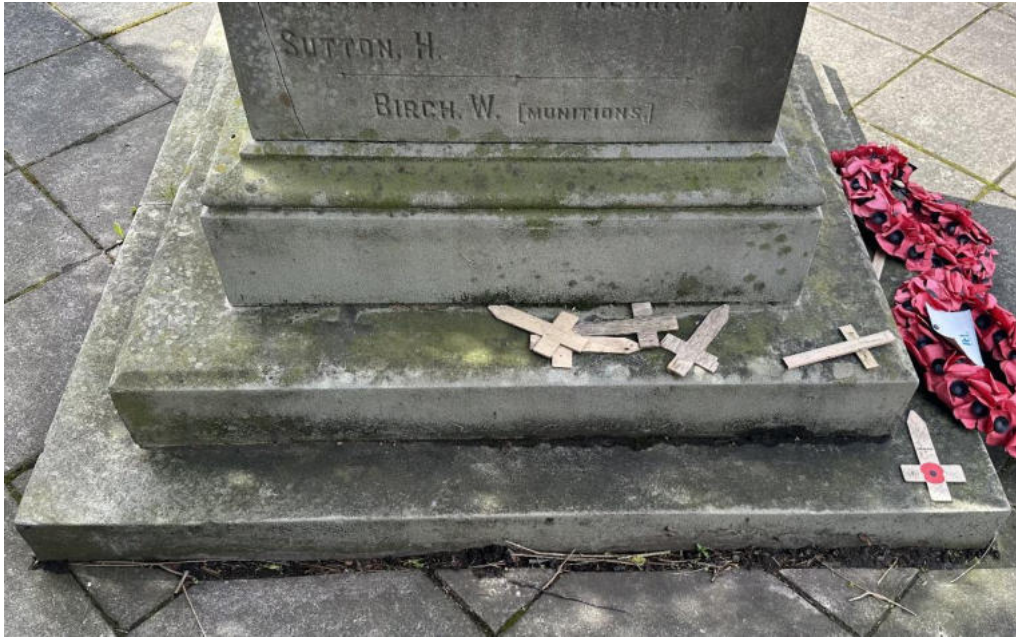
| <b>4.1</b> | <p>The stone of the stepped base is in good condition. There is a covering of green algae on sky facing surfaces that could be cleaned off. Cleaning should be considered with an appropriate biocide. If results are not satisfactory a superheated steam system could be considered. No abrasive or high-pressure methods should be employed. <b>STONE CLEANING</b></p> | <b>4</b> |

| 2 | STONE CLEANING | 4.1, 4.3, 4.5, 4.6, | C |

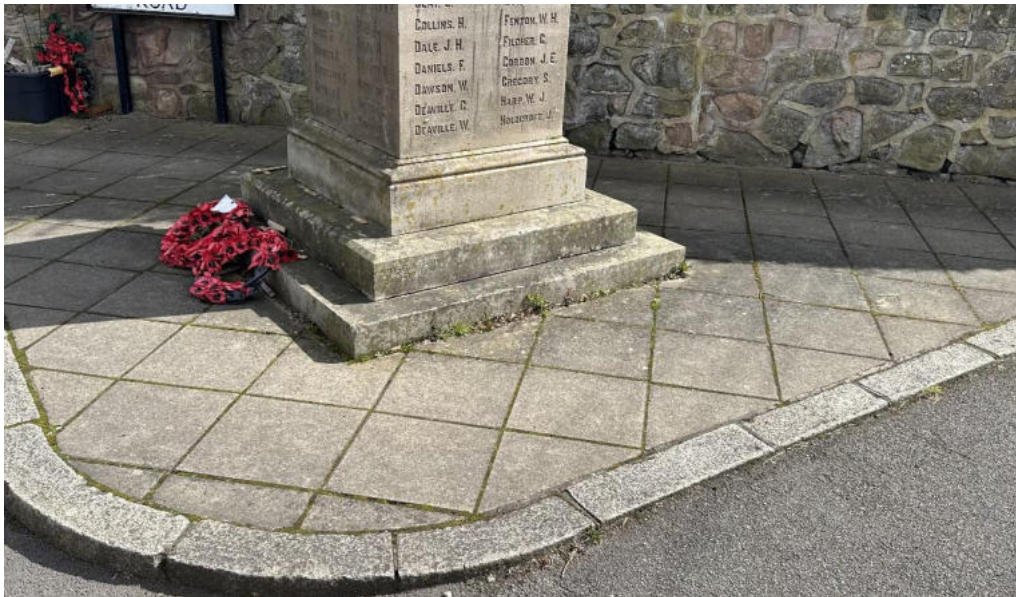
| <b>4.2</b> | <p>The area is paved with concrete slabs retained by granite kerbs. These were also covered with dirt and algae and would benefit from cleaning. <b>PAVING CLEANING</b></p> | <b>4</b> |

| 3 | PAVING CLEANING | 4.2, | C |

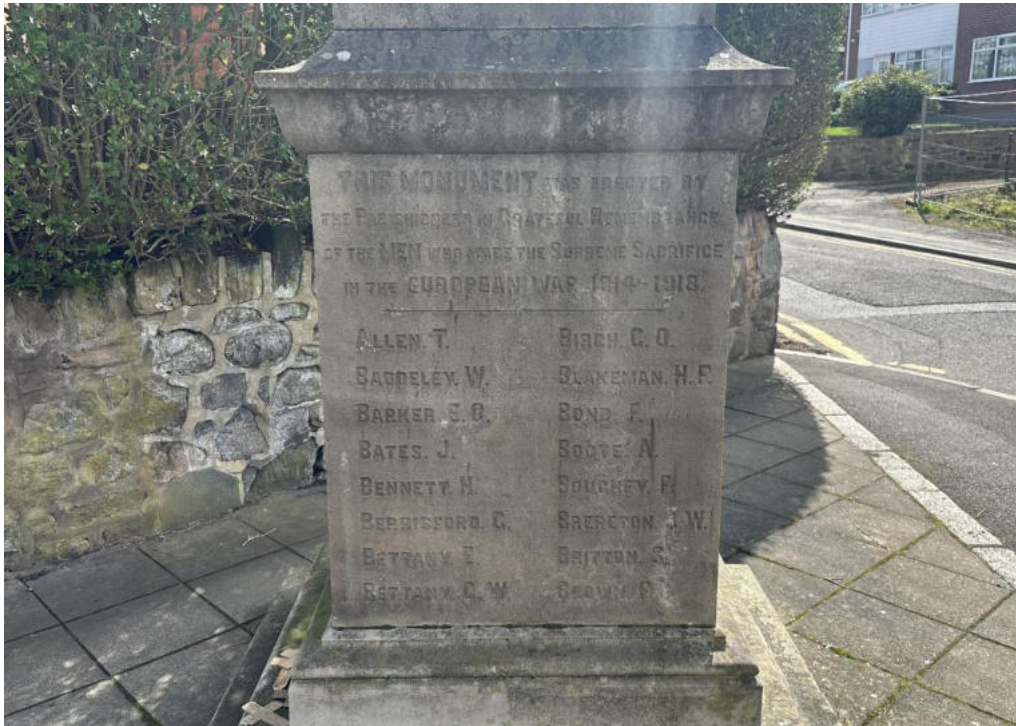
| <b>4.3</b> | <p>The stone plinth is inscribed on all faces. The stone is stained with atmospheric dirt and algae and would benefit from cleaning. Cleaning should be considered with an appropriate biocide. If results are not satisfactory a superheated steam system could be considered. No abrasive or high-pressure methods should be employed. <b>STONE CLEANING</b></p> | <b>4</b> |

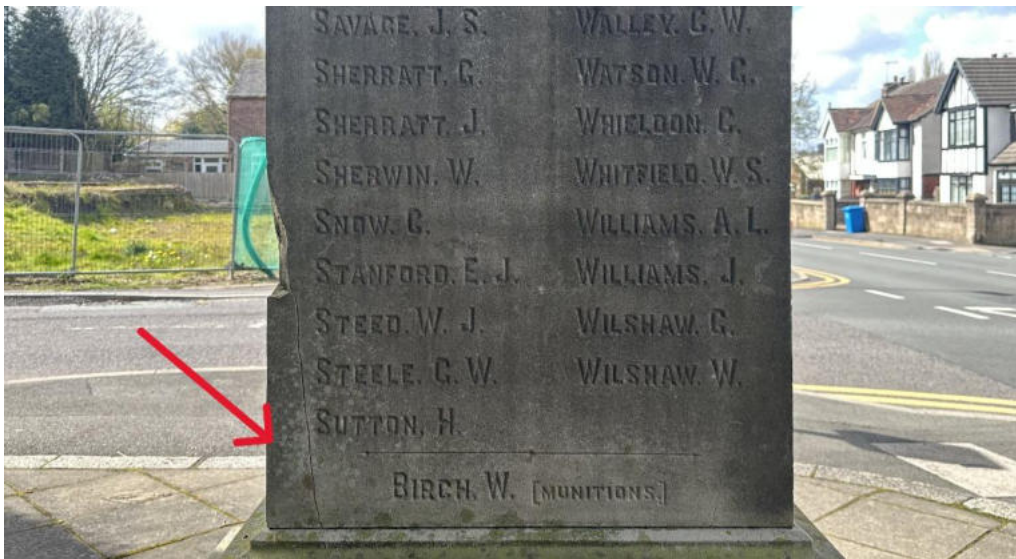
**In the immediate term,** stone repair is needed to a crack on the southwest corner to pin and indent stone.

| <b>4.4</b> | <p>The stone is cracked and a section missing on the southwest corner. The remaining stone should be pinned and a new section indented above. <b>STONE REPAIRS</b></p> | <b>3</b> |

| 1 | STONE REPAIRS | 4.4, | |

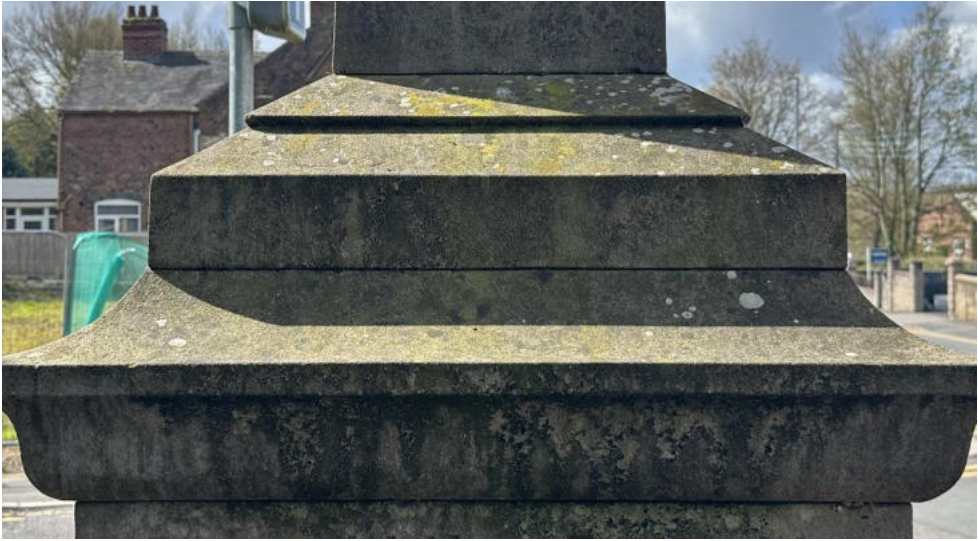
| 4.5 | <p>The capping stones are in good condition and joints are tight. There is a covering of green algae that could be cleaned off. <b>STONE CLEANING</b></p> | 4 |

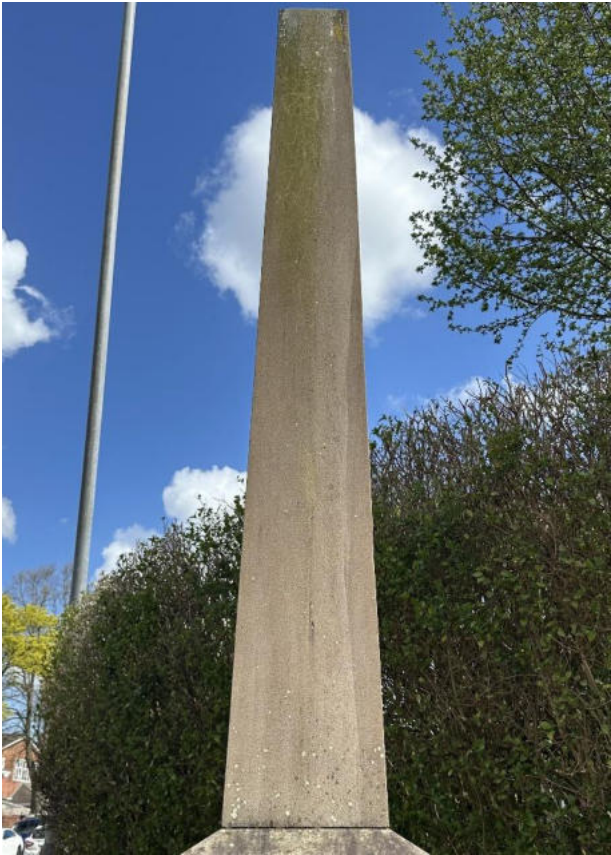
| 4.6 | <p>The obelisk is a single length of stone cut to a taper and appeared both plumb and stable when pushed. There is some staining from water run off from the apex. <b>STONE CLEANING</b></p> | 4 |
