# Fenton War Memorial

## Condition Report

Document ID: 140-05-CR25

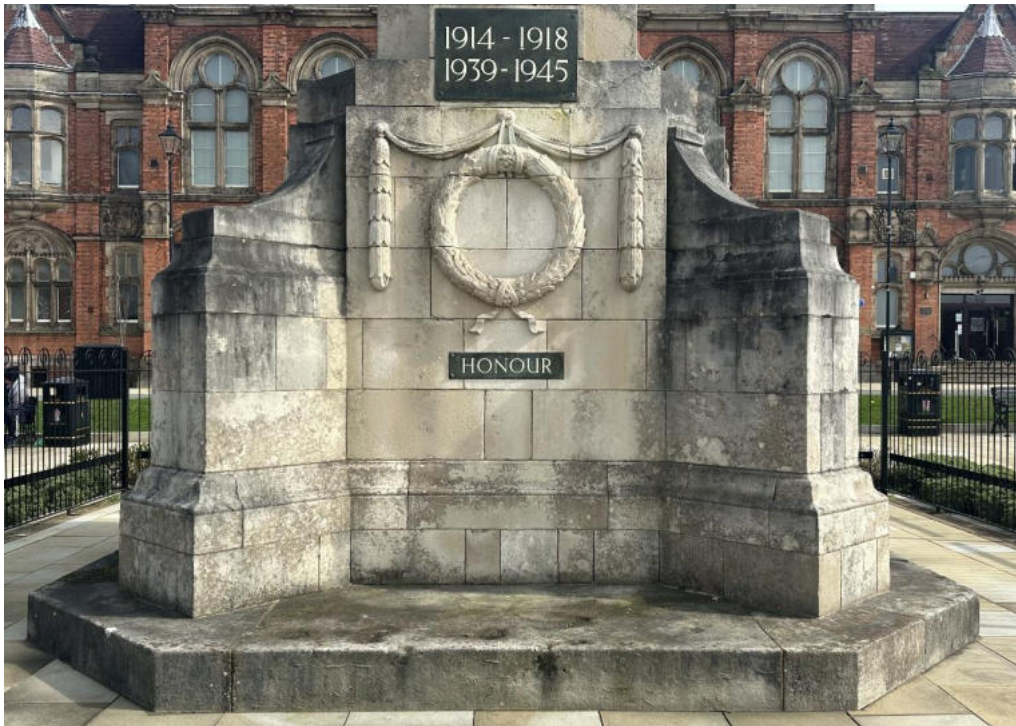
| <b>4.4</b> | <p>The base is constructed of Portland Stone laid with tight ashlar joints. There are newspaper reports of the monument being cleaned in 2022, but there is a build up of atmospheric dirt particularly on sky facing surfaces that would benefit from further cleaning. Cleaning should be considered with an appropriate biocide. If results are not satisfactory a superheated steam system could be considered. No abrasive or high-pressure methods should be employed. <b>STONE CLEANING</b></p> | <b>5</b> |

| 5 | STONE CLEANING | 4.4, 4.12, 4.14, | L, C |

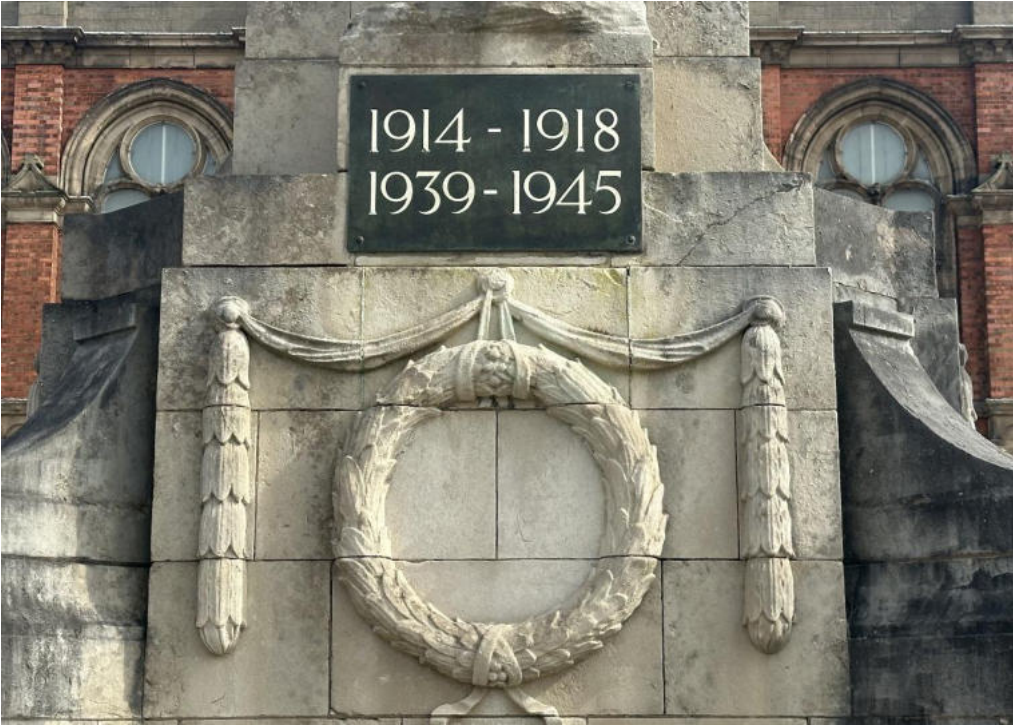
| <p><b>4.5</b></p> | <p>Ashlar joints are recessed or open and should be repointed with a fine lime mortar.</p> <p><b>REPOINTING</b></p> | <p><b>3</b></p> |

| 1 | REPOINTING | 4.5, 4.8, 4.9, 4.11, 4.13, | L, C |

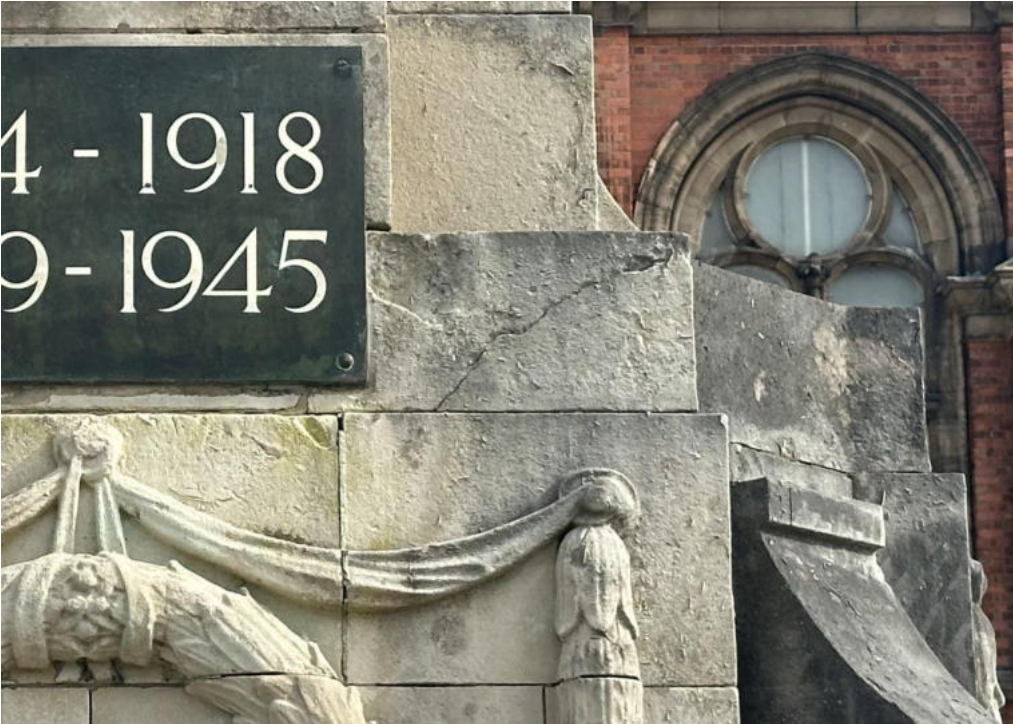
| <p><b>4.6</b></p> | <p>On the west face above the wreath and festoons a stone is cracked but appears in place. The crack could be finely grouted to prevent water ingress. <b>STONE REPAIR</b></p> | <p><b>4</b></p> |

| 2 | STONE REPAIR | 4.6, | L, C |

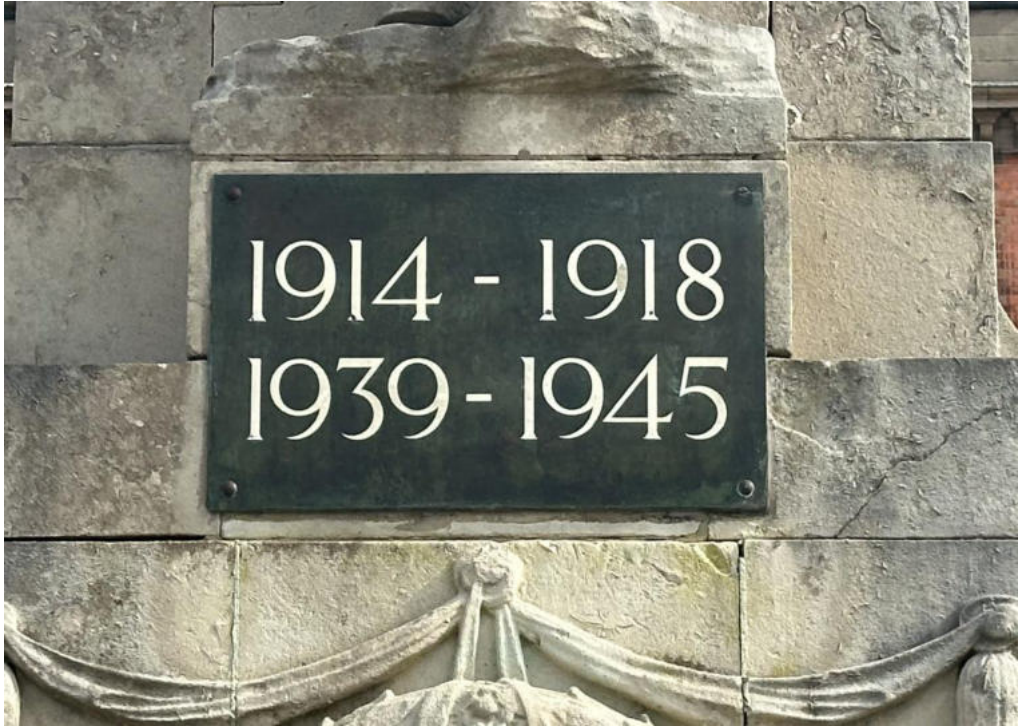
| 4.7 | <p>Bronze plaques have memorial dates painted on the surface and were in good condition. The bronze could have a coating of wax for protection. <b>CONSIDER WAX COATING OF BRONZE</b></p> | 5 |

| 3 | WAX COAT BRONZE | 4.7 | C |

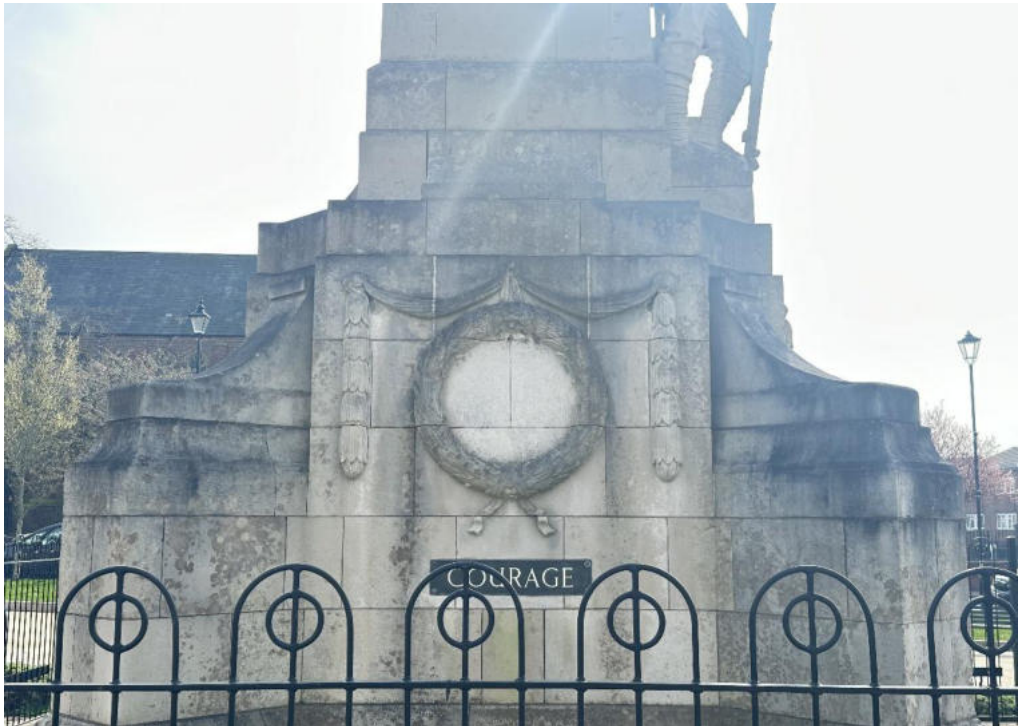
| 4.8 | <p>There are recessed and open joints on the north face that need repointing. <b>REPOINTING</b></p> | 3 |

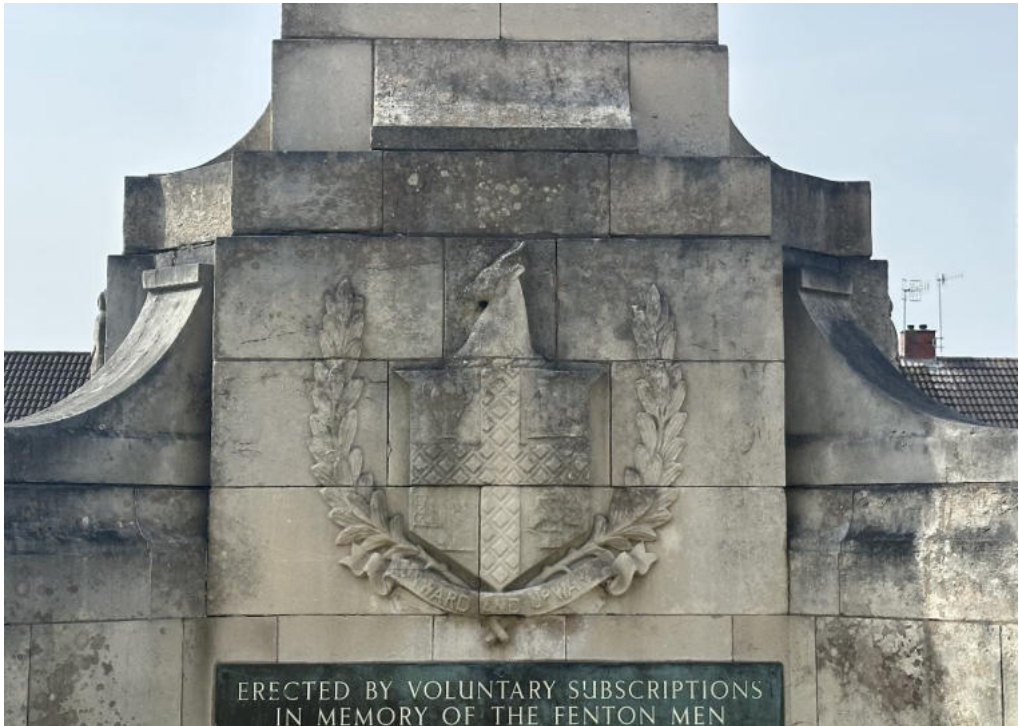
| <p><b>4.9</b></p> | <p>The east face has recessed and open joints that need repointing. <b>REPOINTING</b></p> | <p><b>3</b></p> |

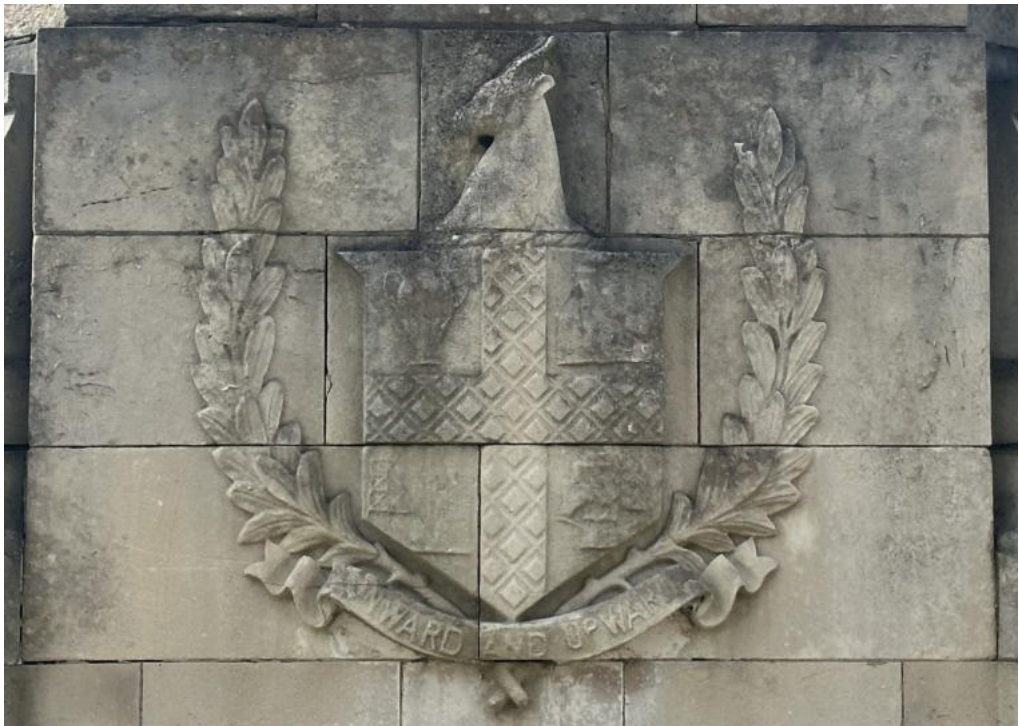
| <p><b>4.10</b></p> | <p>Detail and lettering is missing and eroded from the coat of arms. A record of the remaining should be made. <b>RECORD STONE DETAILS</b></p> | <p><b>5</b></p> |

| 4 | RECORD STONE DETAILS | 4.10 | V |

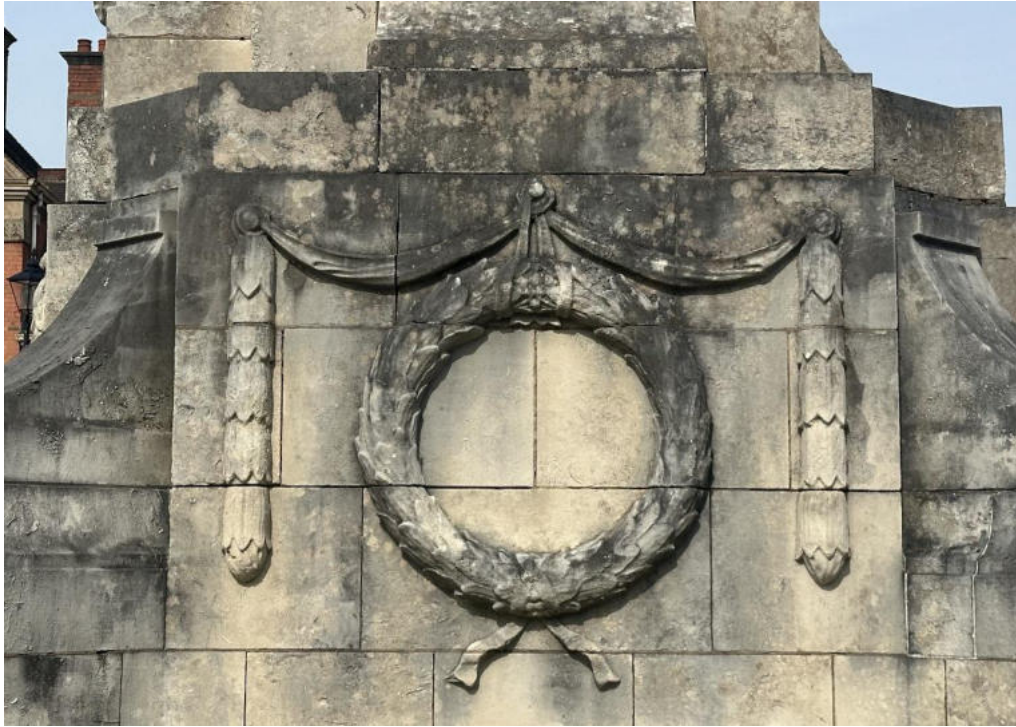
4.11

The south face has recessed and open joints that need repointing. **REPOINTING**

3

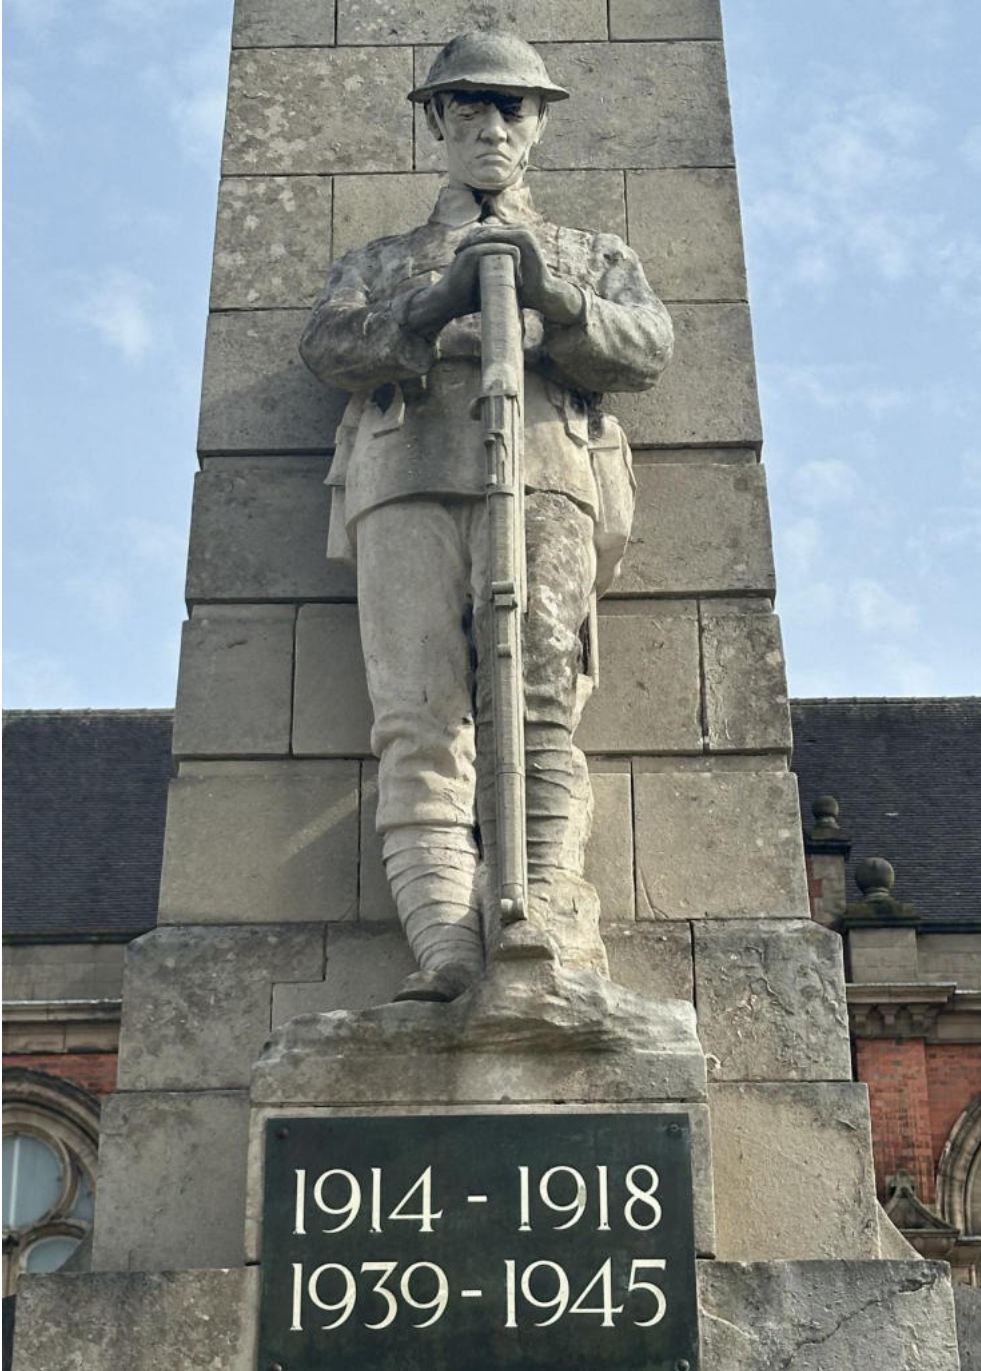
| <b>4.12</b> | <p>The figure on the west face is well detailed and stone condition appears fair. Some light cleaning could be considered. Cleaning should be considered with an appropriate biocide. If results are not satisfactory a superheated steam system could be considered. No abrasive or high-pressure methods should be employed. <b>STONE CLEANING</b></p> | <b>5</b> |

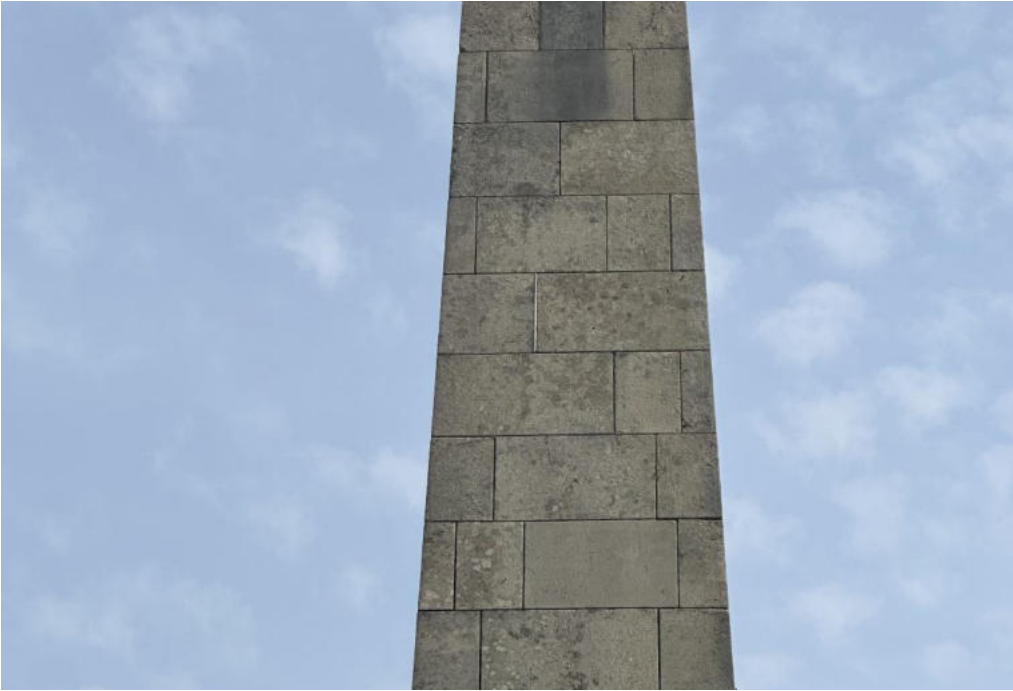
| <p><b>4.13</b></p> | <p>The stone of the obelisk is sharply cut and laid with tight ashlar joints. Joints are recessed and open and would benefit from repointing. <b>REPOINTING</b></p> | <p><b>3</b></p> |

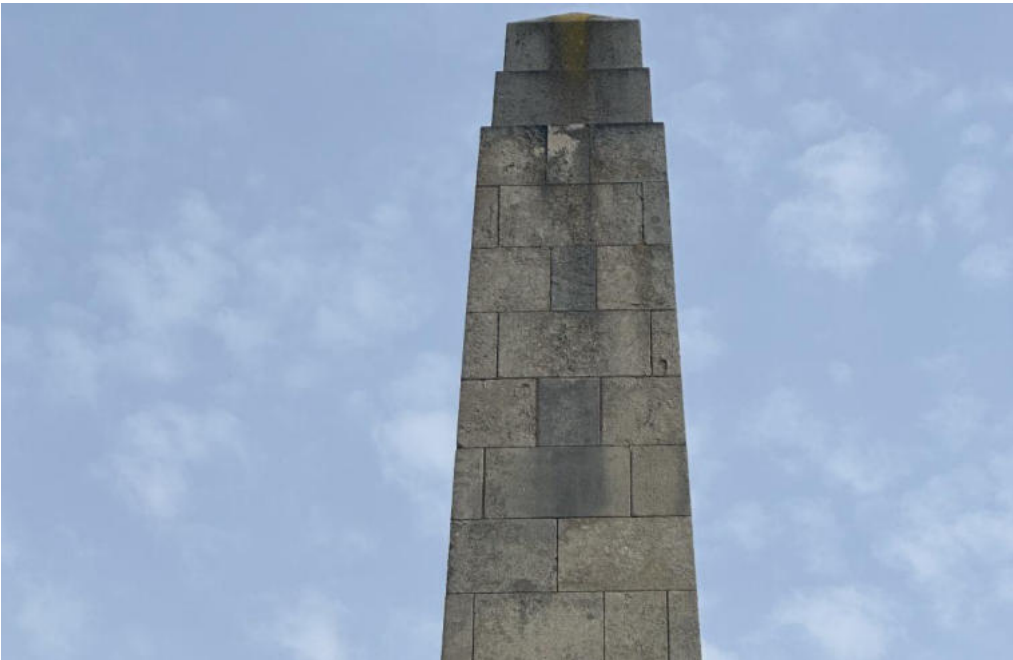
| <p><b>4.14</b></p> | <p>There is some water staining from the apex. Cleaning should be considered with an appropriate biocide. If results are not satisfactory a superheated steam system could be considered. No abrasive or high-pressure methods should be employed. <b>STONE CLEANING</b></p> | <p><b>5</b></p> |
