# **‘Her Head’ Condition Report**

Date: 13.04.2026

Document ID: 140-05-CR24

Her Head is a bronze sculpture by Dhruva Mistry.

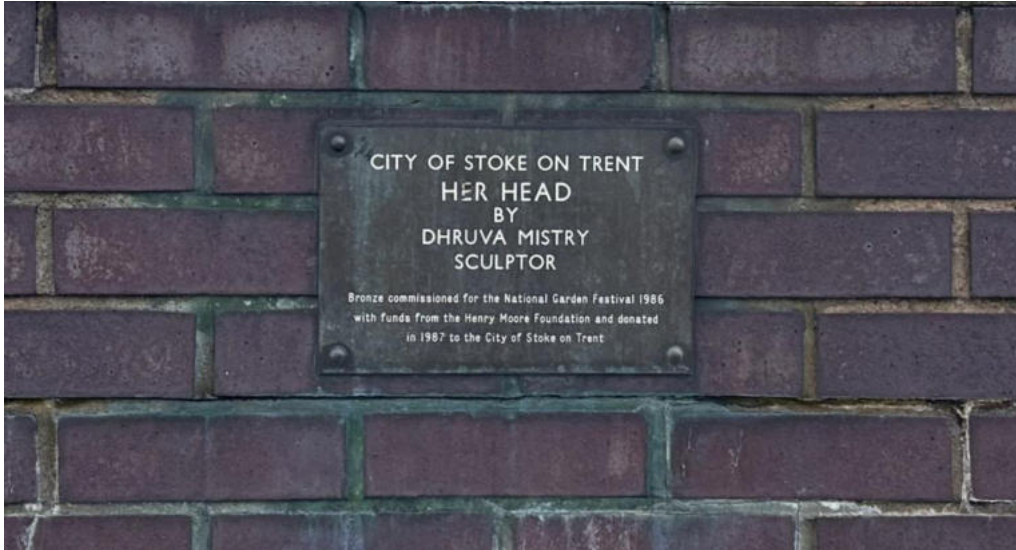
| <b>4.1</b> | <p>The base plinth is a monolith of Staffordshire Blue brick. A metal plaque on the west face has a painted inscription. The lettering is sharp and attempts at cleaning may affect the lettering, so should be undertaken carefully by hand. <b>CLEAN PLAQUE</b></p> | <b>5</b> |

| | WAX COATING TO BRONZE | 4.1, 4.7, | C |

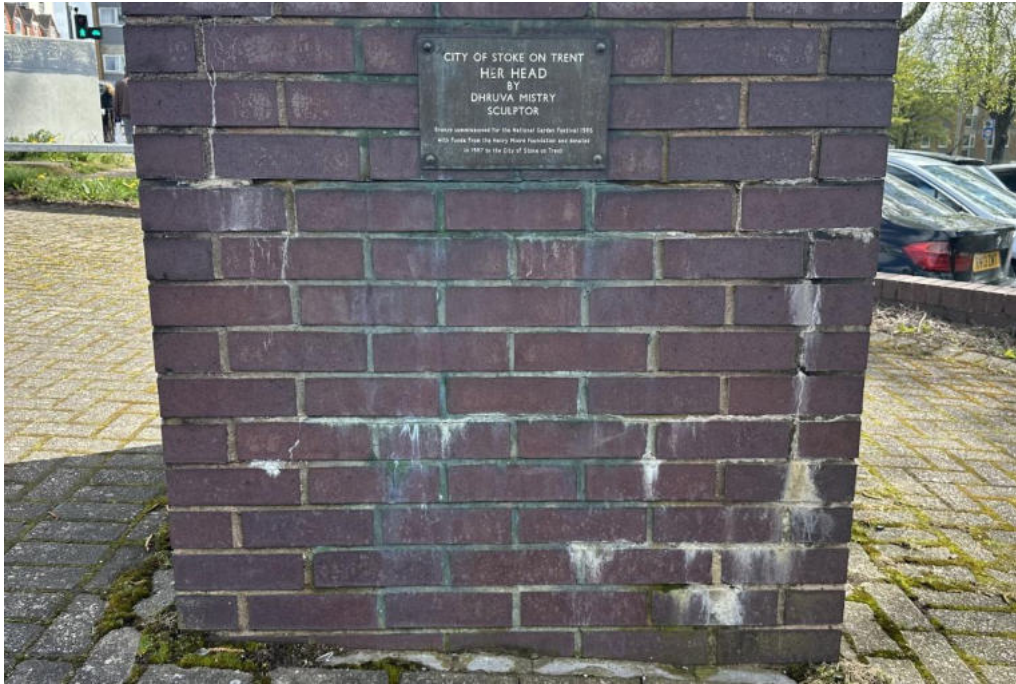
| <b>4.2</b> | <p>All brick faces are stained with efflorescence from the mortar, and would benefit from cleaning. Water based cleaning is not likely to be effective against salts and could just lead to their re-absorption. A mild abrasive may be more effective (e.g. walnut shell, dry ice etc), and the hard engineering brick should tolerate this. <b>MASONRY CLEANING</b></p> | <b>5</b> |

| | MASONRY CLEANING | 4.2, 4.6, | C |

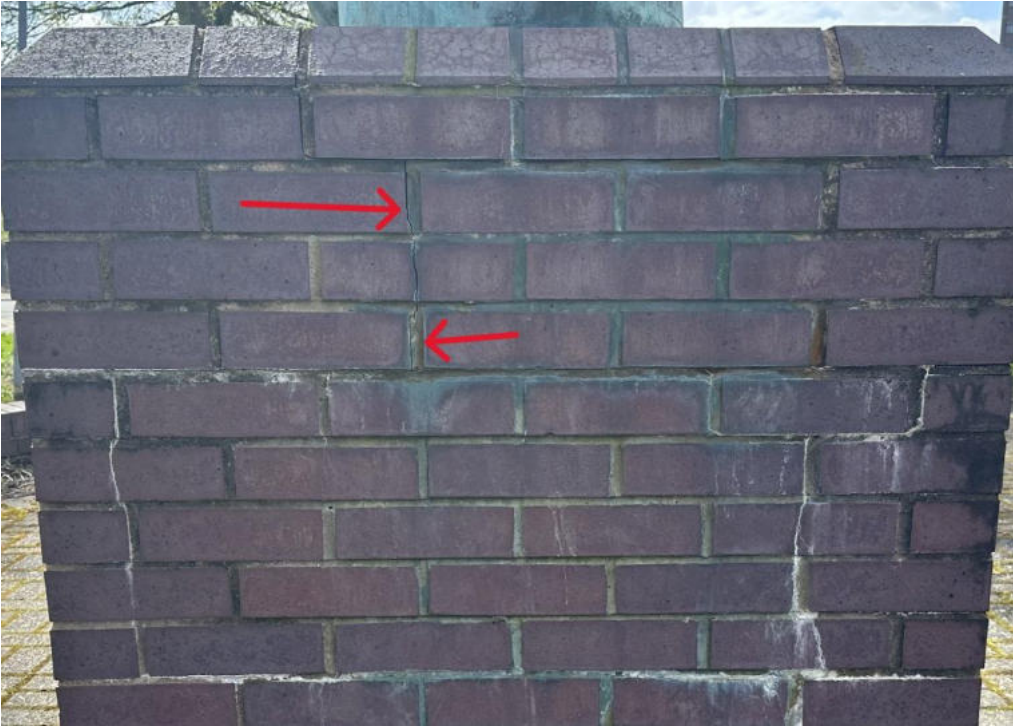
| <p><b>4.3</b></p> | <p>On the north face there is a crack through joints and a split brick. Joints should be repointed and cracked brick replaced. <b>MASONRY REPAIRS</b></p> | <p><b>3</b></p> |

| | MASONRY REPAIRS | 4.3, 4.4, 4.5, | |

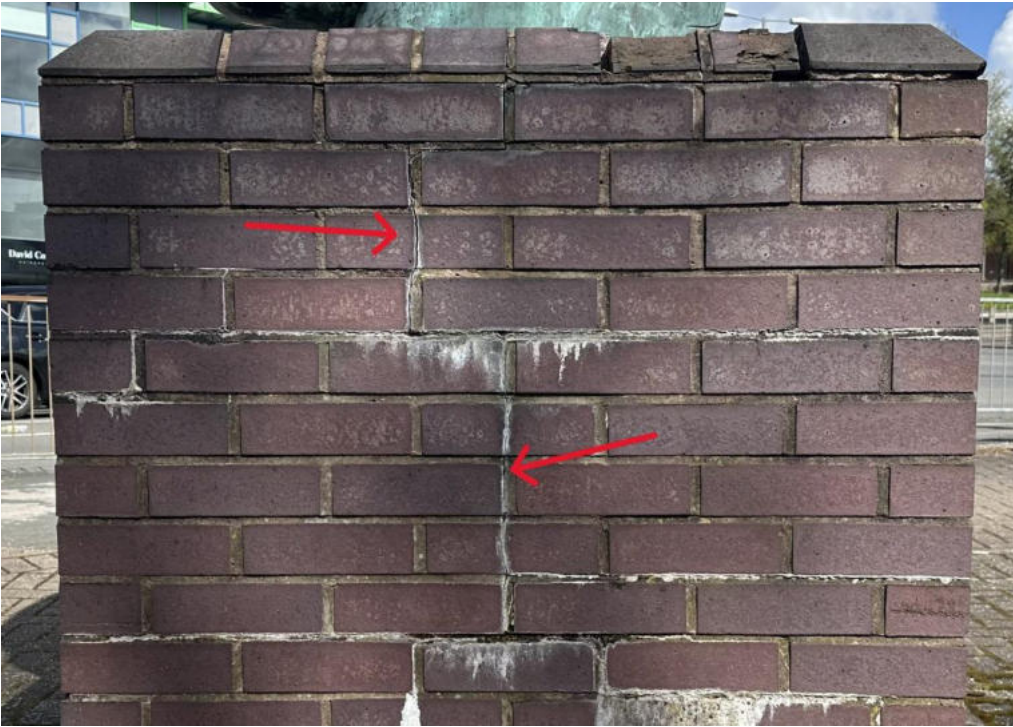
| <p><b>4.4</b></p> | <p>On the south face there is a crack through joints and a split brick. Joints should be repointed and cracked brick replaced. <b>MASONRY REPAIRS</b></p> | <p><b>3</b></p> |

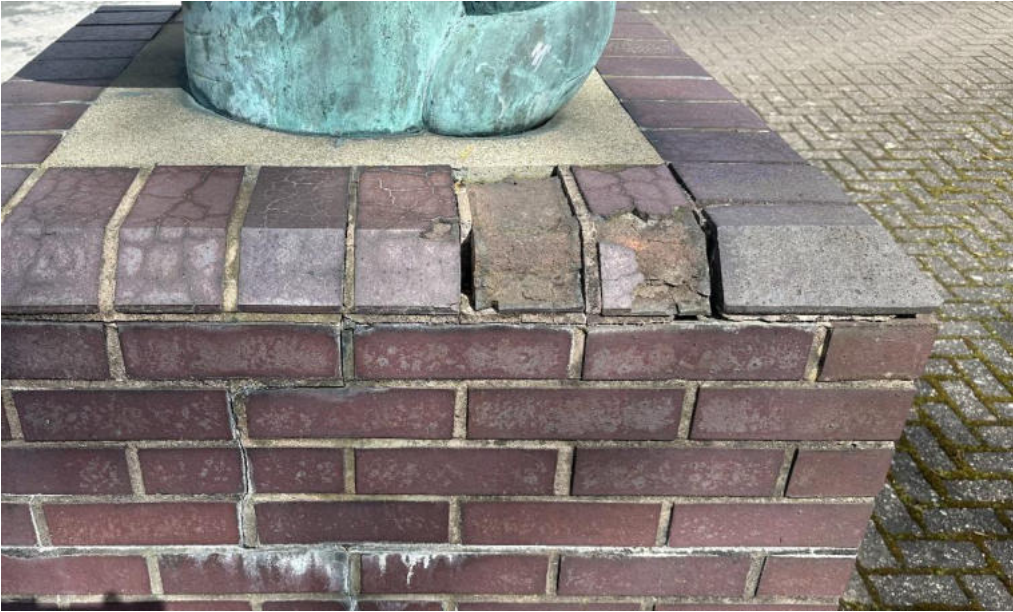
| 4.5 | <p>Cant bricks on the south side have shaled and mortar joints are open. The corner capping brick is loose and should be re-bedded. <b>MASONRY REPAIRS</b></p> | 3 |

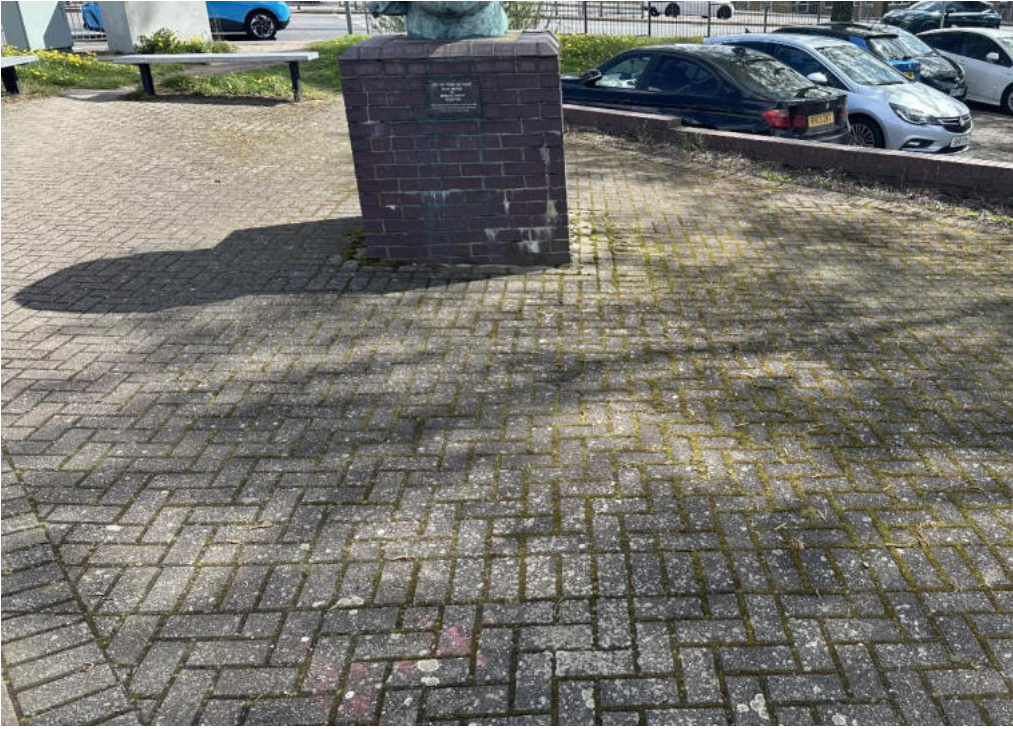
| 4.6 | <p>The surrounding area is paved with concrete setts. There is moss growth to all joints and faces are covered with algae spotting. The area could be cleaned to improve appearance. Cleaning should be considered with an appropriate biocide. Pressure washing may also suffice but pointing should be inspected and replaced afterward if disturbed. <b>MASONRY CLEANING</b></p> | 5 |

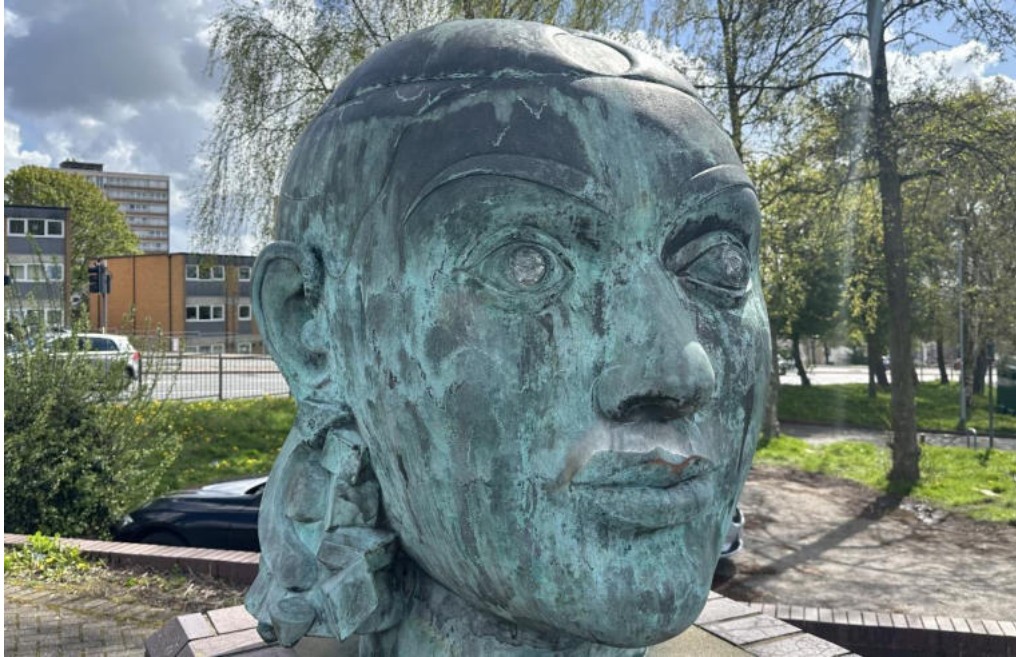
| 4.7 | <p>The bronze may have been pre-patinated when first installed at its site in the Garden Festival, however the surface could be further preserved <b>CONSIDER WAX COATING OF BRONZE</b></p> | 5 |

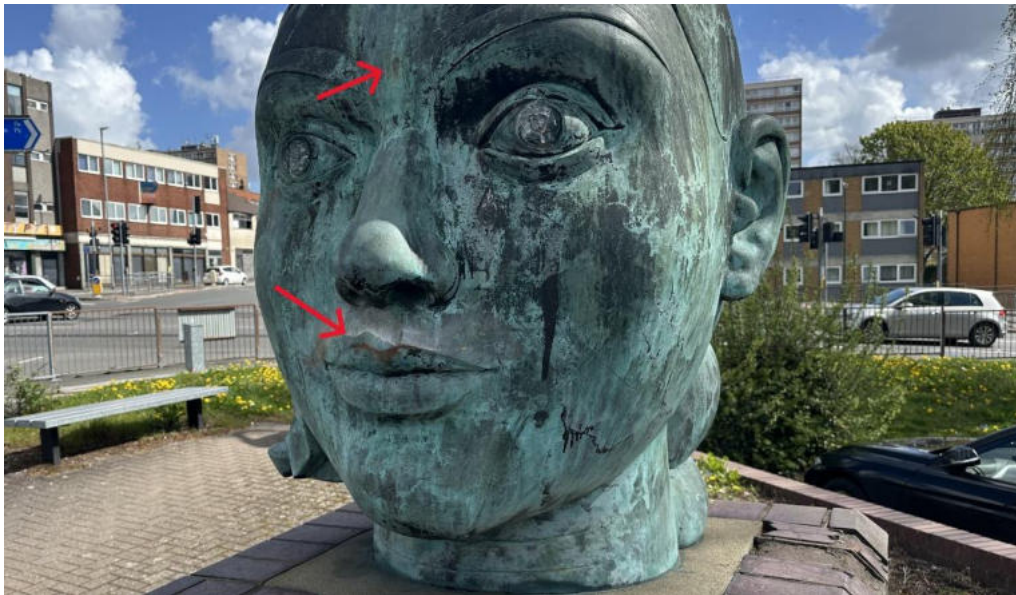
| 4.8 | <p>There are a couple of areas of ferrous oxidation which could be due to internal steel armatures showing through. The corrosion is not severe enough to warrant intrusive work to replace internal metalwork, but the discolouration of the surface should be managed. <b>RUST TREATMENT</b></p> | 4 |

| | RUST TREATMENT | 4.8, | |

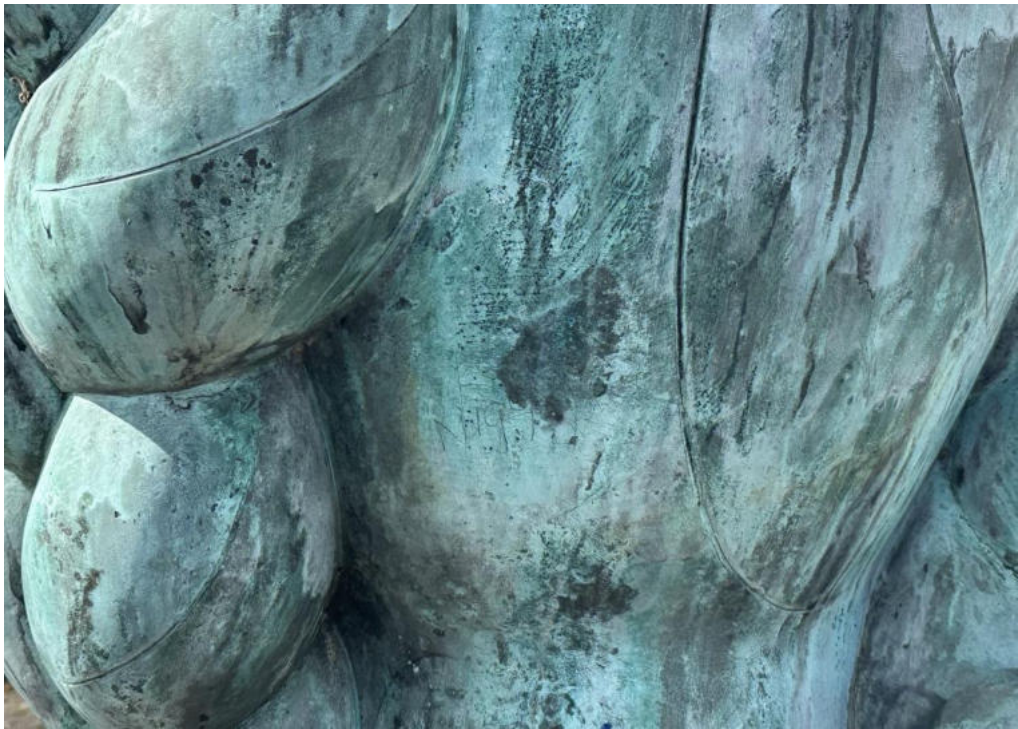
| 4.9 | <p>There is an instance of graffiti etched into the surface, but this may prove impossible to remove without damaging the existing patina. Spray painted graffiti to the mouth and eyes is probably going to prove easier to remove. If a light abrasive (e.g. wire wool) needs to be used then the area affected may need to be re-patinated to blend with the existing finish..</p> <p><b>GRAFFITI REMOVAL</b></p> | 4 |

| | GRAFFITI REMOVAL | 4.9, | V |
