# Kingsway Cenotaph

## Condition Report

Date: 20.03.2026

Document ID: 140-05-CR18

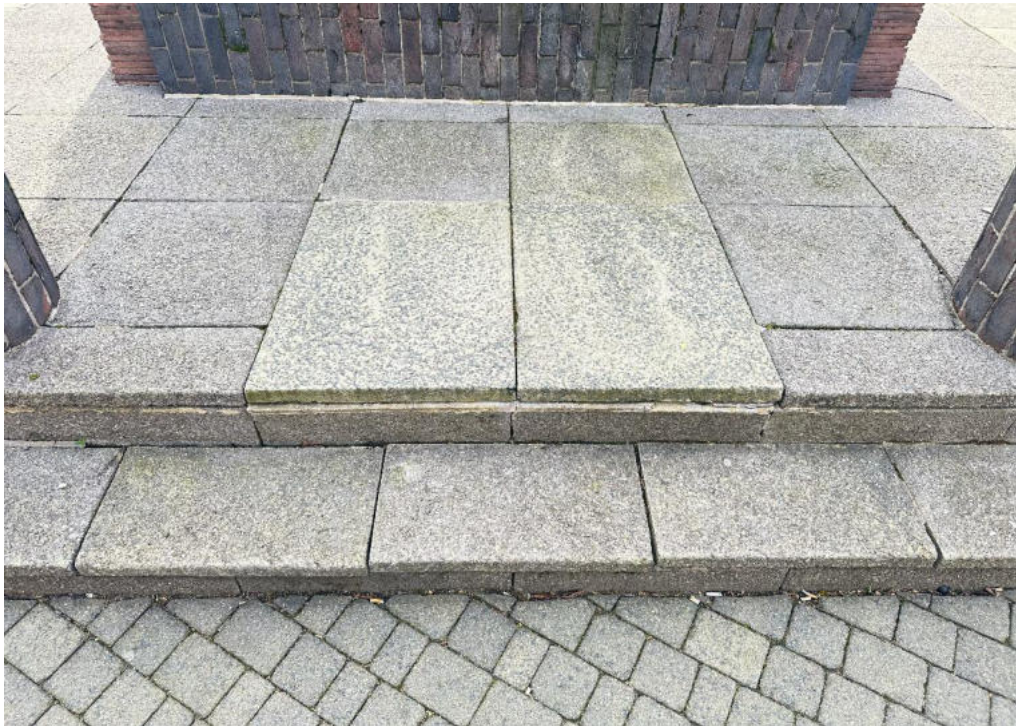
| <b>4.2</b> | <p>Paving slabs all have open joints but would have originally been tightly jointed. Slabs are loose to all sides and are rocking on the lower step and all should be re-bed in mortar.</p> <p><b>RE-LAY PAVING SLABS</b></p> | <b>2</b> |

| 3 | RE-LAY PAVING | 4.2 | |

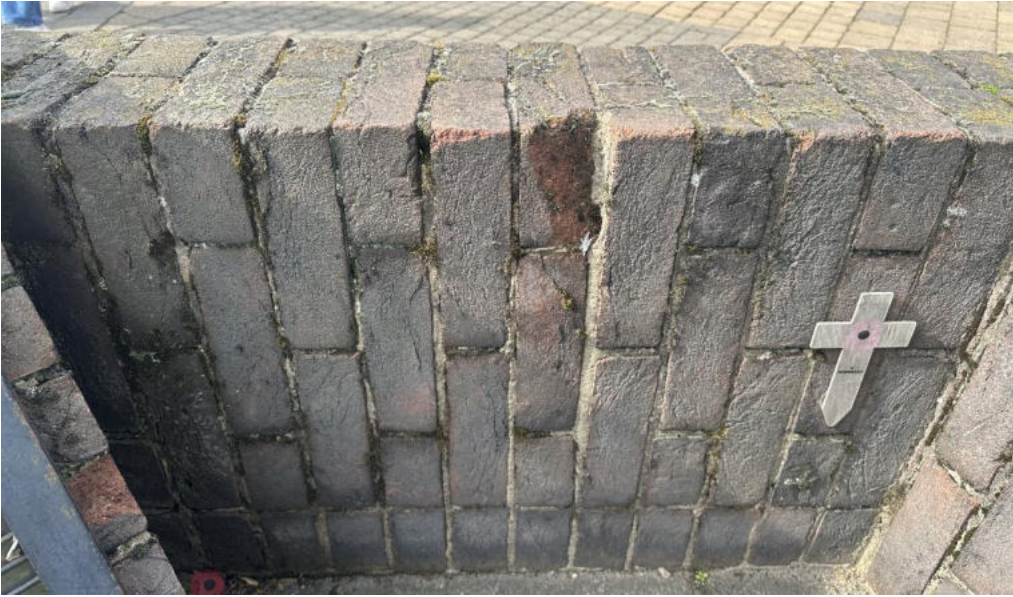
| <p><b>4.3</b></p> | <p>The dwarf walls have bricks laid vertically and a circular pier to each end. A brick is chipped in the southwest corner and should be repaired. <b>BRICK REPAIR</b></p> | <p><b>3</b></p> |

| 6 | BRICK MORTAR REPAIR | 4.3, 4.14 | L |

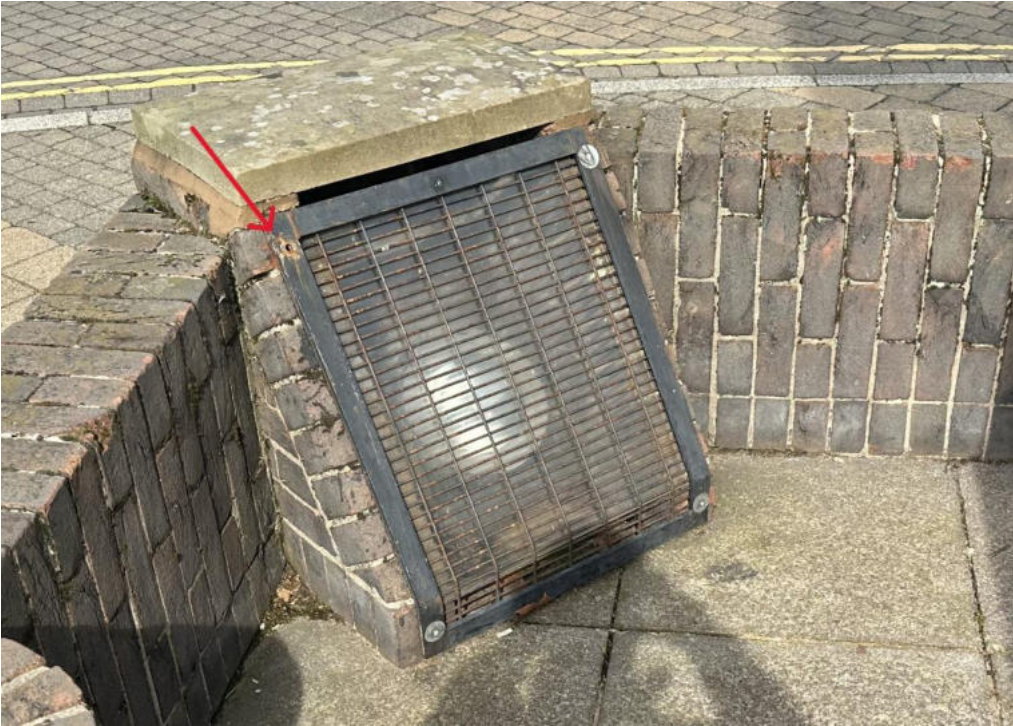
| <p><b>4.4</b></p> | <p>Each corner has a floodlight with polycarbonate and metal grille. There is a fixing bolt missing to the grille in the northwest corner. <b>REPLACE FIXING BOLT</b></p> | <p><b>4</b></p> |

| 8 | REPLACE FIXING BOLT | 4.4, 4.5, | |

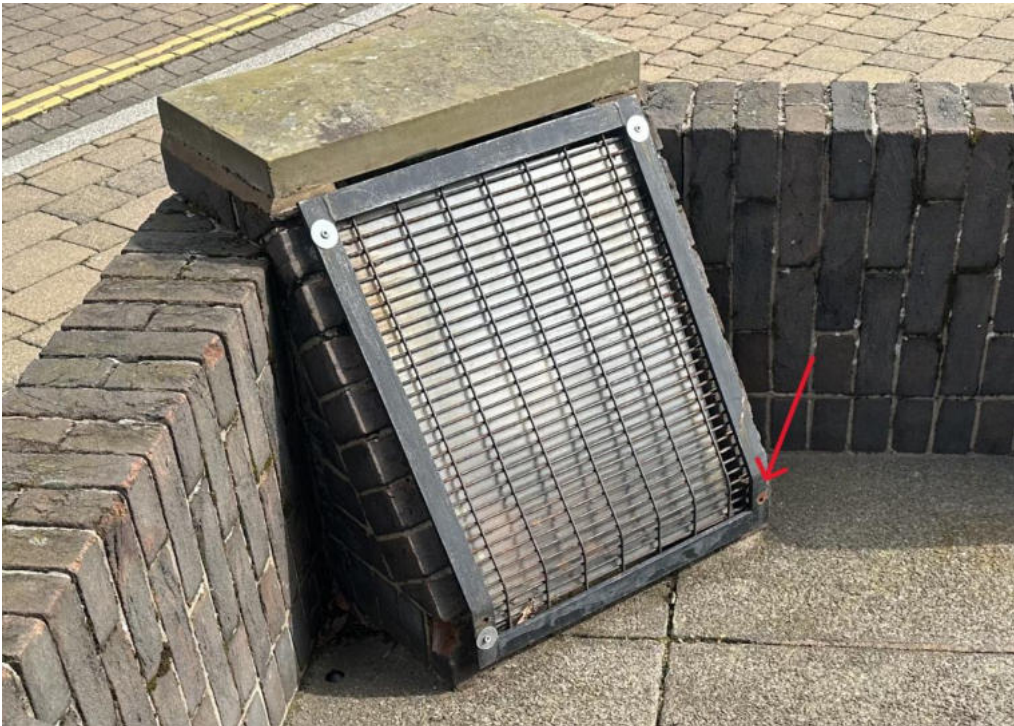
| <p><b>4.5</b></p> | <p>There is a fixing bolt missing from the grille in the northeast corner. <b>REPLACE FIXING BOLT</b></p> | <p><b>4</b></p> |

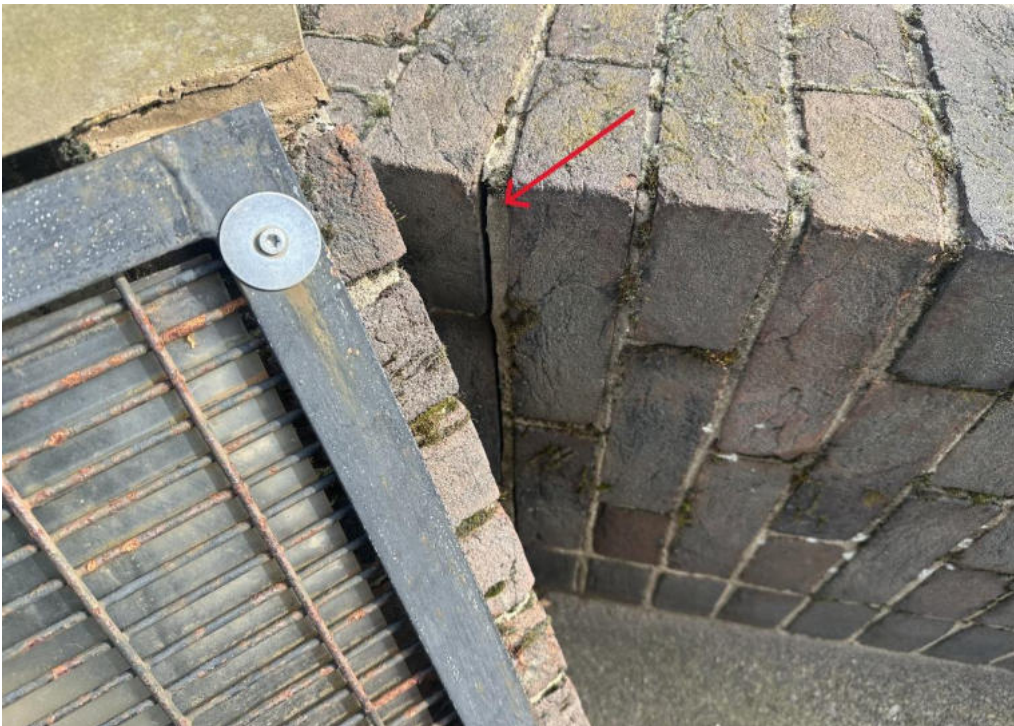
| <p><b>4.6</b></p> | <p>There is movement in the bricks on the northeast corner and a joint has opened. The joint should be repointed. <b>REPOINTING</b></p> | <p><b>2</b></p> |

| 4 | REPOINTING | 4.6, 4.11, 4.13, 4.21, 4.24, | |

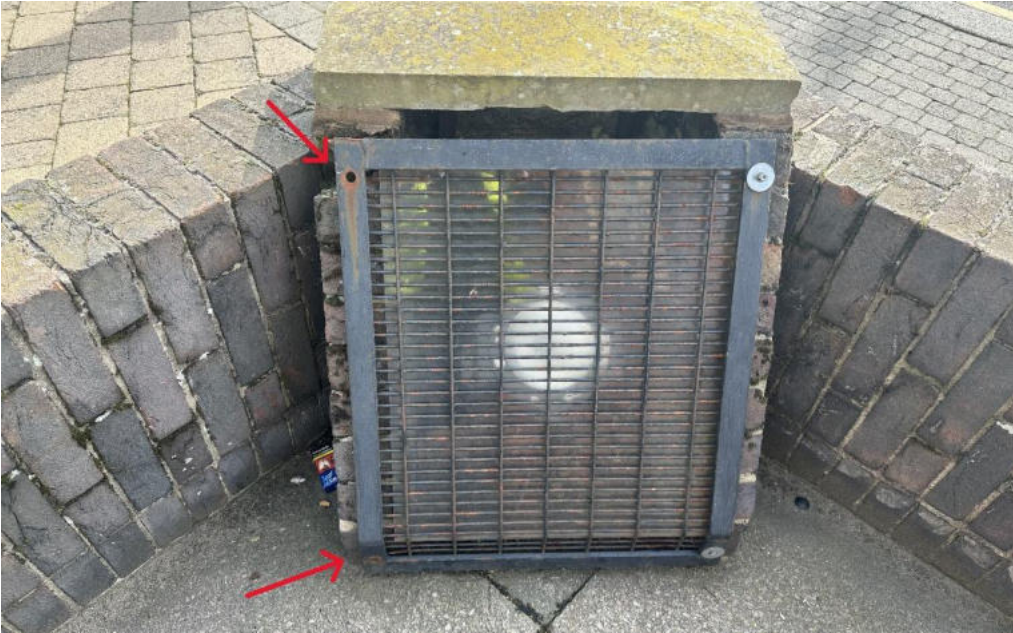
| <p><b>4.7</b></p> | <p>There are bolts missing from the grille of the southeast corner, that need replacing to prevent unauthorised access to the interior. <b>REPLACE FIXING BOLTS</b></p> | <p><b>1</b></p> |

| 1 | REPLACE FIXING BOLTS | 4.7 | |

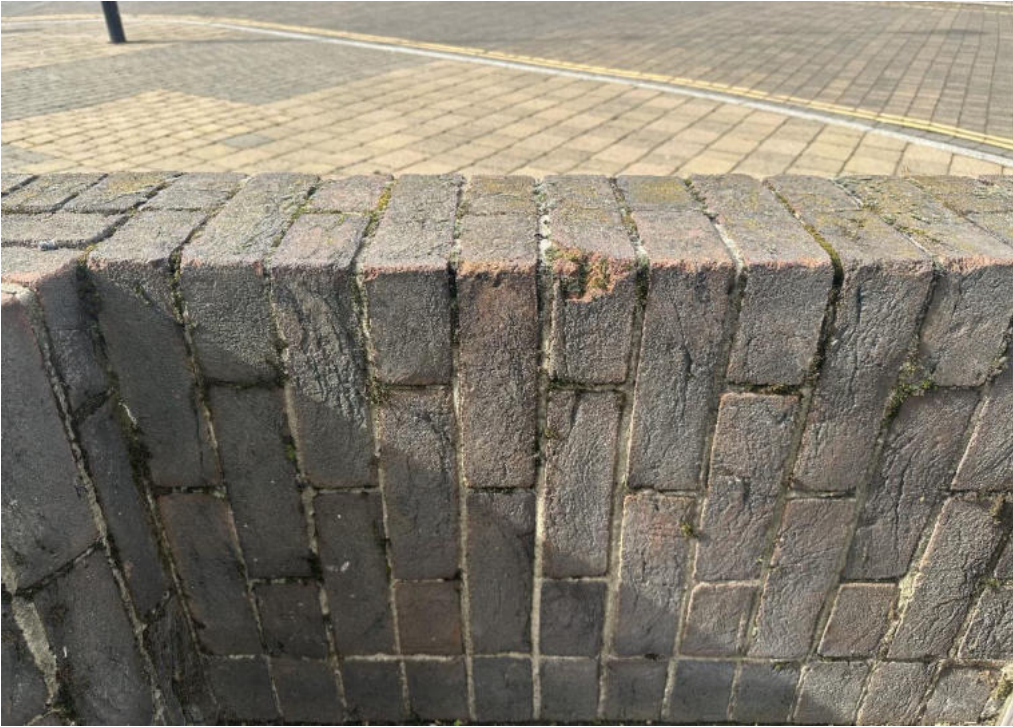
| <p><b>4.8</b></p> | <p>Moss should be removed from all joints and any open joints repointed. <b>REMOVE MOSS AND REPOINT</b></p> | <p><b>3</b></p> |

| 7 | DEVEGETATE AND REPOINT | 4.8, | V |

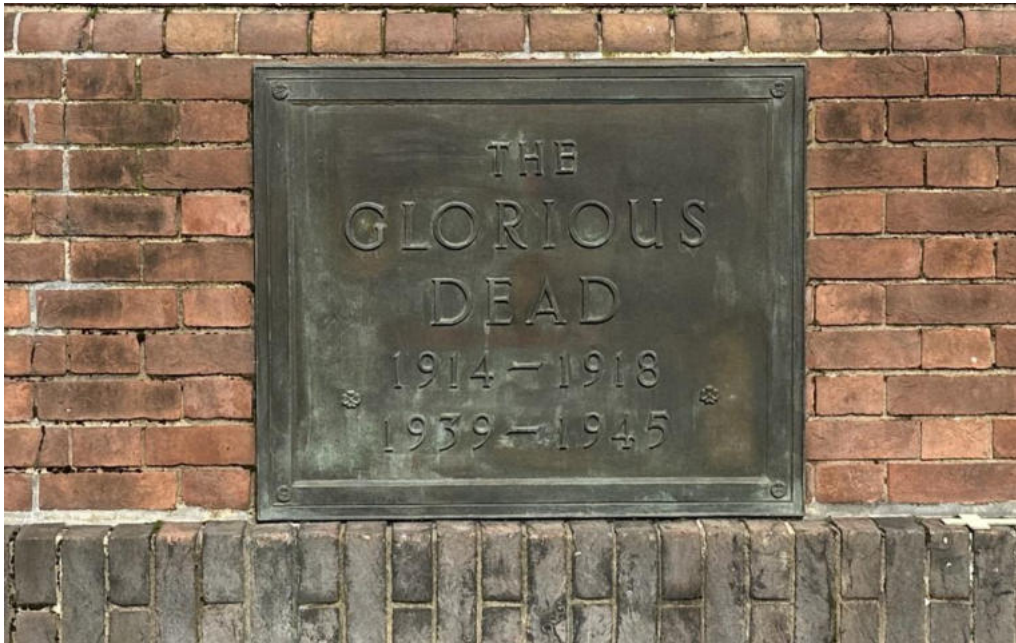
| <b>4.10</b> | <p>On the south face there is a bronze plaque inscribed 'The Glorious Dead'. A hot or cold wax coating could be considered following cleaning. <b>CONSIDER WAX COATING OF BRONZE</b></p> | <b>5</b> |

| 11 | BRONZE WAXING | 4.10, 4.15, 4.16, 4.19, | C |

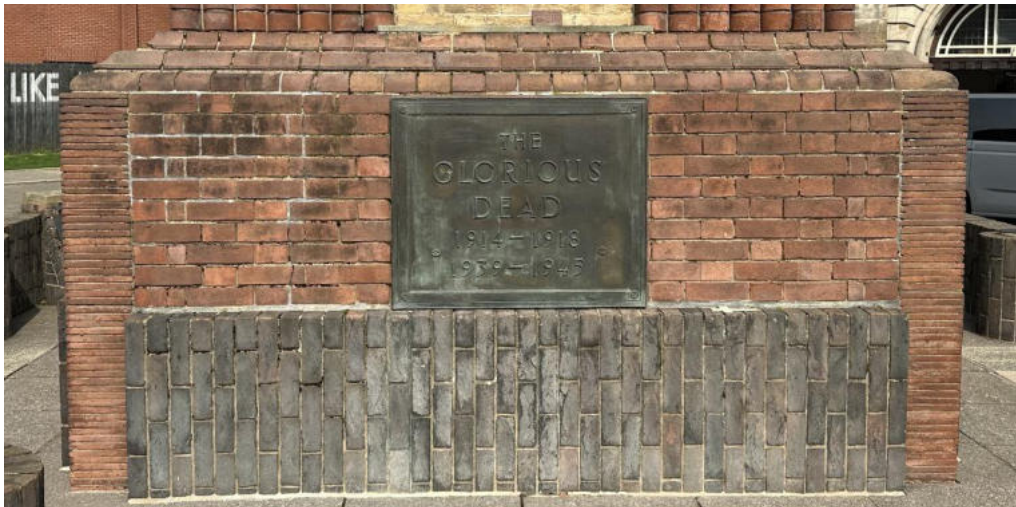
| <b>4.11</b> | <p>The plinth has open joints that need repointing. <b>REPOINTING</b></p> | <b>2</b> |

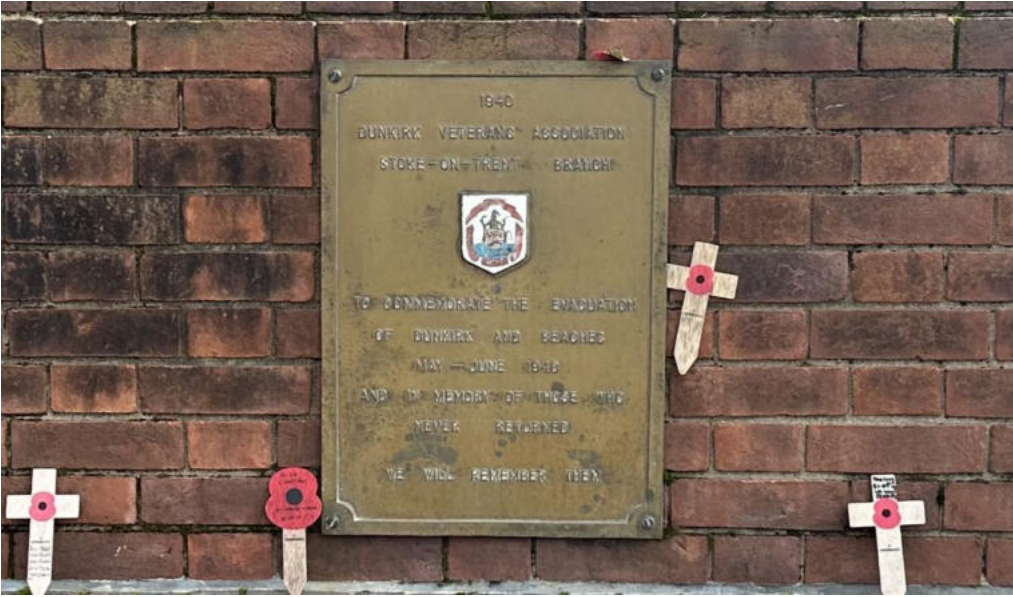
| <p><b>4.12</b></p> | <p>The west face has a brass plaque commemorating the Dunkirk Veterans. There is some tarnishing of the metal that could be polished out. <b>CONSIDER METAL POLISH</b></p> | <p><b>5</b></p> |

| 12 | METAL POLISH | 4.12, | V |

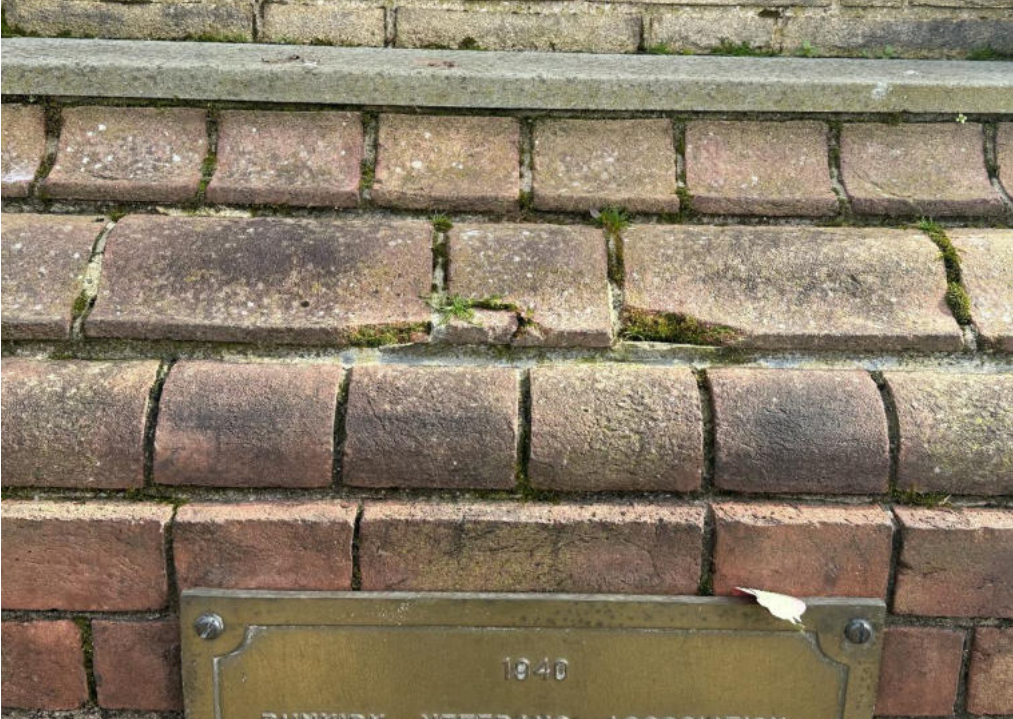
| <p><b>4.14</b></p> | <p>Plinth bricks are chipped and a mortar repair should be carried out to prevent water ingress. <b>BRICK MORTAR REPAIR</b></p> | <p><b>3</b></p> |

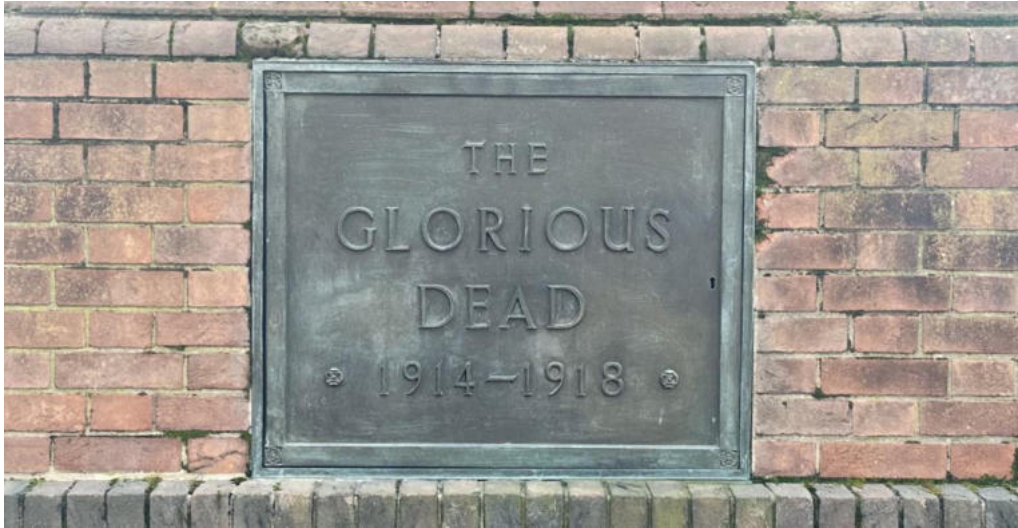
| 4.15 | <p>The north face has a similar bronze plaque as the south inscribed 'The Glorious Dead'. A hot or cold wax coating could be considered following cleaning. <b>CONSIDER WAX COATING OF BRONZE</b></p> | 5 |

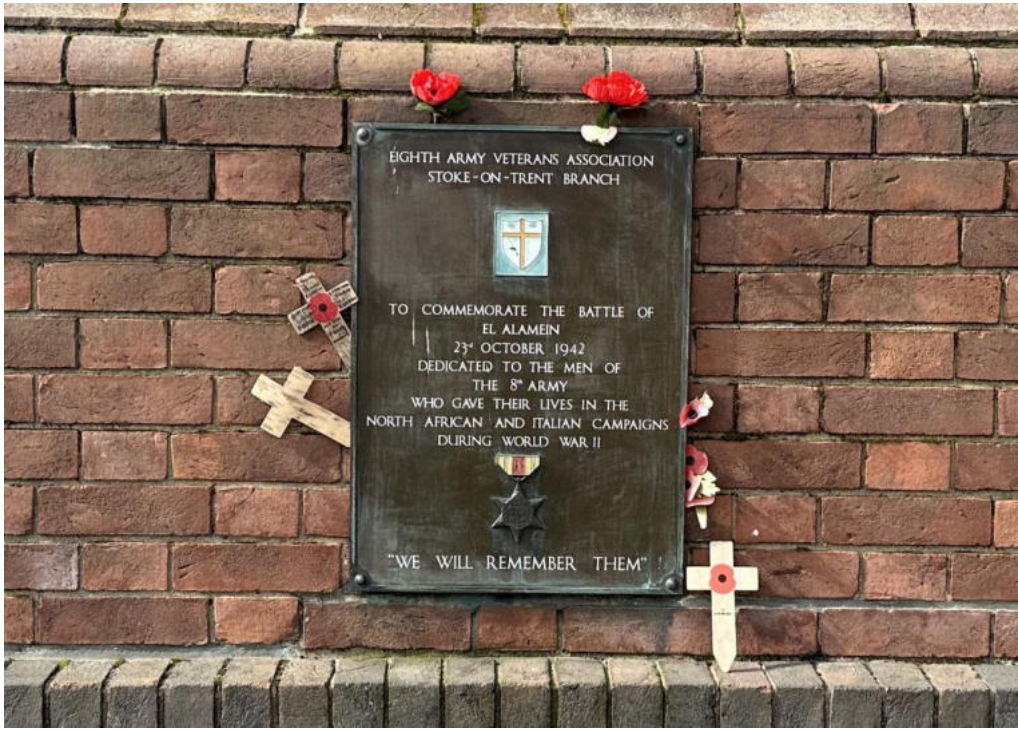
| 4.16 | <p>The east face has a bronze plaque commemorating the El Alamein veterans. There has been a previous application of a coating but this is wearing. A reapplication of a hot or cold wax coating could be considered following cleaning. <b>CONSIDER WAX COATING OF BRONZE</b></p> | 5 |

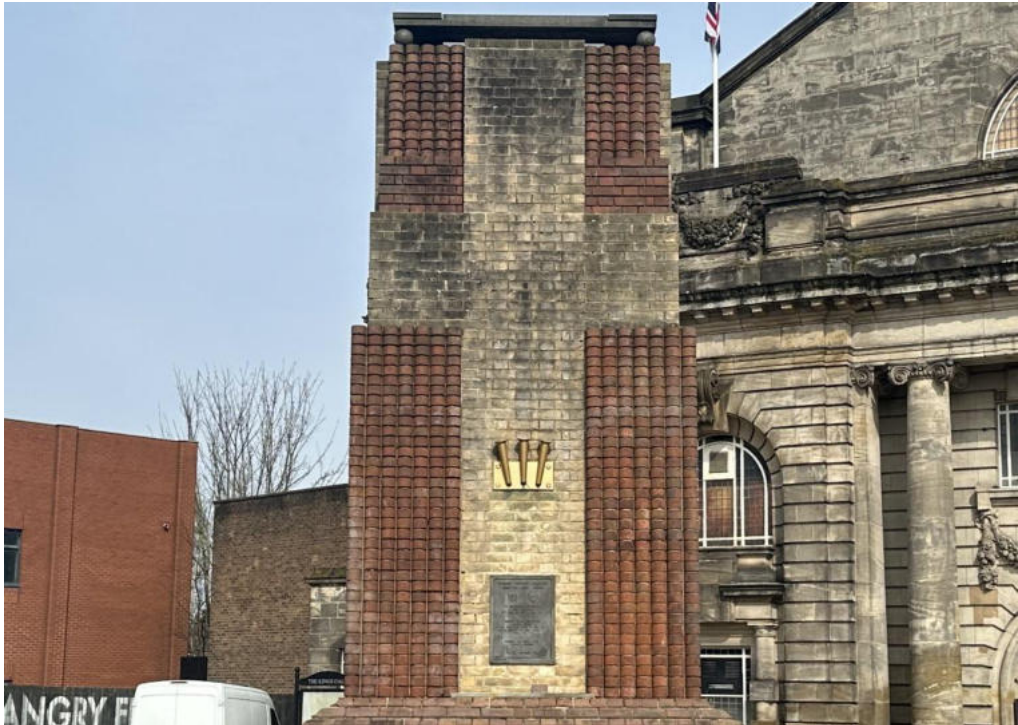
| 4.18 | <p>Rising from the plinth the monument has red bullnose bricks laid in a stacked form to the corners with a recessed buff brick to the centre forming a cross. On the south face brickwork is stained from atmospheric dirt and consideration should be given to cleaning. Cleaning should be considered with an appropriate biocide. If results are not satisfactory a superheated steam system could be considered. No abrasive or high-pressure methods should be employed. <b>BRICK CLEANING</b></p> | 4 |

| 9 | BRICK CLEANING | 4.18, 4.20, 4.22, 4.23, | |

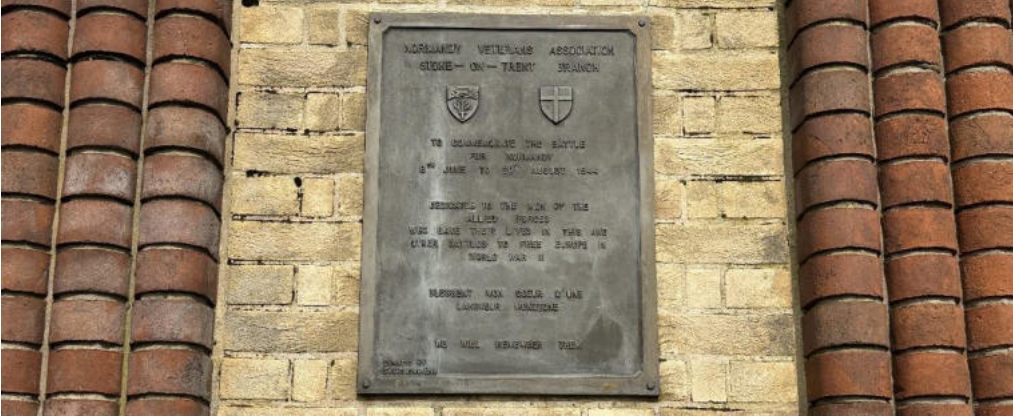
| <p><b>4.19</b></p> | <p>A bronze plaque commemorates the Normandy veterans. A reapplication of a hot or cold wax coating could be considered following cleaning. <b>CONSIDER WAX COATING OF BRONZE</b></p> | <p><b>5</b></p> |

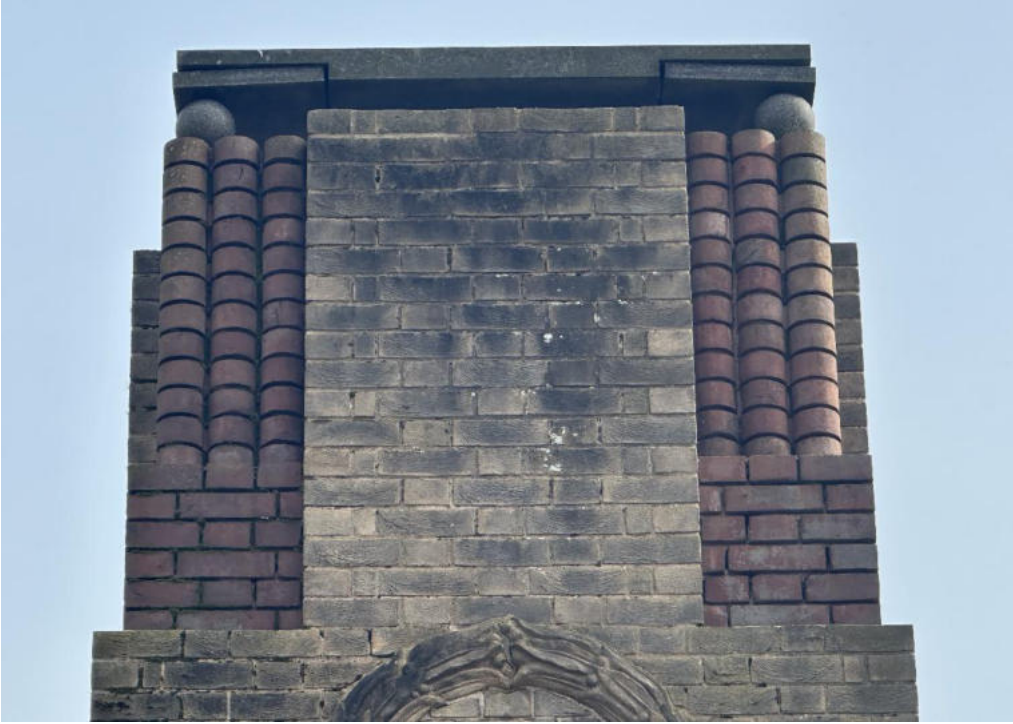
| <p><b>4.20</b></p> | <p>The west side has similar discolouration of the brickwork. Cleaning should be considered with an appropriate biocide. If results are not satisfactory a superheated steam system could be considered. No abrasive or high-pressure methods should be employed. <b>BRICK CLEANING</b></p> | <p><b>4</b></p> |

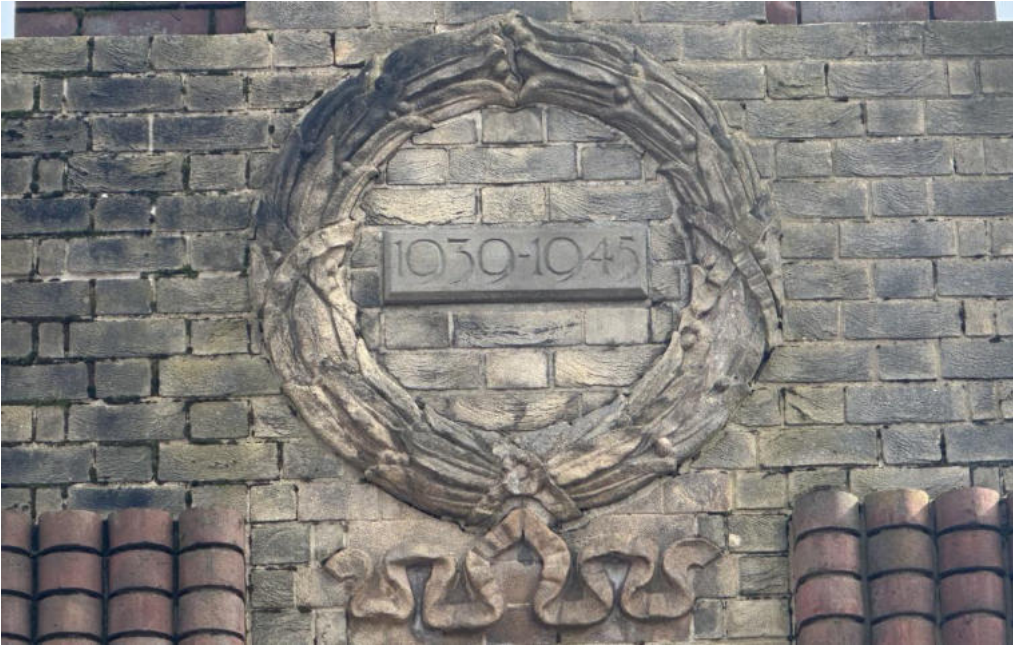
| 4.21 | <p>There is a carved stone wreath inlaid at high level. Joints are open around the stone and should be repointed. <b>REPOINTING</b></p> | 2 |

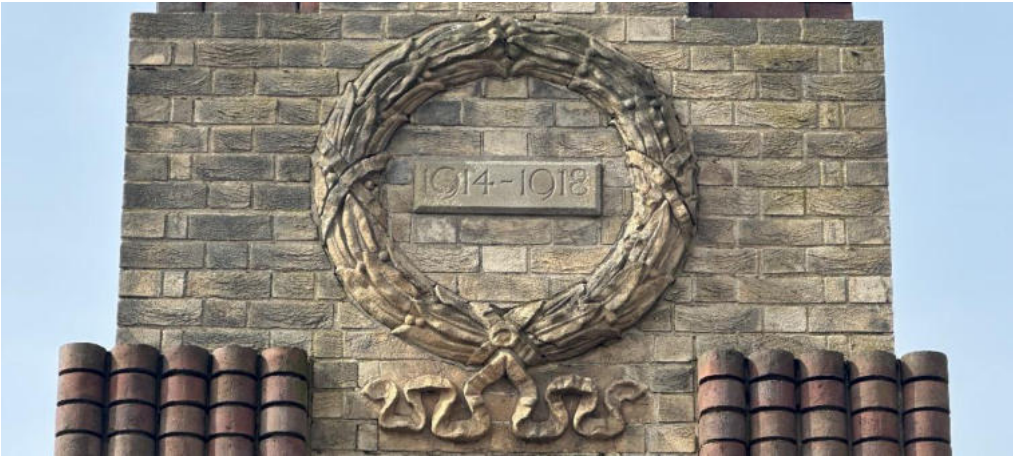
| 4.24 | <p>There is a similar carved stone wreath inlaid at high level. Joints are cracked around the stone and should be repointed. <b>REPOINTING</b></p> | 2 |

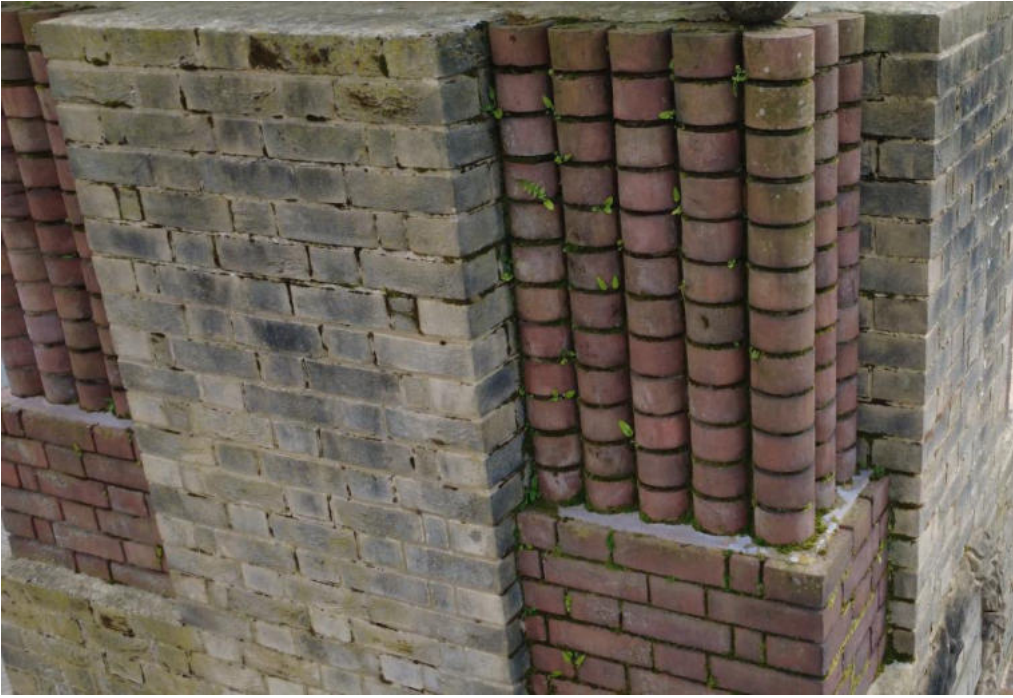
| <p><b>4.25</b></p> | <p>Open joints are particularly prevalent within the circular bricks, where vegetation has started to take hold. Vegetation should be removed and bricks re-pointed. <b>REPOINTING</b></p> | <p><b>2</b></p> |

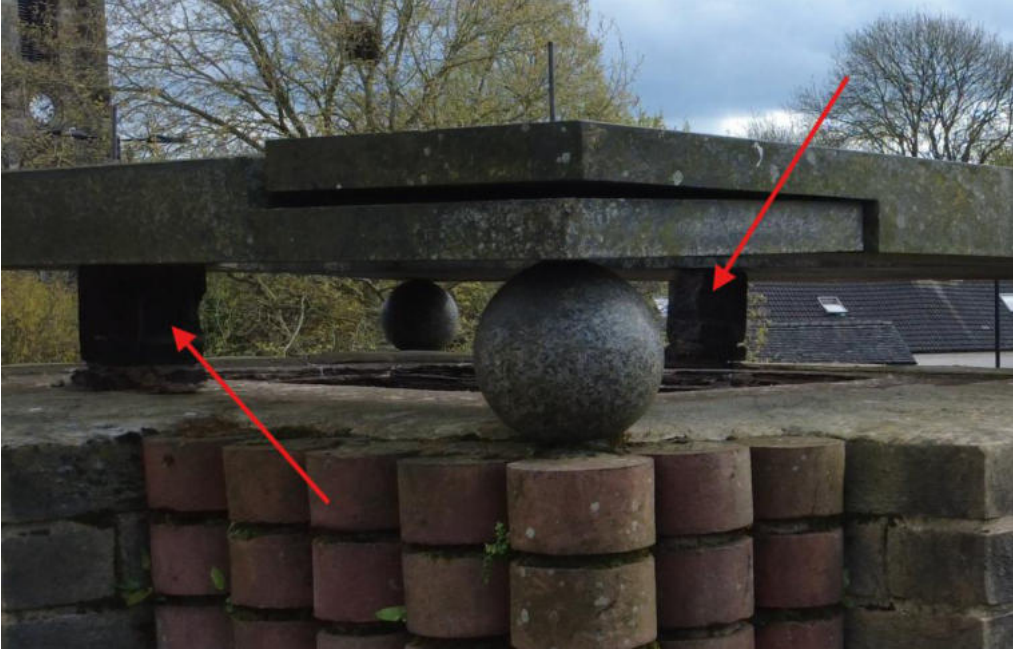
| <p><b>4.26</b></p> | <p>At the head of the monument there is a raised table frame which looks to be constructed of granite slabs supported on spheres on each corner. Joints have opened up to each corner where the slabs do not appear to be well fixed together. Slabs on the longest sides are tipping outward and propped by what look to be loose fragments of brick. Stability of this whole structure needs to be checked. <b>CHECK/STABILISE TABLE FRAME</b></p> | <p><b>1</b></p> |

| 2 | CHECK / STABILISE TABLE FRAME | 4.26 | |

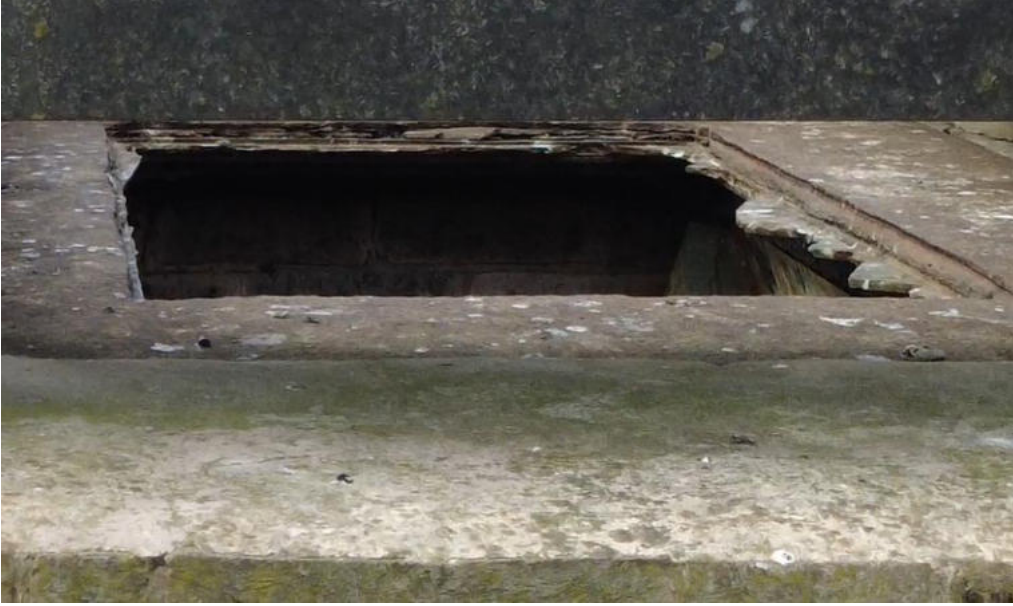
| 4.26 | <p>The cenotaph is a hollow structure - the interior can be accessed via a door disguised as the plaque on the north side, however interior access was not available at the time of survey. The interior appears to have been daylit by a glazed panel set into a wrought iron frame in the top of the structure. Oblique views show that the glazing is missing with some remnants remaining around the perimeter. The wrought iron frame is corroded and need to be removed or de-scaled and decorated. <b>REDECORATE WROUGHT IRON</b></p> | 4 |

| 4.27 | <p>The opening should be filled with a new glazed panel or at least mesh to prevent bird access. <b>MESH/GLAZE OPENING</b></p> | 2 |

| 10 | DECORATE WROUGHT IRON | 4.26 | |

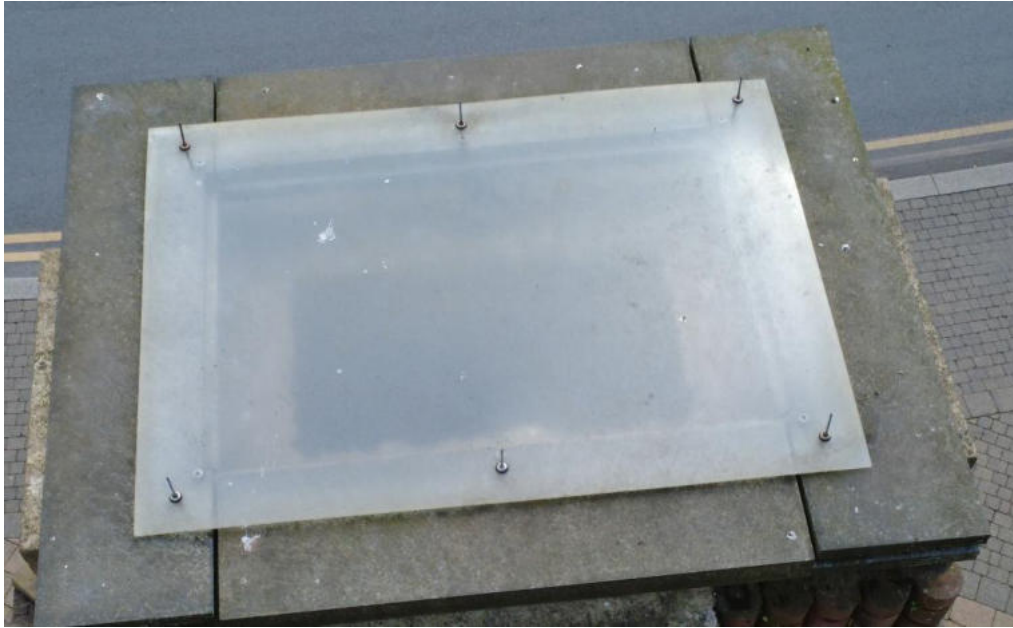
**4.29**

The top is now weathered with a sheet of thin polycarbonate which prevent rain from entering the opening. The sheet appears well-fixed with steel rivets. The polycarbonate has clouded and distorted slightly but remains unseen and functional.
