# Orthopaedic Hospital Railings

## Condition Report

Document ID: 140-05-CR22

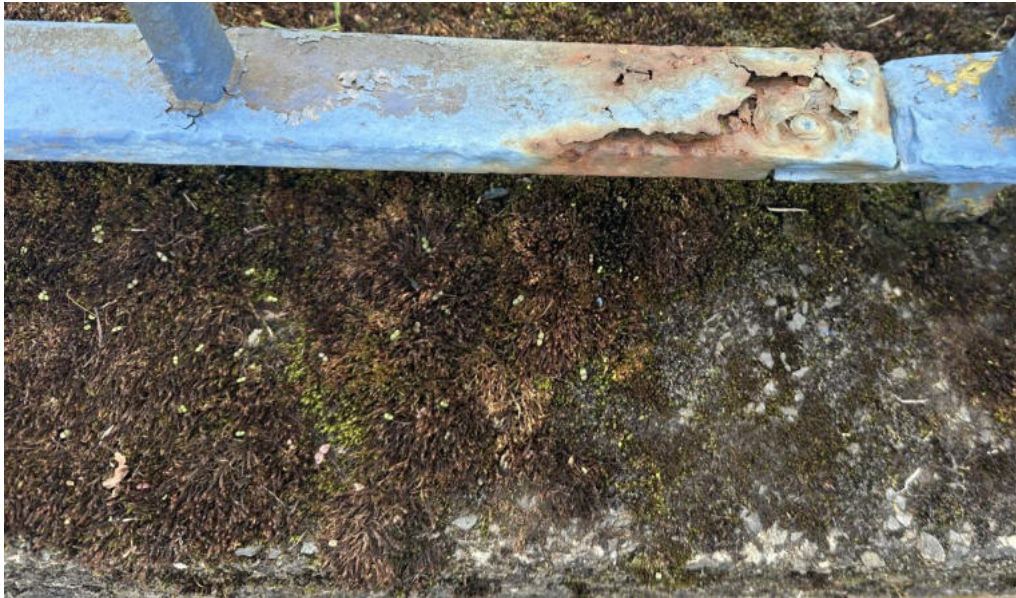
| <b>4.1</b> | <p>The wall base to all panels is of brick with a mix of stone and concrete cappings. Mortar joints are generally filled. All brick facings have moss covering at low level. Concrete cappings have a moss covering that would be beneficial to remove and concrete repaired where necessary. <b>REMOVE MOSS COVERING</b></p> | <b>4</b> |

| 2 | REMOVE MOSS COVERINGS | 4.1 | C, V |

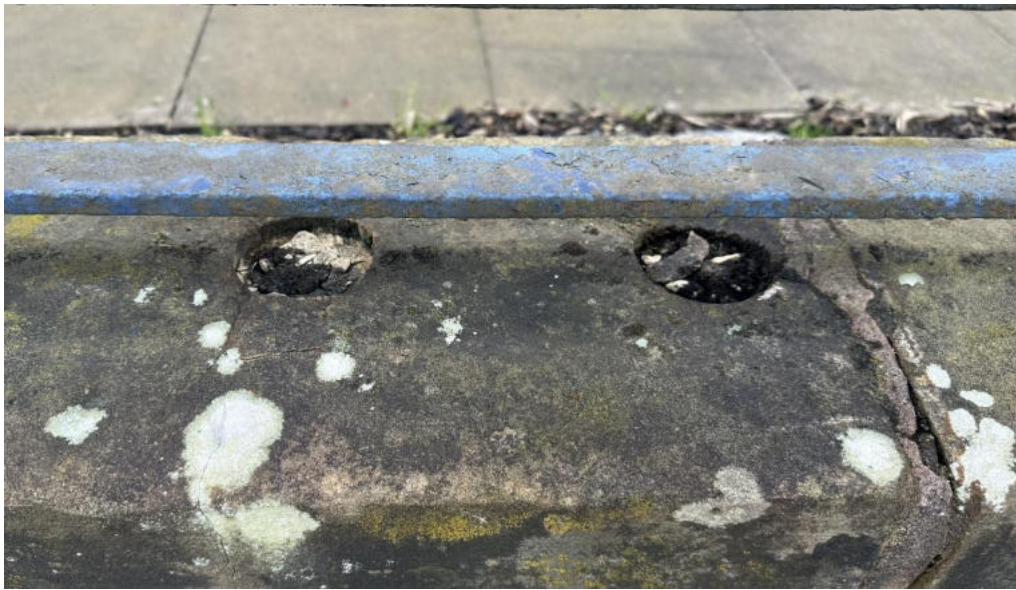
| <b>4.2</b> | <p>Some stone cappings have holes drilled that need filling flush with the surface with a stone mortar repair, cracked stone should be pinned. <b>STONE REPAIR</b></p> | <b>4</b> |

| 3 | STONE REPAIRS | 4.2 | L, C |

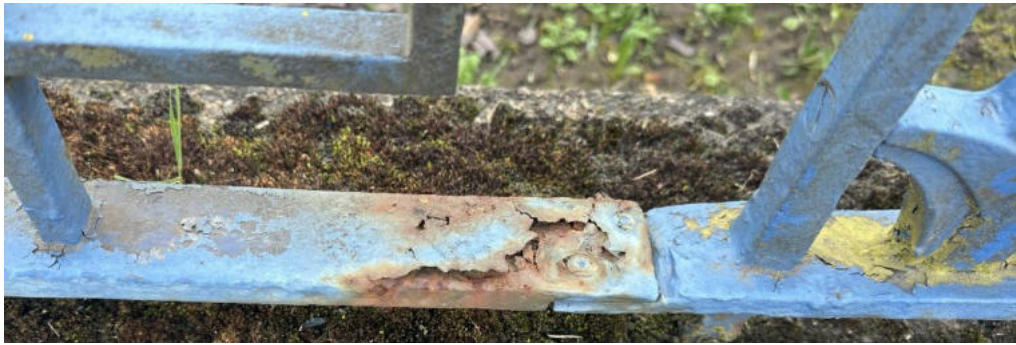
| <b>4.5</b> | Where paint has peeled at joints, metal has corroded and needs descaling, an application of rust inhibitor and redecoration. <b>REDECORATION</b> | <b>3</b> |

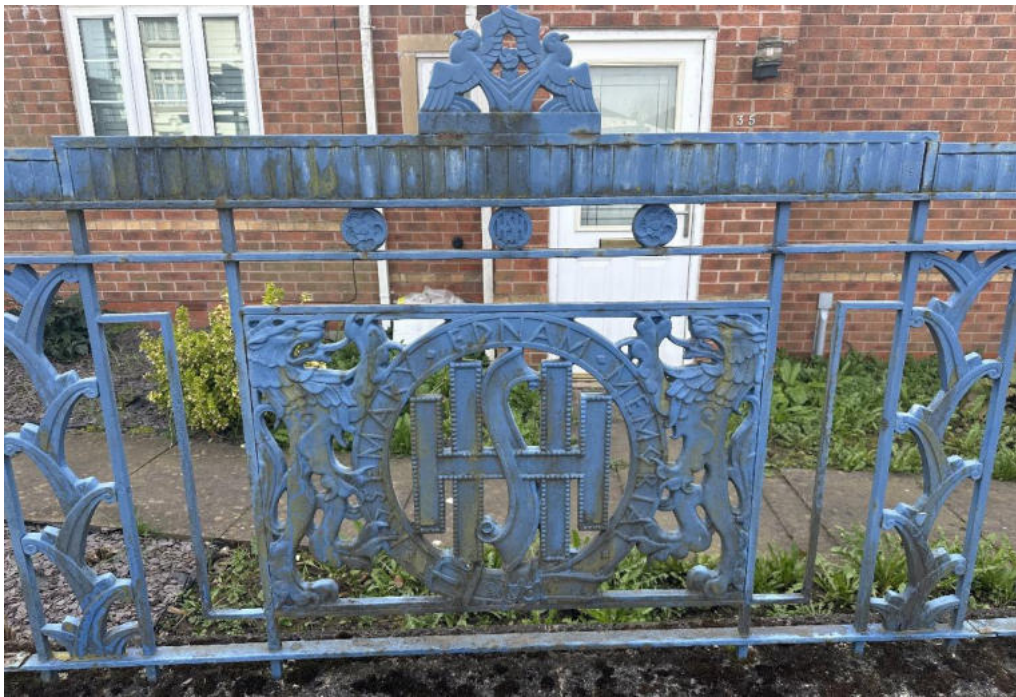
| <b>4.6</b> | Paint is peeling generally and there is a covering of green algae on the surface. Flaking paint should be removed and the whole washed down before repainting. <b>REDECORATION</b> | <b>3</b> |

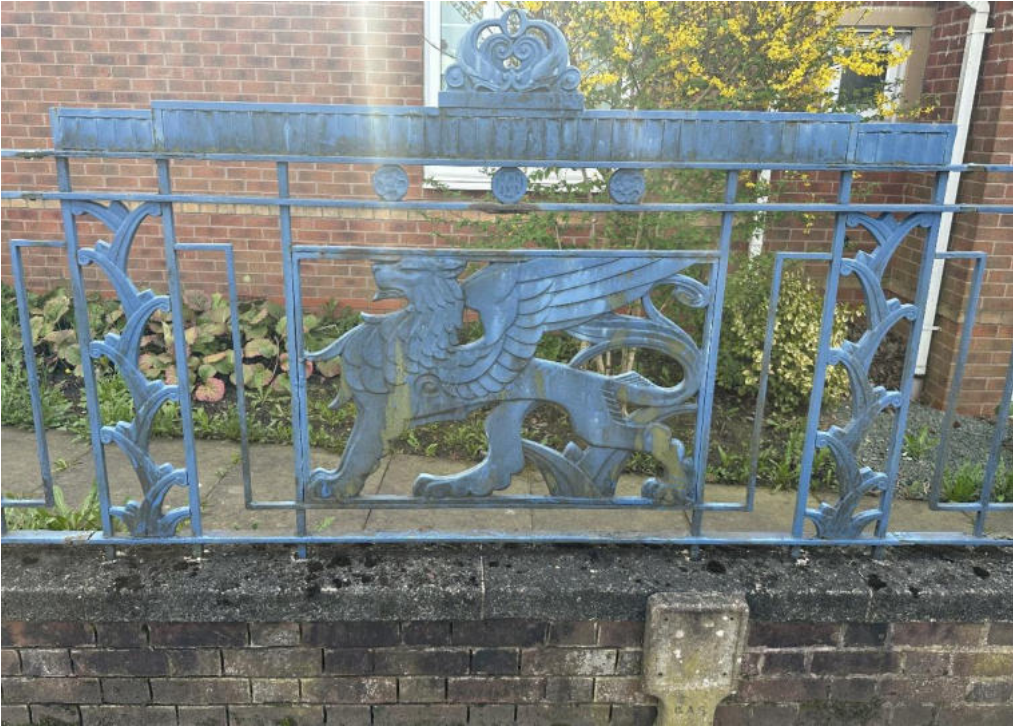
| 4.8 | <p>Paint is peeling generally and there is a covering of green algae on the surface. Flaking paint should be removed and the whole washed down before repainting.</p> <p><b>REDECORATION</b></p> | 3 |

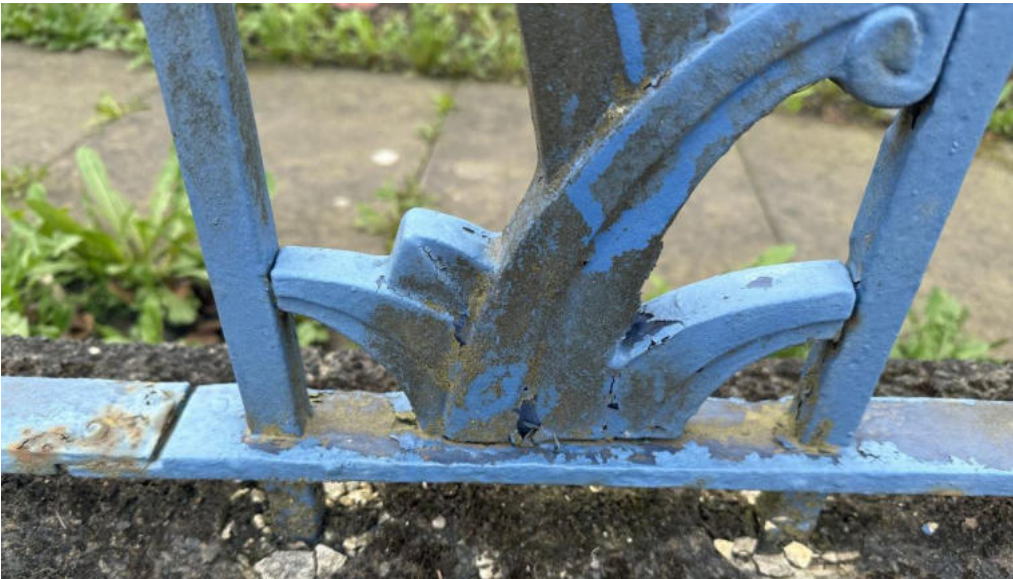
| 4.9 | <p>Corroded metal needs descaling, an application of rust inhibitor and redecoration.</p> <p><b>REDECORATION</b></p> | 3 |

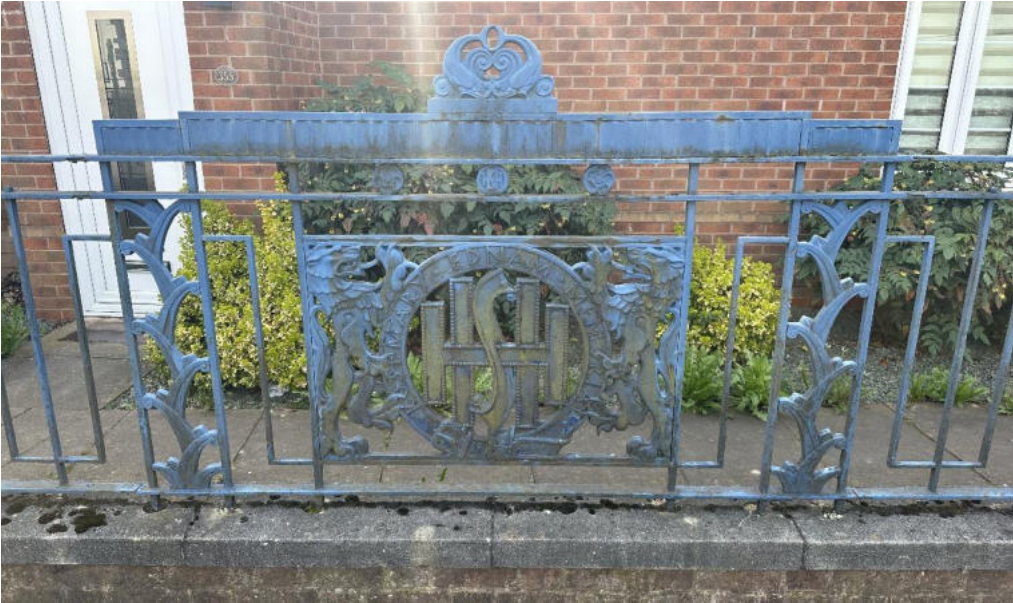
| 4.11 | <p>Paint is peeling generally and there is a covering of green algae on the surface. Flaking paint should be removed and the whole washed down before repainting.</p> <p><b>REDECORATION</b></p> | 3 |

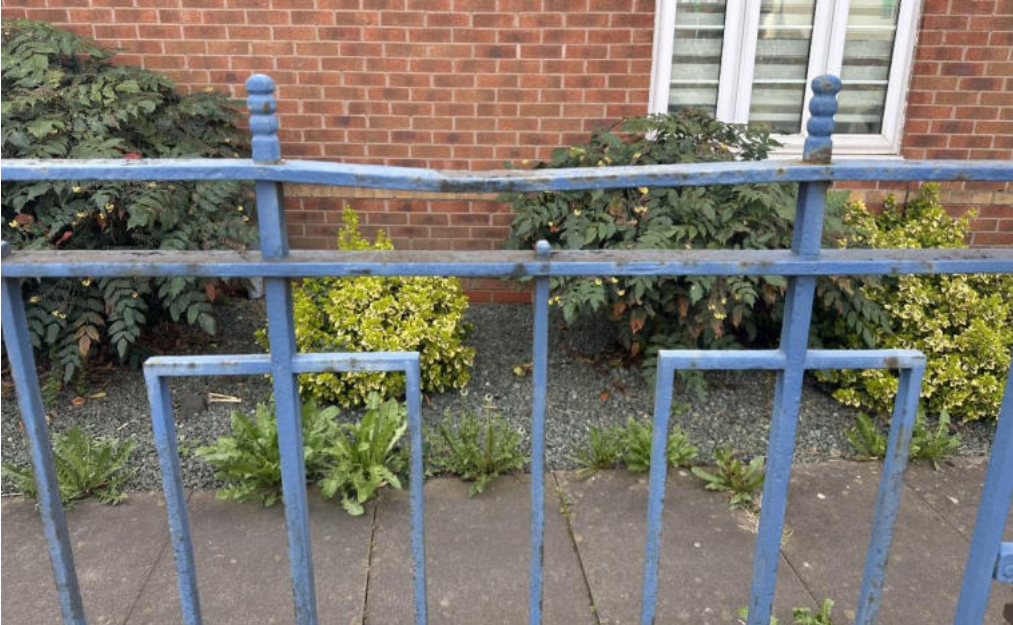
| 4.12 | <p>The top rail is deformed and should be gently re-aligned. <b>METAL REPAIR</b></p> | 4 |

| 4 | METAL REPAIR | 4.12, | L, C |

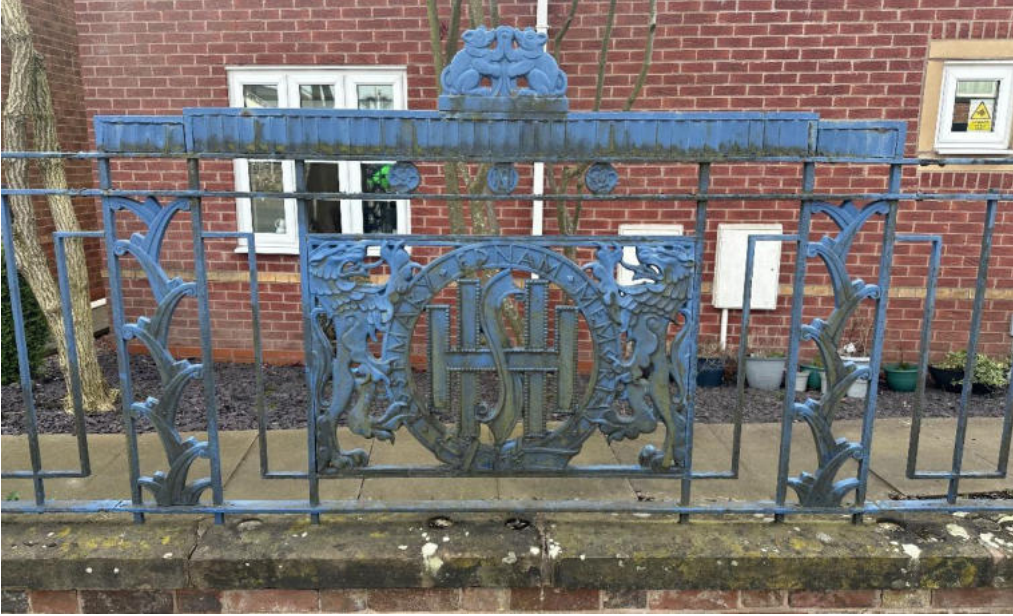
| 4.14 | <p>Paint is peeling generally and there is a covering of green algae on the surface. Flaking paint should be removed and the whole washed down before repainting.</p> <p><b>REDECORATION</b></p> | 3 |

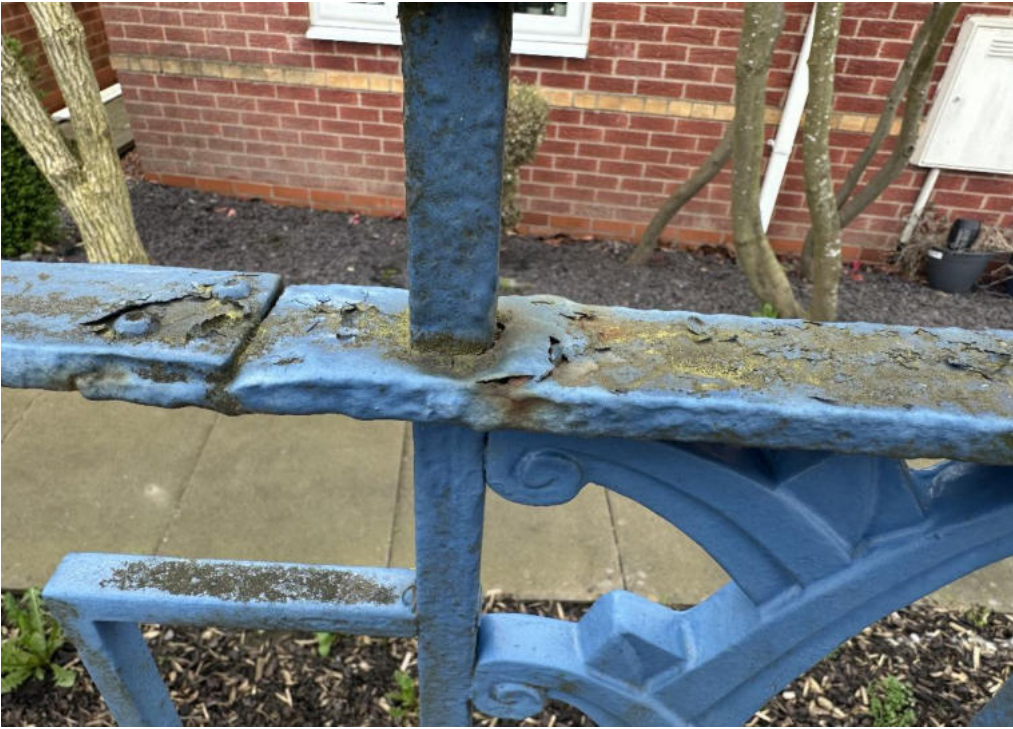
| 4.15 | <p>Where paint has peeled at joints, metal has corroded and needs descaling, an application of rust inhibitor and redecoration. <b>REDECORATION</b></p> | 3 |

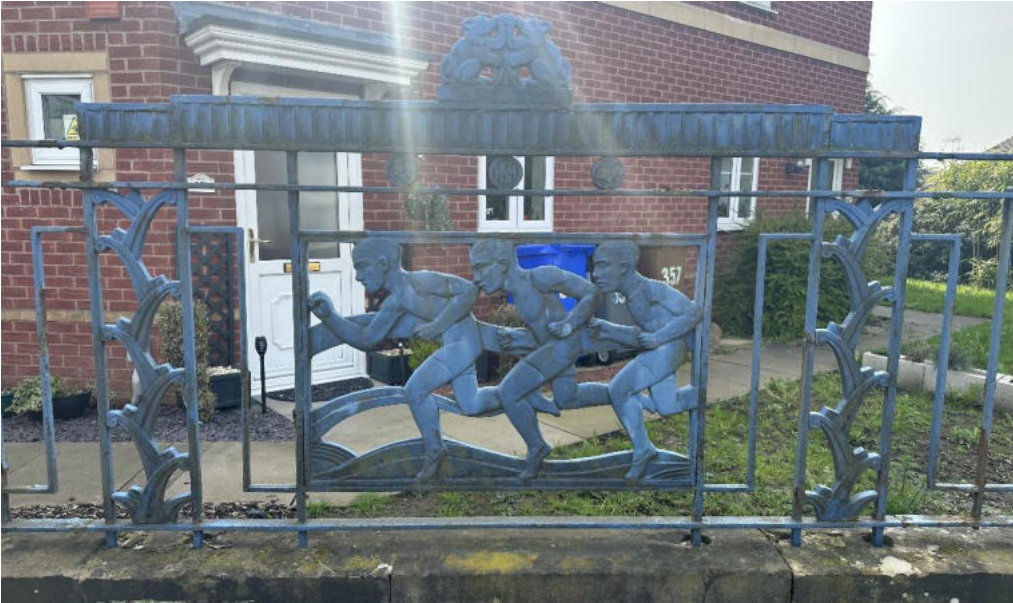
| 4.17 | <p>Paint is peeling generally and there is a covering of green algae on the surface. Flaking paint should be removed and the whole washed down before repainting.</p> <p><b>REDECORATION</b></p> | 3 |

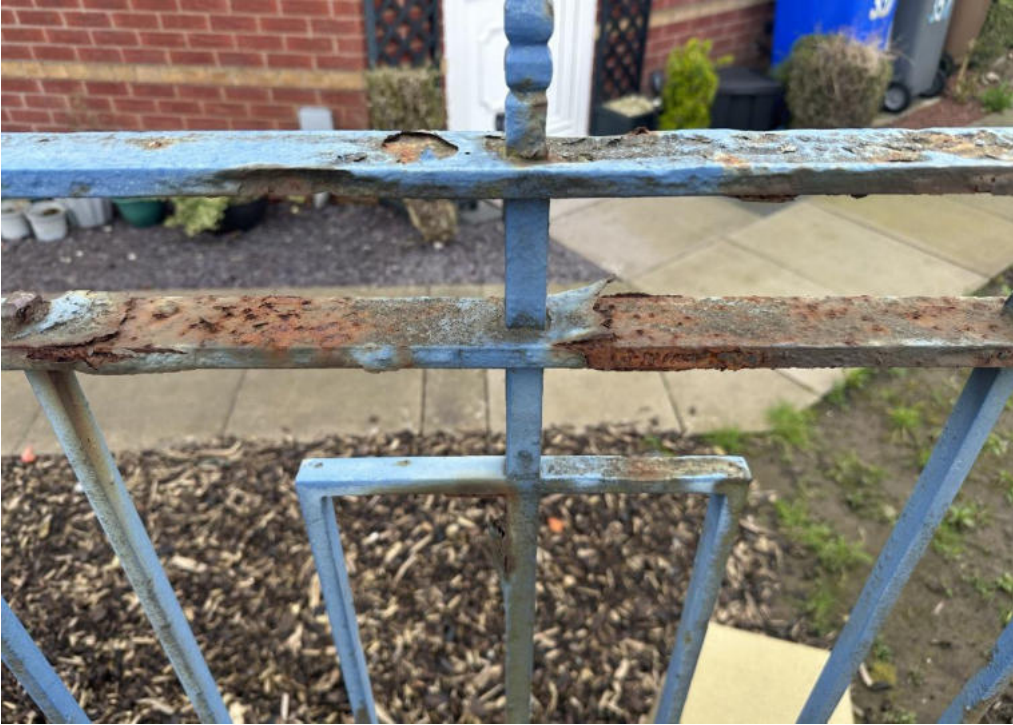
| 4.18 | <p>There are several areas where paint has peeled at joints, metal has corroded and needs descaling, an application of rust inhibitor and redecoration. <b>REDECORATION</b></p> | 3 |

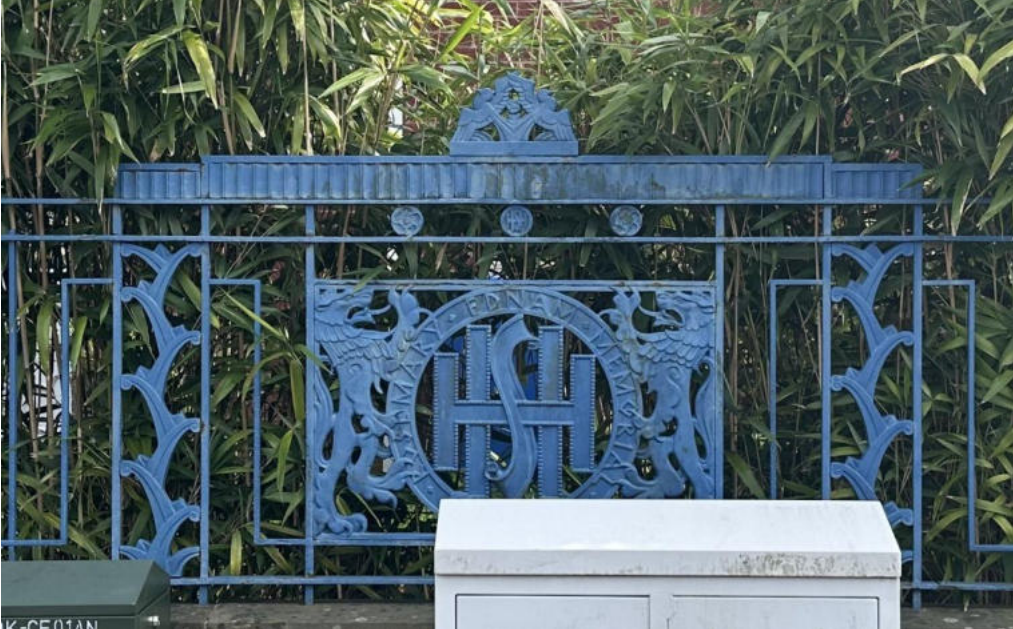
| 4.20 | <p>Condition of this panel is better and needs a general wash down and redecoration. <b>REDECORATION</b></p> | 3 |

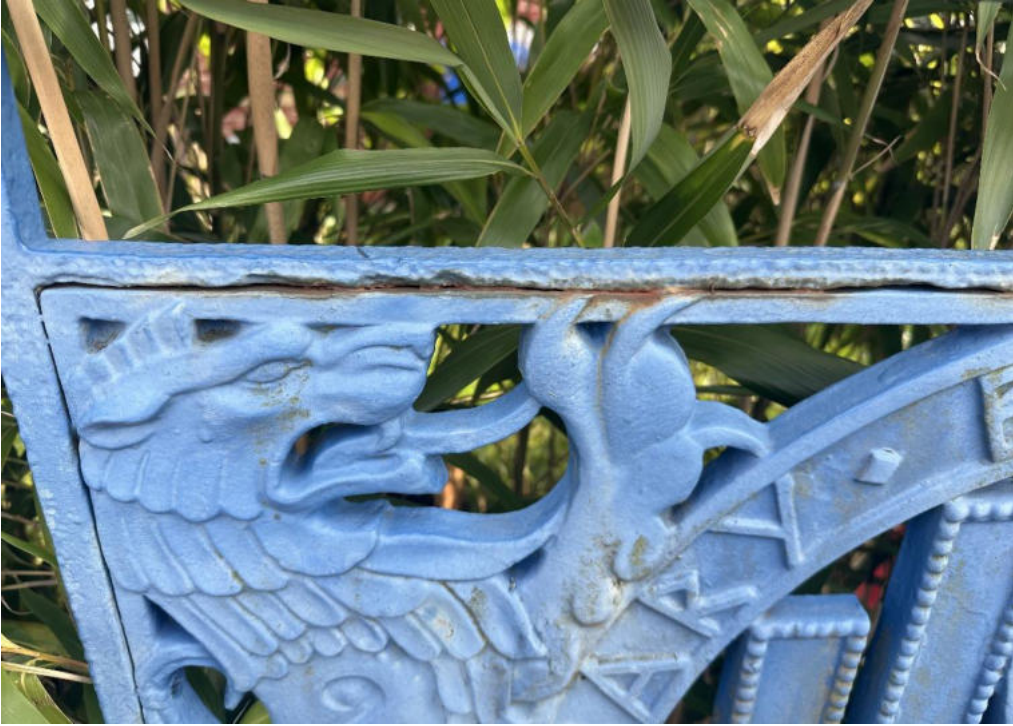
| 4.21 | <p>There are some minor areas where metal has corroded and needs descaling, an application of rust inhibitor and redecoration. <b>REDECORATION</b></p> | 3 |

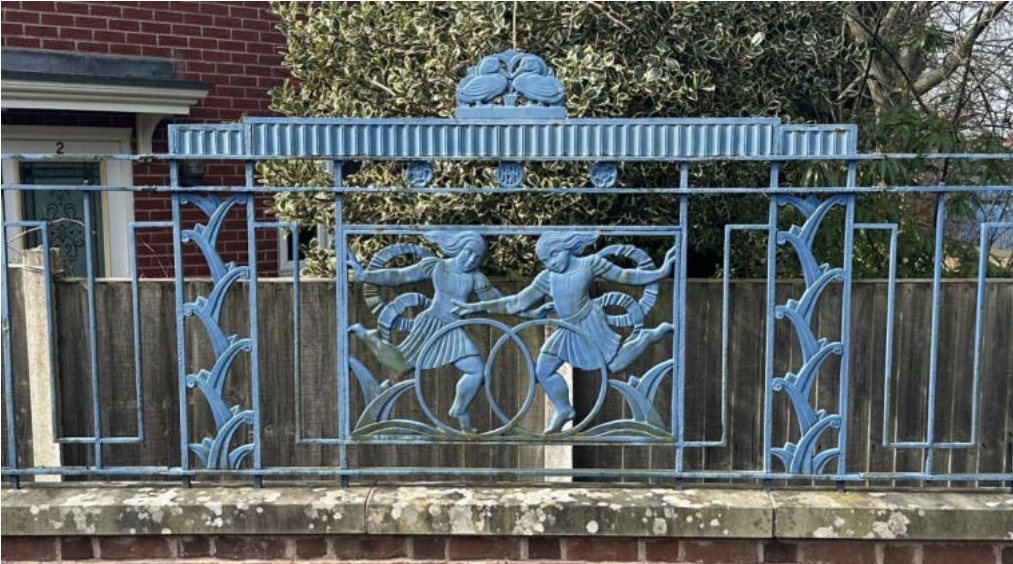
| 4.23 | <p>Condition of this panel is better and needs a general wash down and redecoration. <b>REDECORATION</b></p> | 3 |

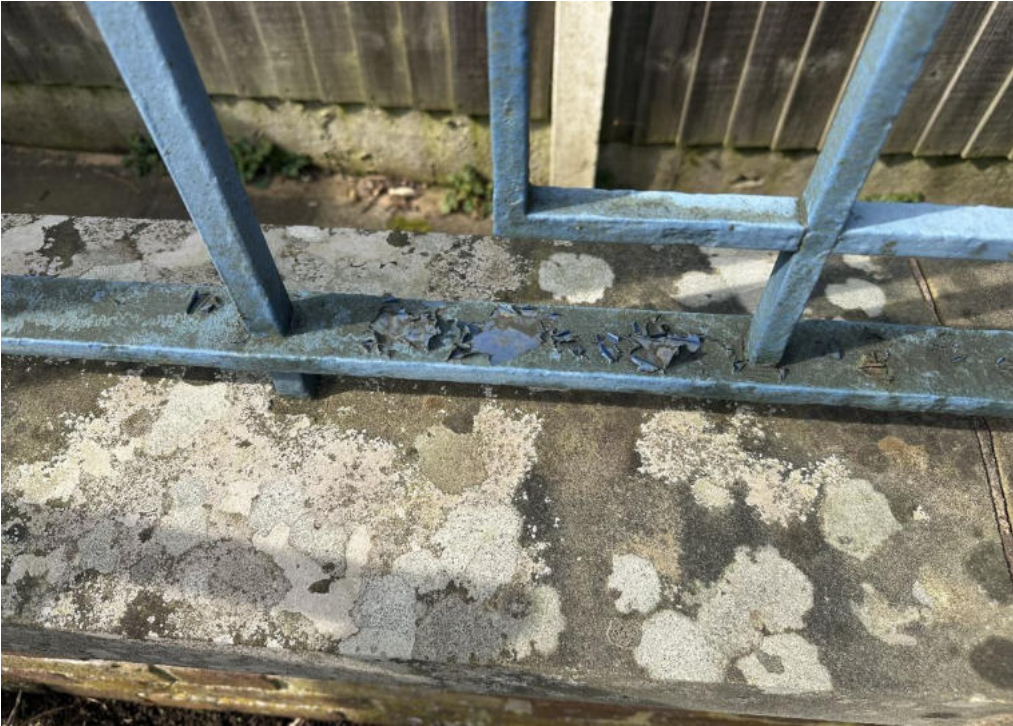
| 4.24 | <p>There is some paint peel that needs descaling and redecoration. <b>REDECORATION</b></p> | 3 |

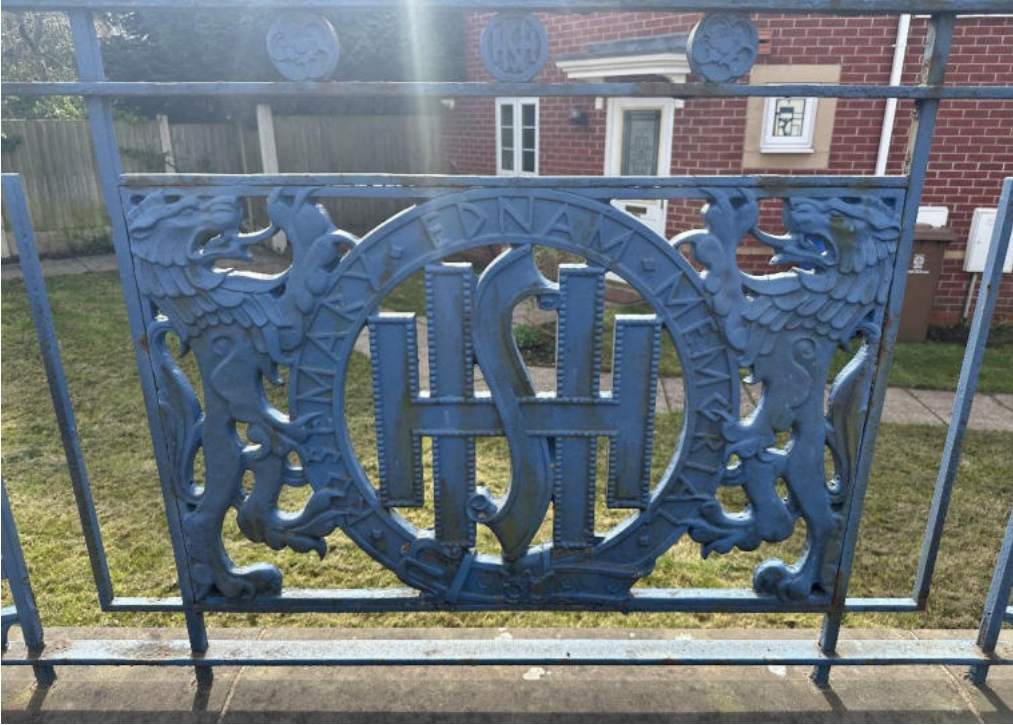
| 4.26 | <p>Paint is peeling generally and there is a covering of green algae on the surface. Flaking paint should be removed and the whole washed down before repainting.</p> <p><b>REDECORATION</b></p> | 3 |

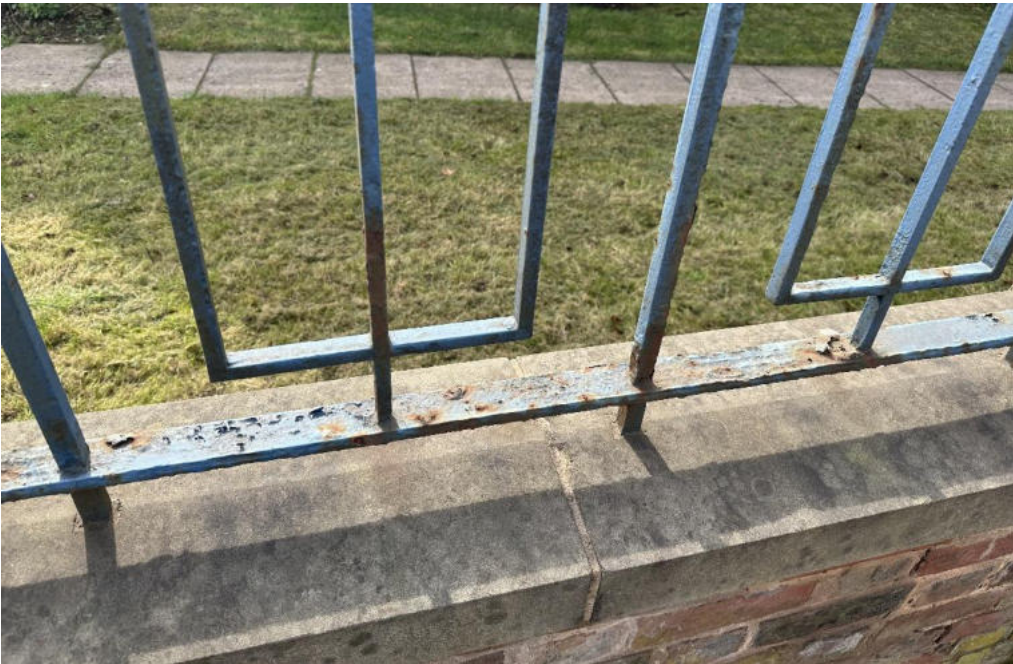
| 4.27 | <p>There are several areas where paint has peeled at joints, metal has corroded and needs descaling, an application of rust inhibitor and redecoration. <b>REDECORATION</b></p> | 3 |

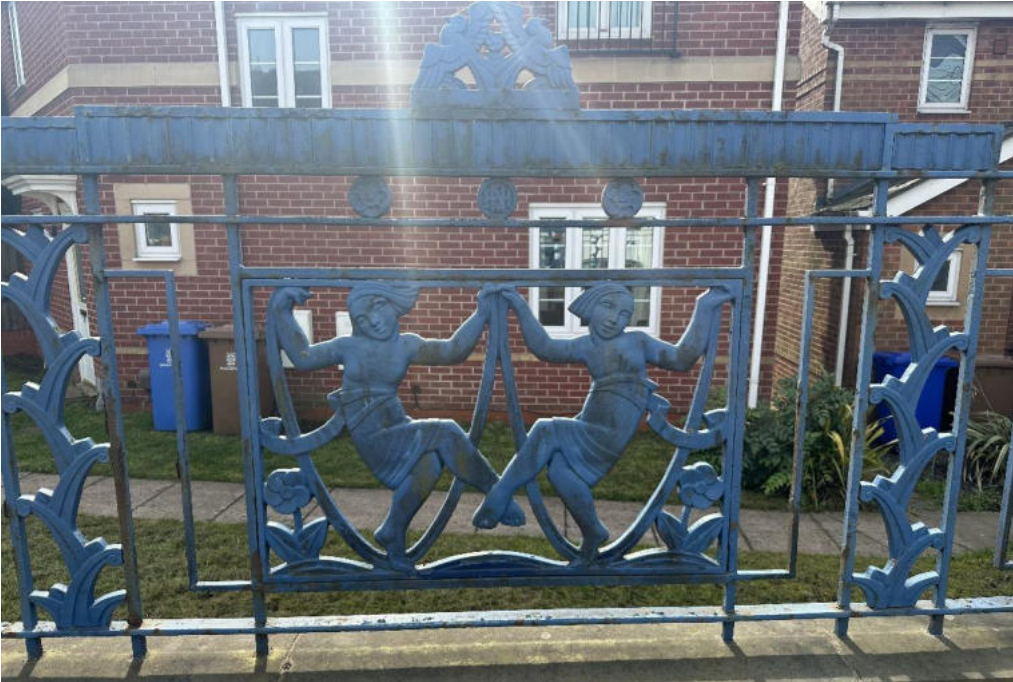
| 4.29 | <p>Paint is peeling generally and there is a covering of green algae on the surface. Flaking paint should be removed and the whole washed down before repainting.</p> <p><b>REDECORATION</b></p> | 3 |

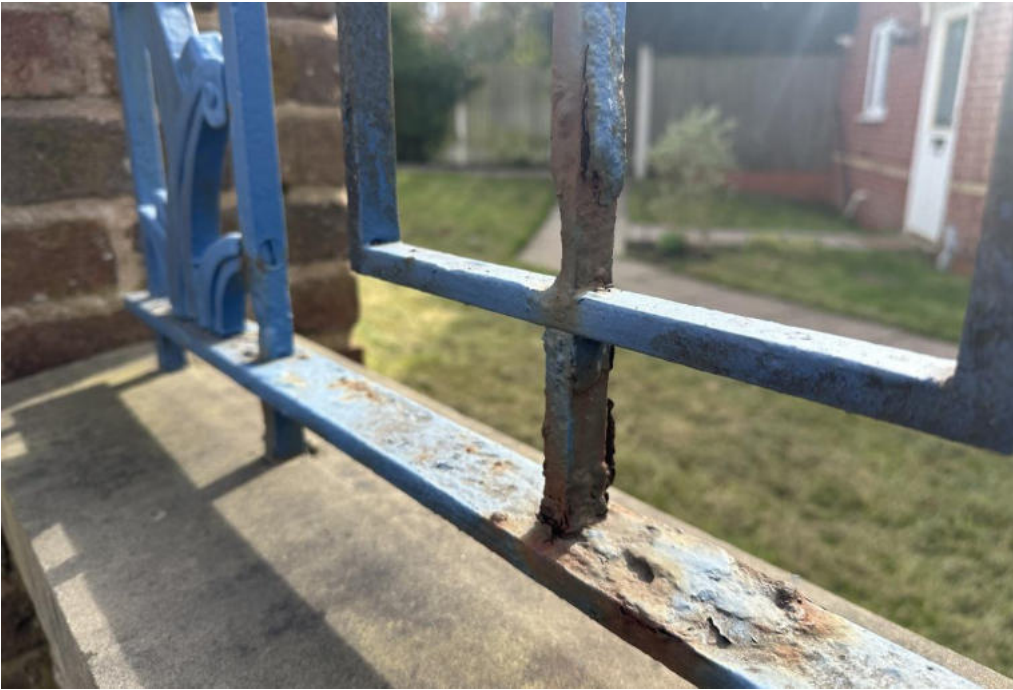
| 4.30 | <p>There are several areas where paint has peeled at joints, metal has corroded and needs descaling, an application of rust inhibitor and redecoration. <b>REDECORATION</b></p> | 3 |

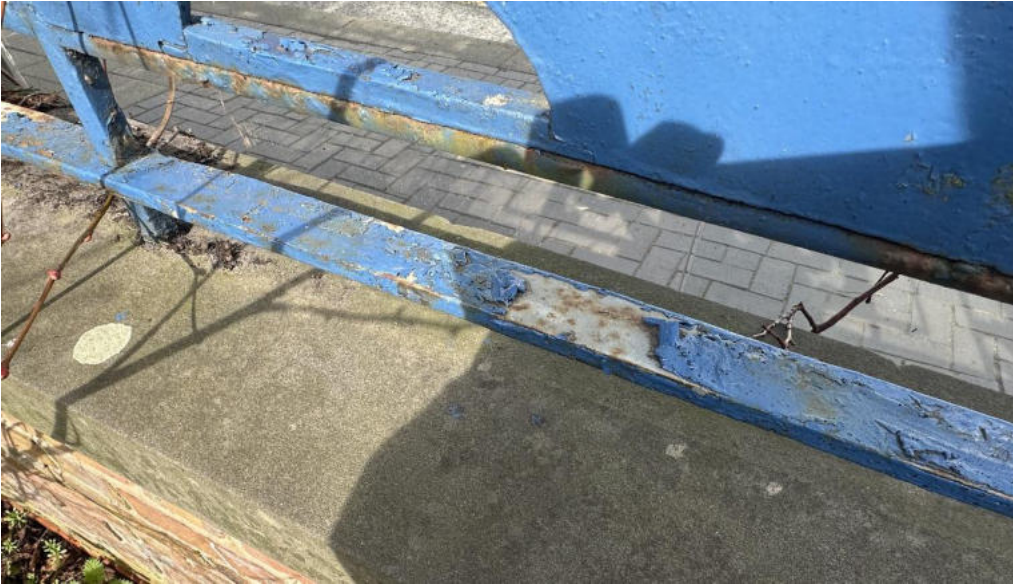
| 4.32 | <p>Paint has peeled back to bare metal in some areas and flaking paint should be removed and the whole washed down before repainting. <b>REDECORATION</b></p> | 3 |

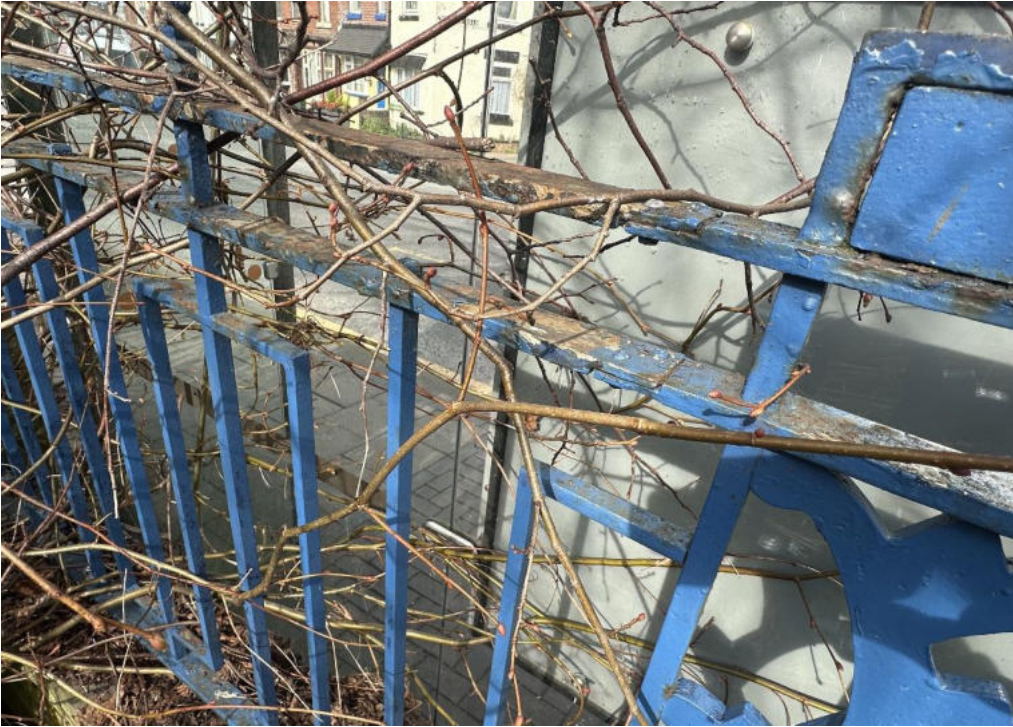
| 4.33 | <p>There are several areas where paint has peeled at joints, metal has corroded and needs descaling, an application of rust inhibitor and redecoration. <b>REDECORATION</b></p> | 3 |

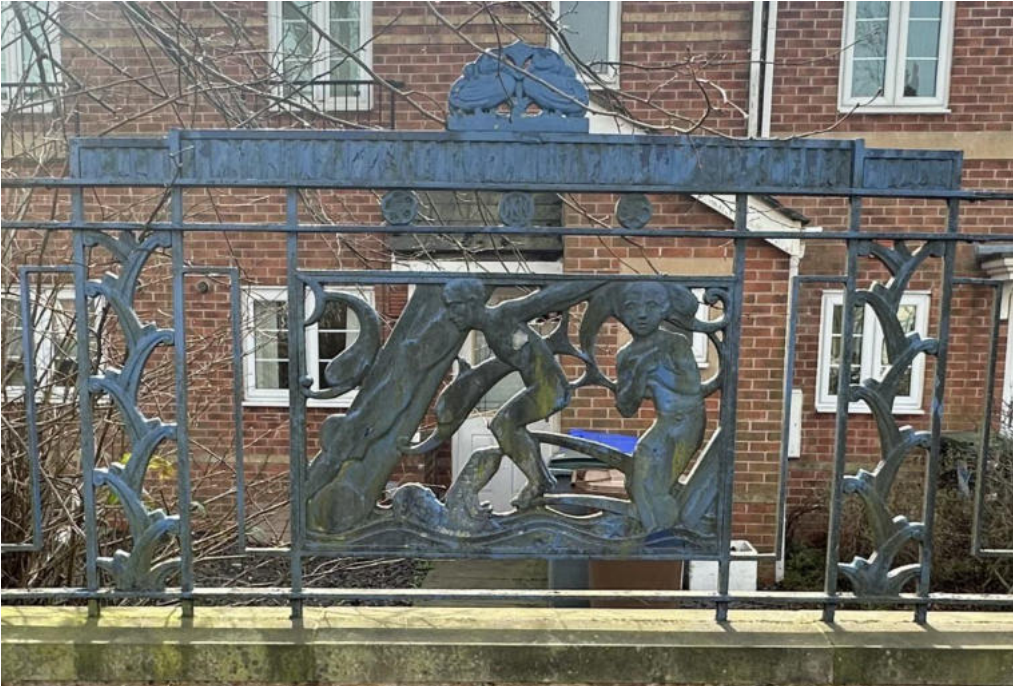
| 4.35 | <p>Paint is peeling generally and there is a covering of green algae on the surface. Flaking paint should be removed and the whole washed down before repainting.</p> <p><b>REDECORATION</b></p> | 3 |

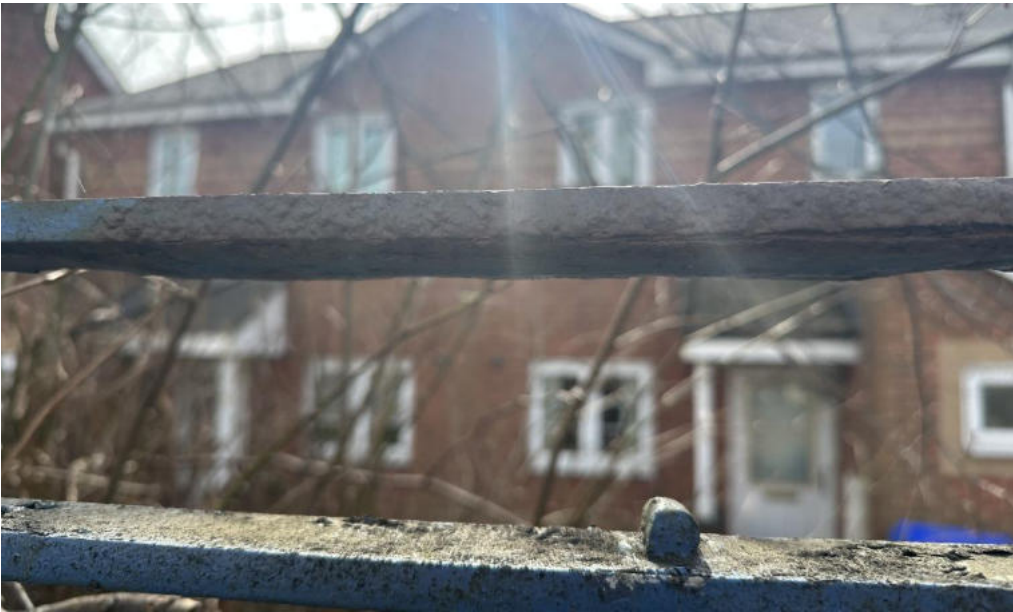
| 4.36 | <p>There are some areas where paint has peeled and metal has corroded and needs descaling, an application of rust inhibitor and redecoration. <b>REDECORATION</b></p> | 3 |
