# Pithead Wheel Memorial

## Condition Report

Document ID: 140-05-CR05

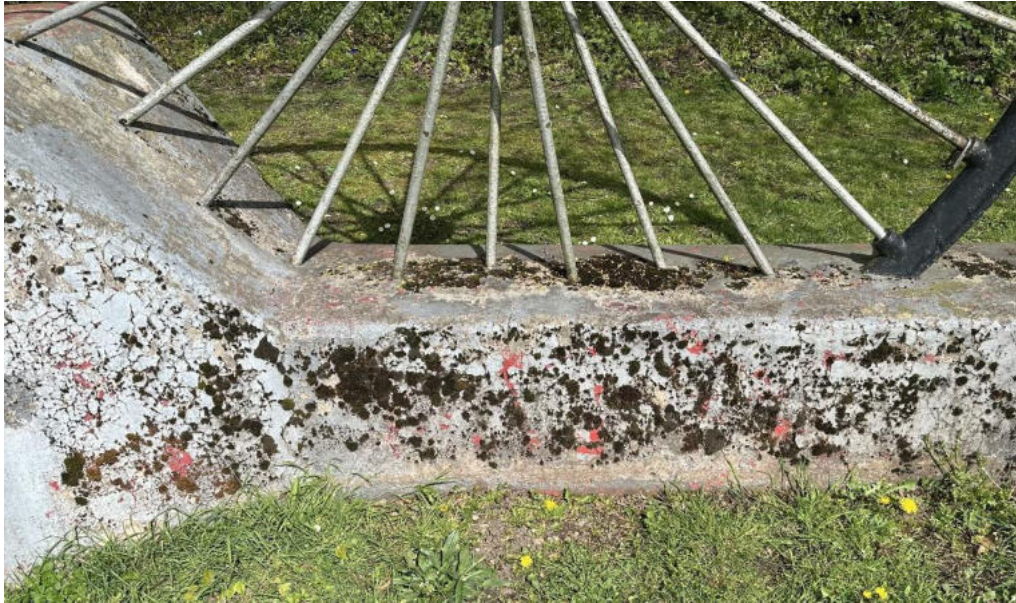
| <b>4.2</b> | <p>Concrete appears in good condition, but the paint covering is flaking revealing previous paint colours and graffiti. There is also moss growing. Remove moss and prepare concrete for repainting. <b>REDECORATION</b></p> | <b>3</b> |

| 1 | REDECORATION | 4.2, 4.5, | C,V |

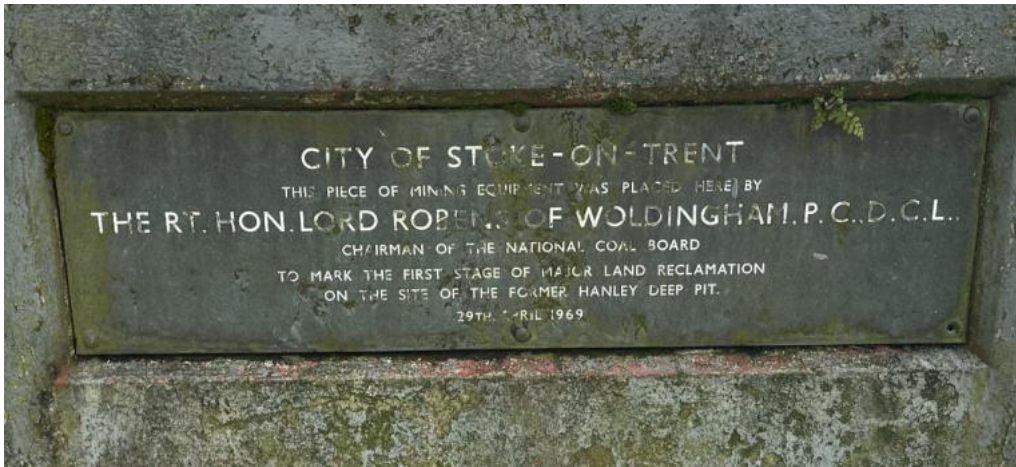
| <b>4.3</b> | <p>The metal plaque is covered with green algae and there is some fern growth behind. Some inscription paint is worn. The vegetation needs to be removed, and the plaque cleaned and inscription lettering improved. Cleaning should utilise an appropriate biocide. If results are not satisfactory a superheated steam system could be considered. <b>CLEANING</b></p> | <b>5</b> |

| 3 | CLEANING | 4.3, | C,V |

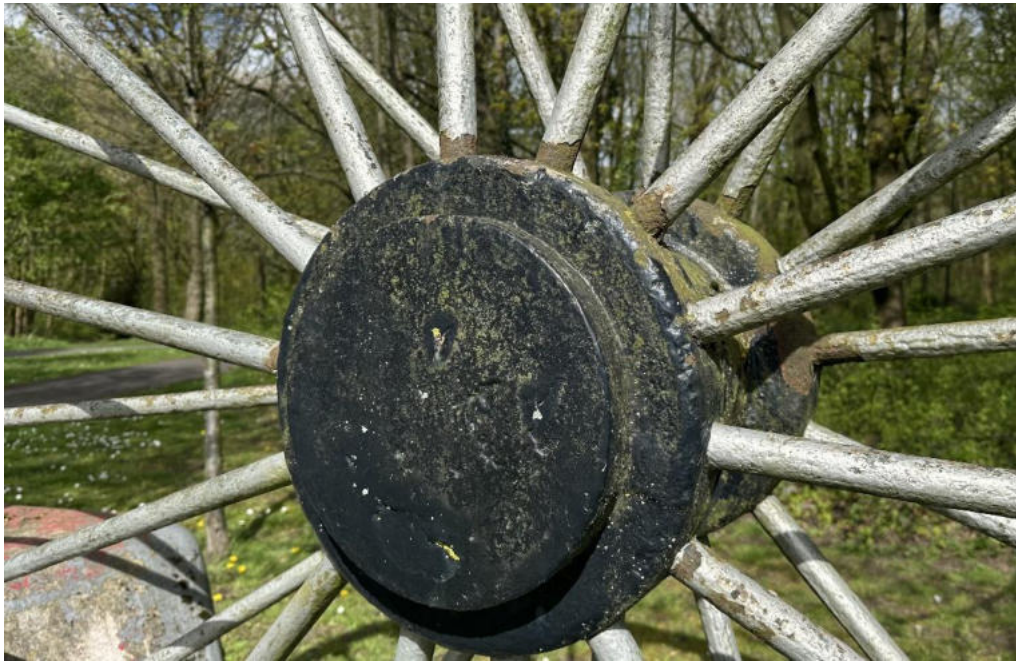
| 4.5 | <p>Paint is flaking on the spokes and hub of the wheel exposing base metal. Descaling, an application of rust inhibitor, priming and repainting is needed. <b>REDECORATION</b></p> | 3 |
| 4.6 | There is a covering of algae over the metalwork that should be cleaned off prior to redecoration. | |

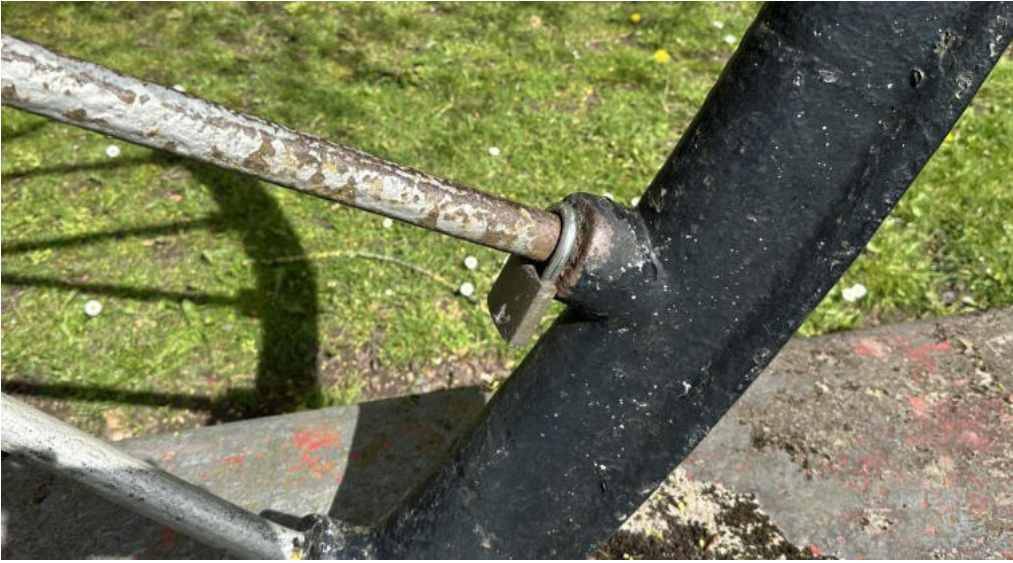
| 4.6 | <p>A padlock has been attached to one of the spokes. This should be removed. <b>REMOVE PADLOCK</b></p> | 4 |

| 2 | REMOVE PADLOCK | 4.6, | |

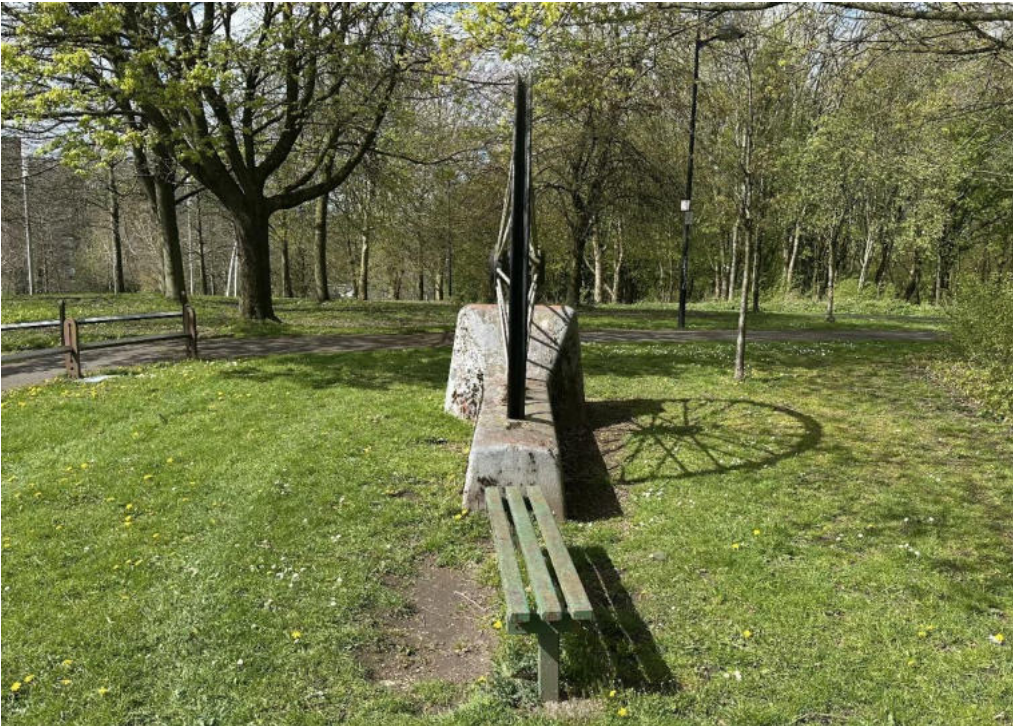
| 4.7 | <p>The area around the memorial is grass and is regularly trimmed; this should continue. Installation of a mowing edge (say a couple of rows of cobbled setts) could help to prevent damage to the plinth paintwork by strimmers and mowers. <b>INSTALL MOWING EDGE</b></p> | 3 |

| 4 | INSTALL MOWING EDGE | 4.7 | |
