# Shirley Drinking Fountain

## Condition Report

Document ID: 140-05-CR23

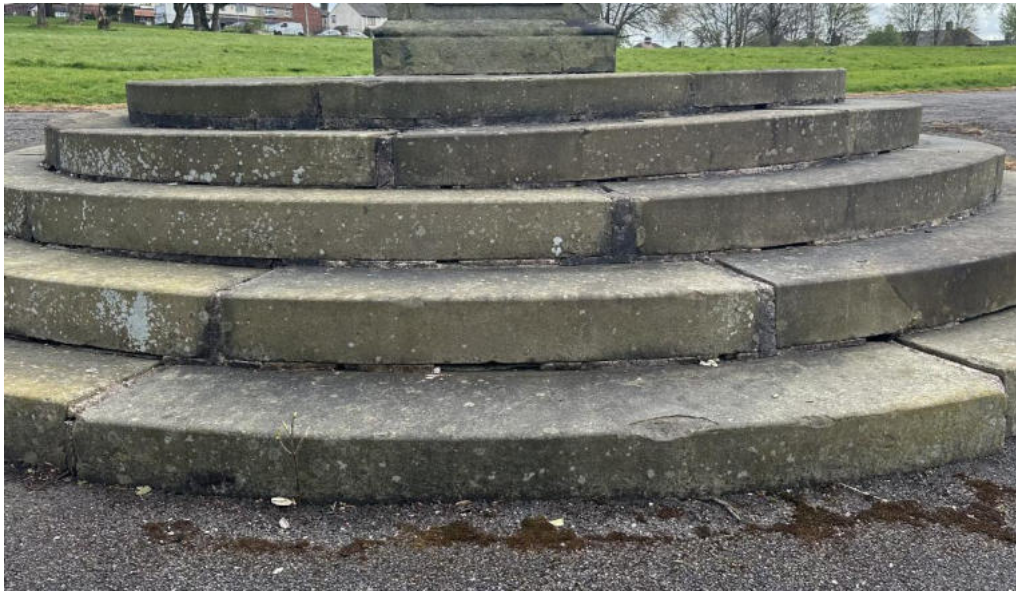
| <b>4.2</b> | <p>On the west side slabs are uneven and fall away from the memorial with the topography. A red granite slab laid into the top has a raised corner and causing a trip hazard. <b>RE-BED STONE STEPS</b></p> | <b>3</b> |

| 6 | RE-BED STONE | 4.2, 4.29, | |

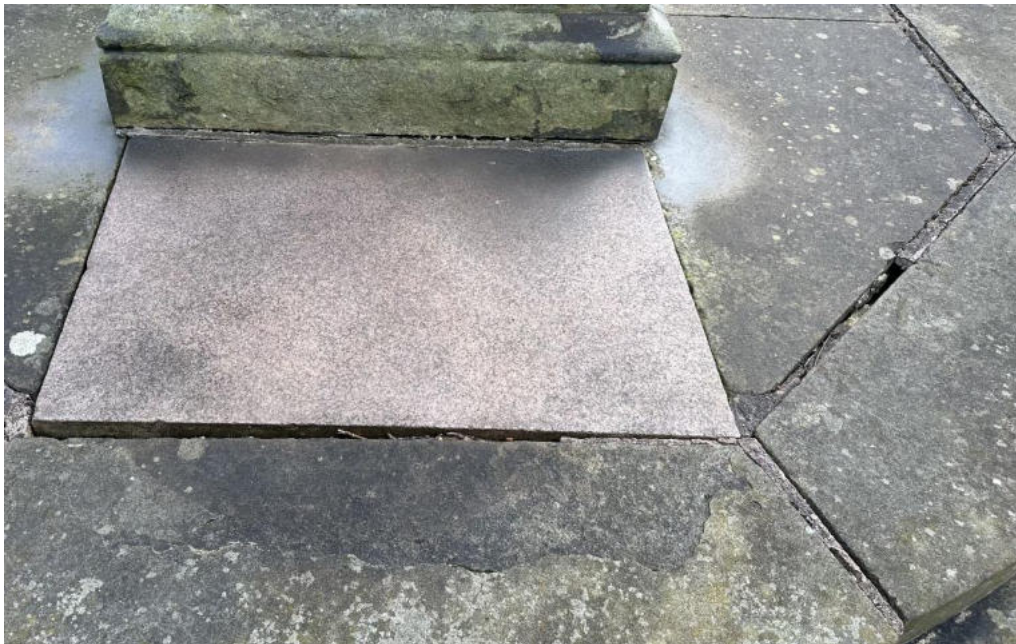
| <b>4.3</b> | <p>Joints are very large and infill cement has cracked open. Slabs should be re-laid level and joints repointed with lime mortar. <b>REPOINTING</b></p> | <b>3</b> |

| 2 | REPOINTING | 4.3, 4.17, 4.24, | |

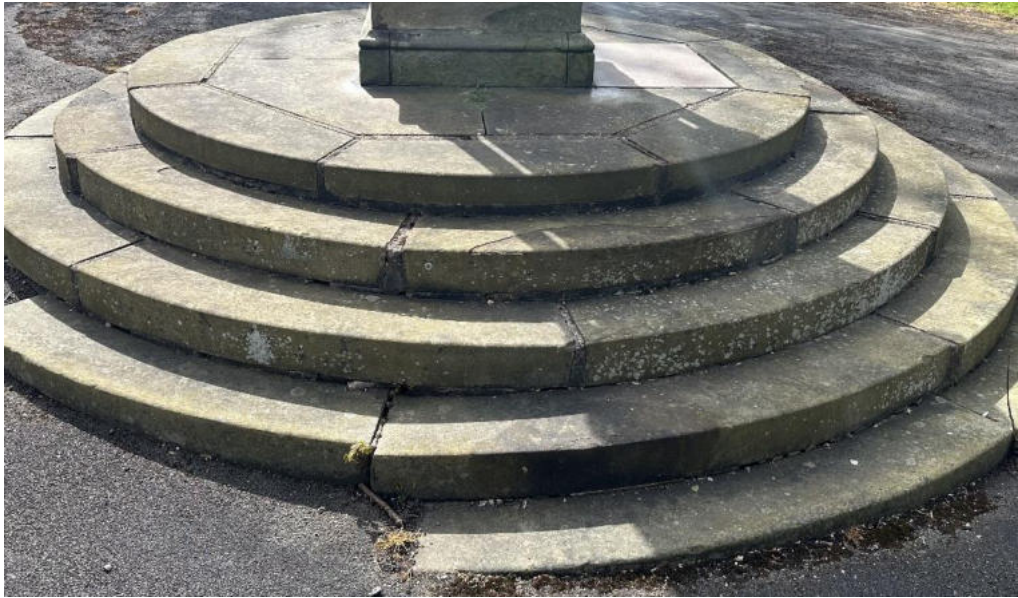
| <p><b>4.4</b></p> | <p>All sides have a similar joint conditions. Slabs are blackened from atmospheric pollution and a covering of green algae that could be cleaned to improve appearance. Cleaning should be considered with an appropriate biocide. If results are not satisfactory a superheated steam system could be considered. No abrasive or high-pressure methods should be employed. <b>STONE CLEANING</b></p> | <p><b>4</b></p> |

| 8 | STONE CLEANING | 4.4, 4.30, | C |

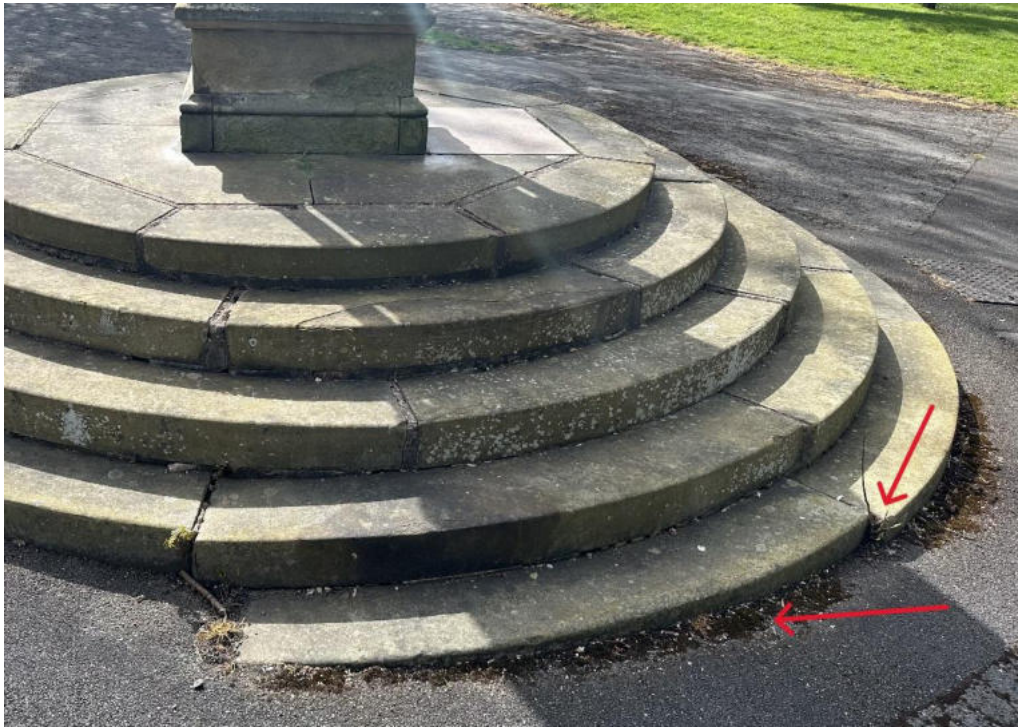
| <p><b>4.5</b></p> | <p>There is plant growth between slabs on the north side that should be removed before it grows larger. The vegetation and moss should be cleared from the stone/tarmac junctions. <b>REMOVE VEGETATION</b></p> | <p><b>3</b></p> |

| 3 | REMOVE VEGETATION | 4.5, 4.6, | C, V |

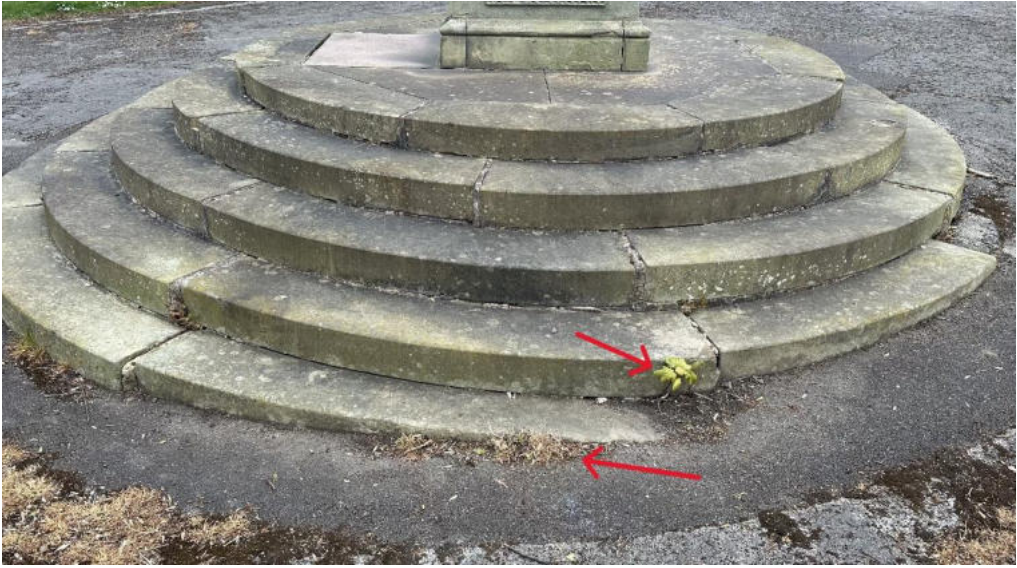
| 4.6 | <p>There is similar growth on the south side that should be removed. <b>REMOVE VEGETATION</b></p> | 3 |

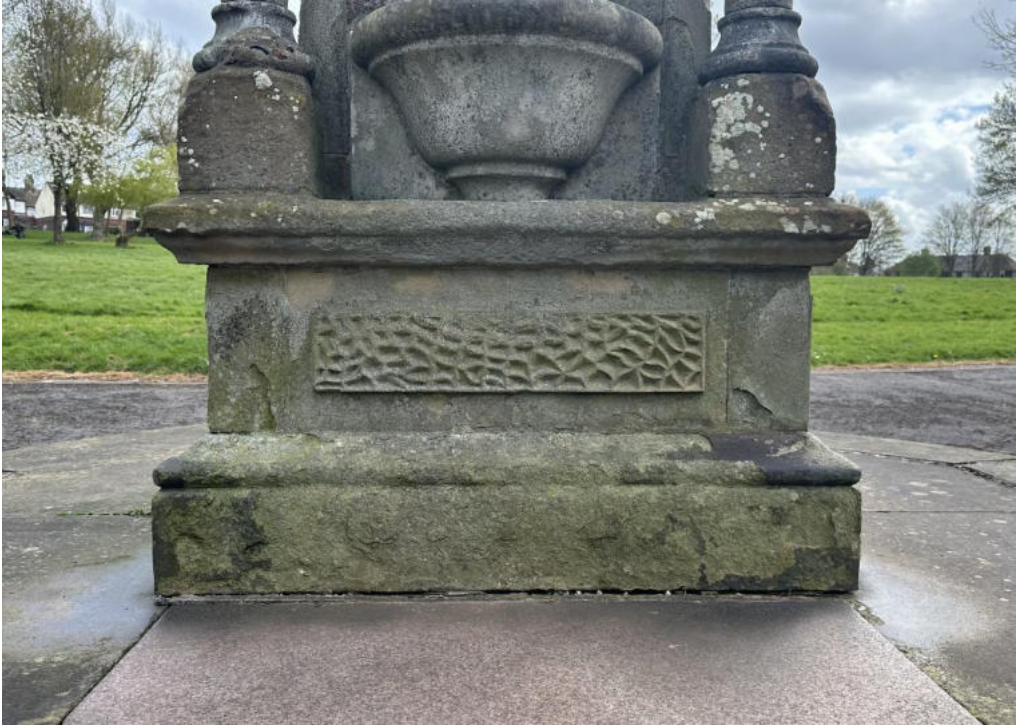
| 4.7 | <p>On the west face stone in the plinth is eroded and delaminated. Loose stone should be gently dressed back. <b>DRESS OFF STONE</b></p> | 3 |

| 7 | DRESS OFF STONE | 4.7, 4.13, 4.15, 4.18, 4.19, 4.23, 4.26, 4.27, | |

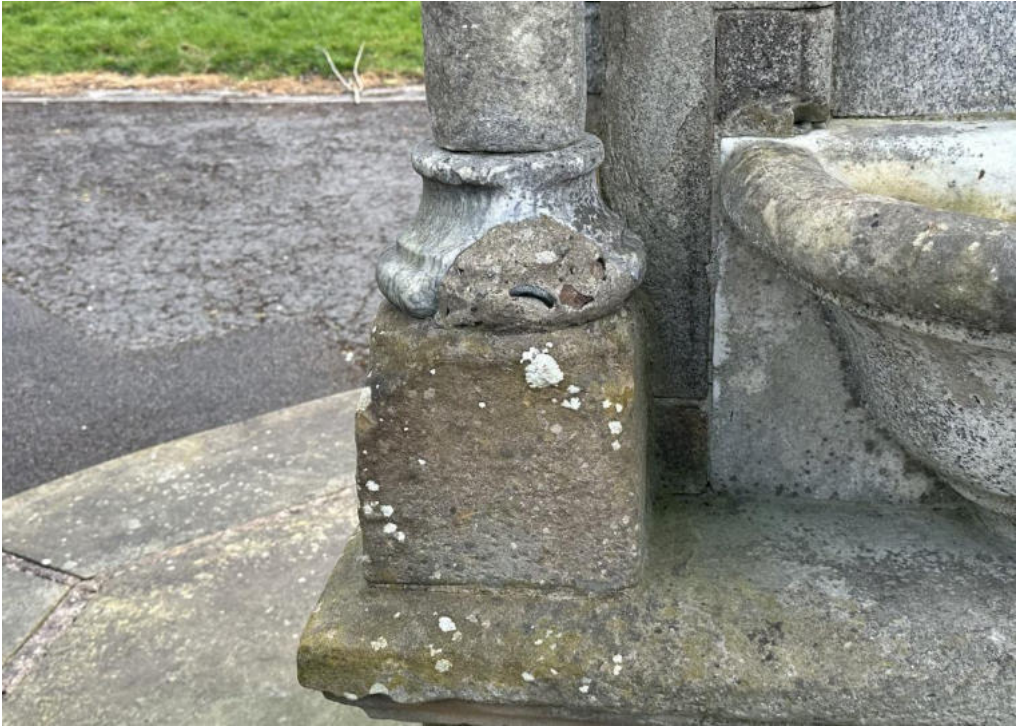
| <p><b>4.8</b></p> | <p>The northwest column base has had a previous repair but with cement and this has eroded exposing some reinforcement. This should be removed and a stone repair carried out with basalt stone. <b>STONE REPAIR</b></p> | <p><b>3</b></p> |

| 4 | STONE REPAIR | 4.8, 4.12, 4.16, 4.20, 4.21, 4.22, 4.28 | |

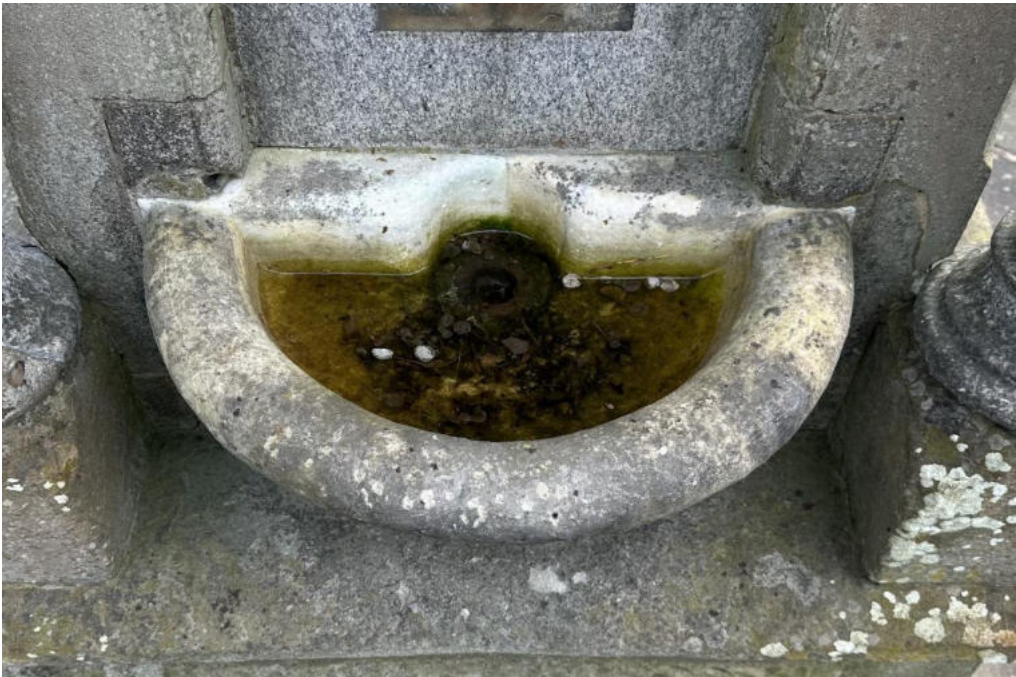
| <p><b>4.9</b></p> | <p>The bowl is full of water and the outlet is blocked and a leaf guard installed. <b>IMPROVE DRAINAGE</b></p> | <p><b>3</b></p> |

| 5 | IMPROVE DRAINAGE | 4.9, | |

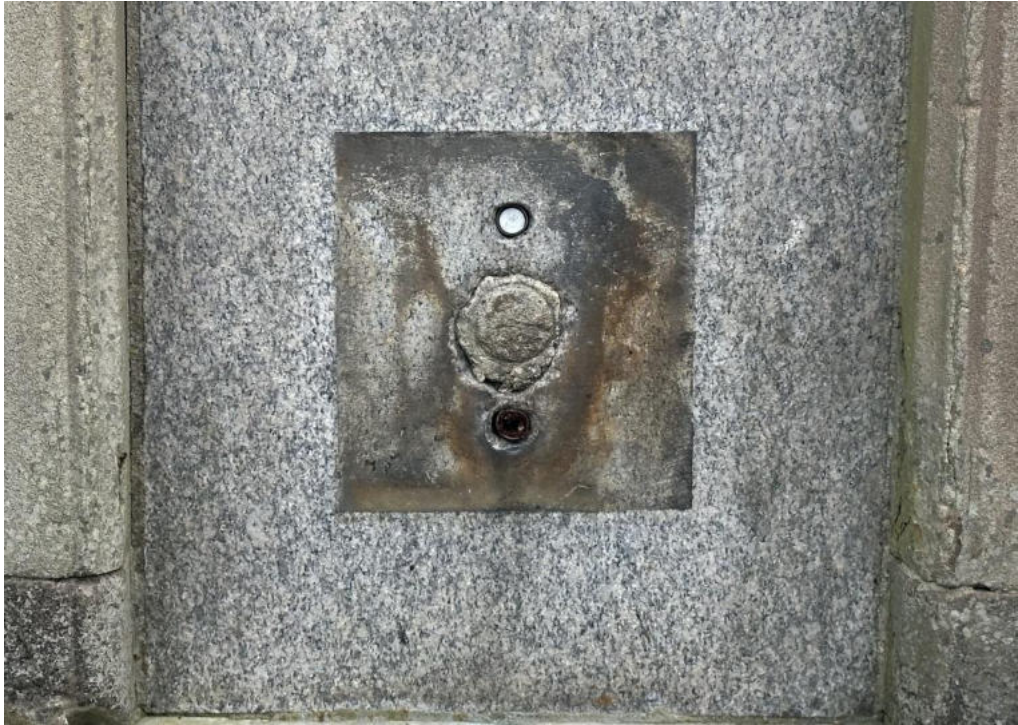
| <p><b>4.10</b></p> | <p>The spout is missing and the supply pipe has been infilled with cement. If appropriate for the location a new faucet should be installed. <b>NEW WATER OUTLET</b></p> | <p><b>5</b></p> |

| 13 | NEW WATER TAP OUTLET | 4.10, | |

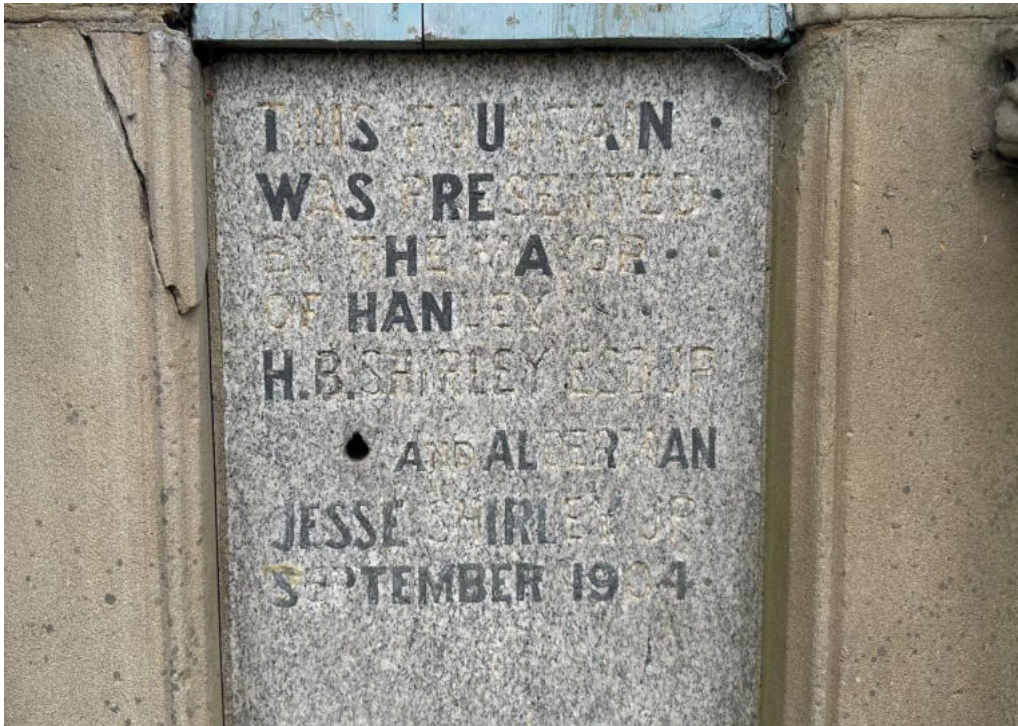
| <p><b>4.11</b></p> | <p>The inscription on the west panel has lost most of the inlay. The inscription could be repainted. <b>REPAINT INSCRIPTION</b></p> | <p><b>4</b></p> |

| 9 | REPAINT INSCRIPTION | 4.11, | |

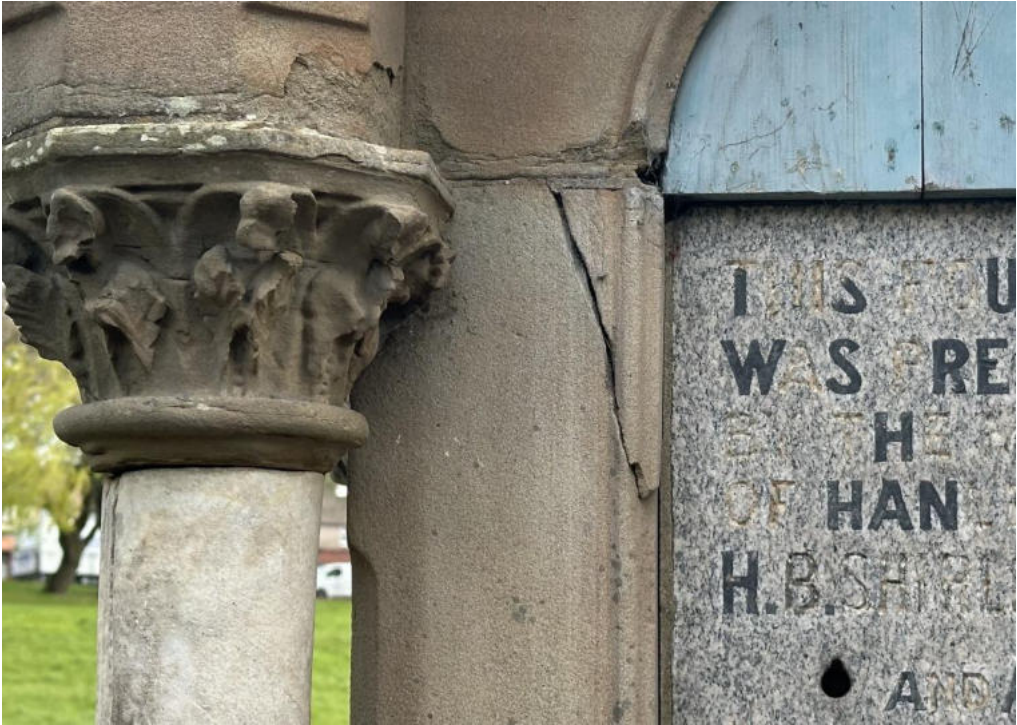
| <p><b>4.12</b></p> | <p>The stone of the northwest jamb is cracked and should be pinned back into place.<br/><b>STONE REPAIR</b></p> | <p><b>3</b></p> |

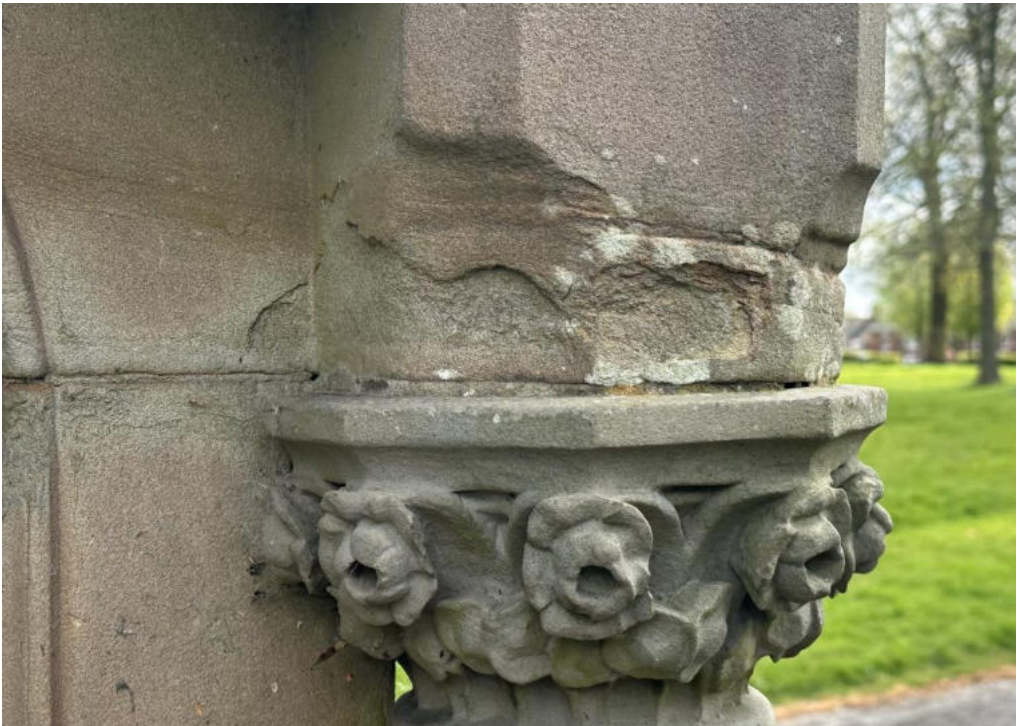
| <p><b>4.13</b></p> | <p>Stone at the top of the columns has delaminated and loose stone needs gentle dressing off. <b>DRESS OFF STONE</b></p> | <p><b>3</b></p> |

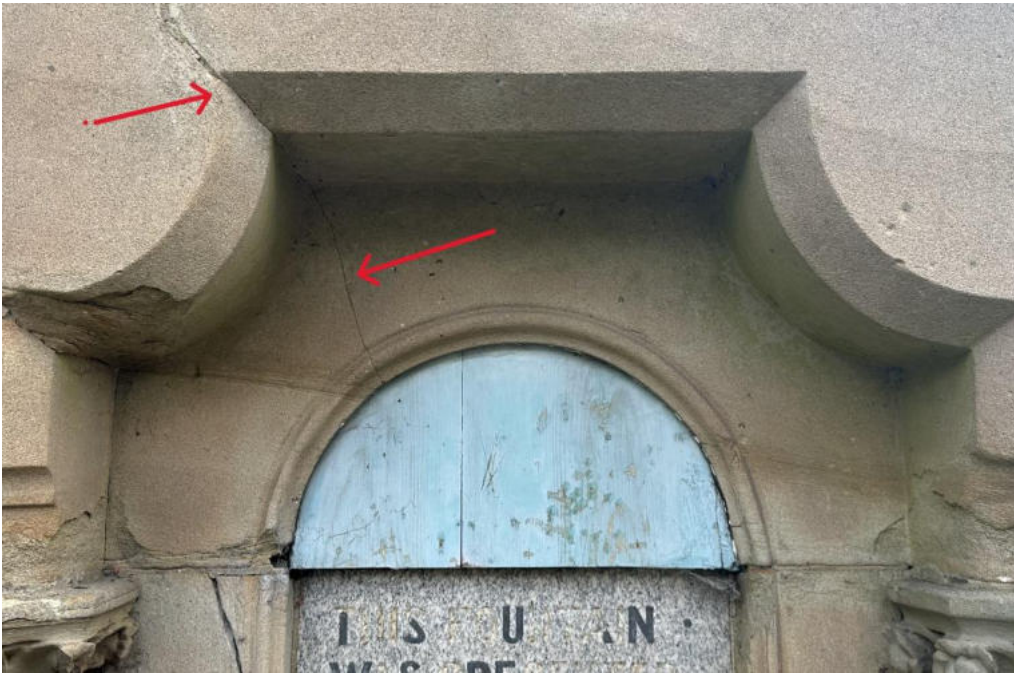
| <p><b>4.14</b></p> | <p>The stone is cracked through the arch and continues through the stone above. There appears to be no movement but the stone could be stitched to prevent future movement. <b>STONE REPAIR</b></p> | <p><b>4</b></p> |

| 12 | STONE REPAIR (LOW PRIORITY) | 4.14, 4.15, 4.19 | |

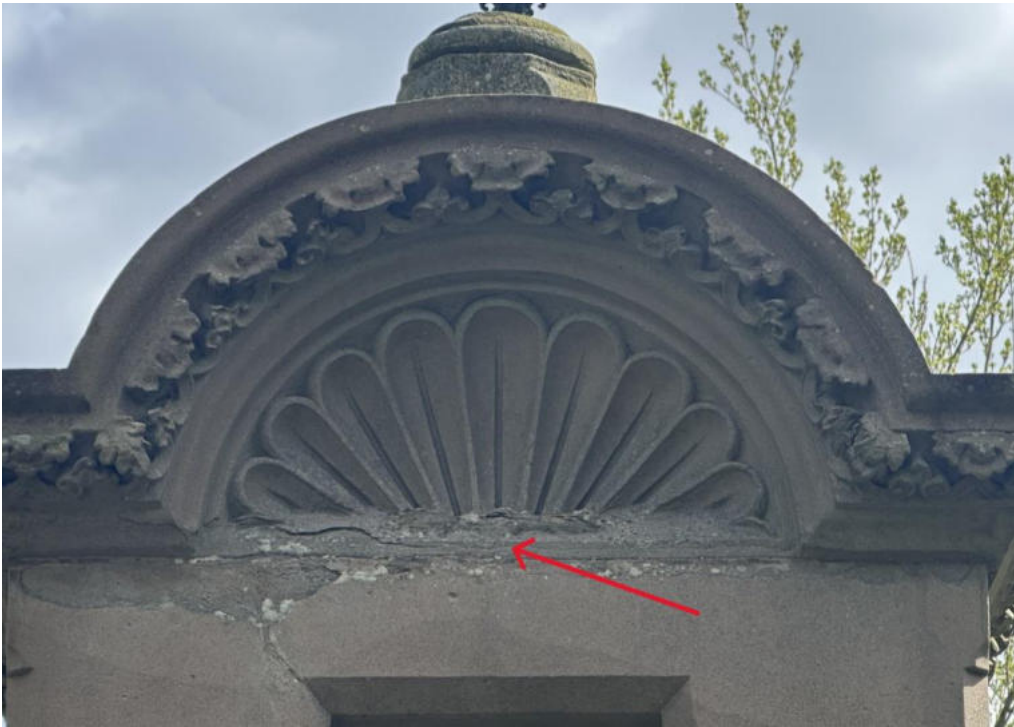
| <p><b>4.15</b></p> | <p>There is delamination of the stone at the base of the scalloped hood. Loose stone should be gently dressed back at least, but indented if funds allow. <b>DRESS OFF STONE</b></p> | <p><b>3</b></p> |

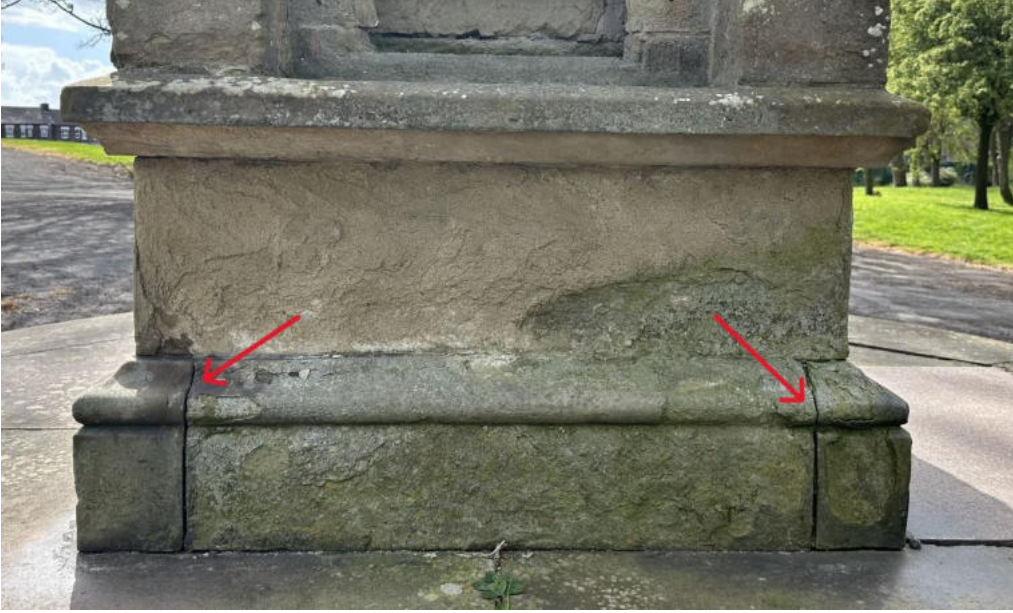
| 4.17 | <p>The base has open joints between stone that should be repointed. <b>REPOINTING</b></p> | 3 |

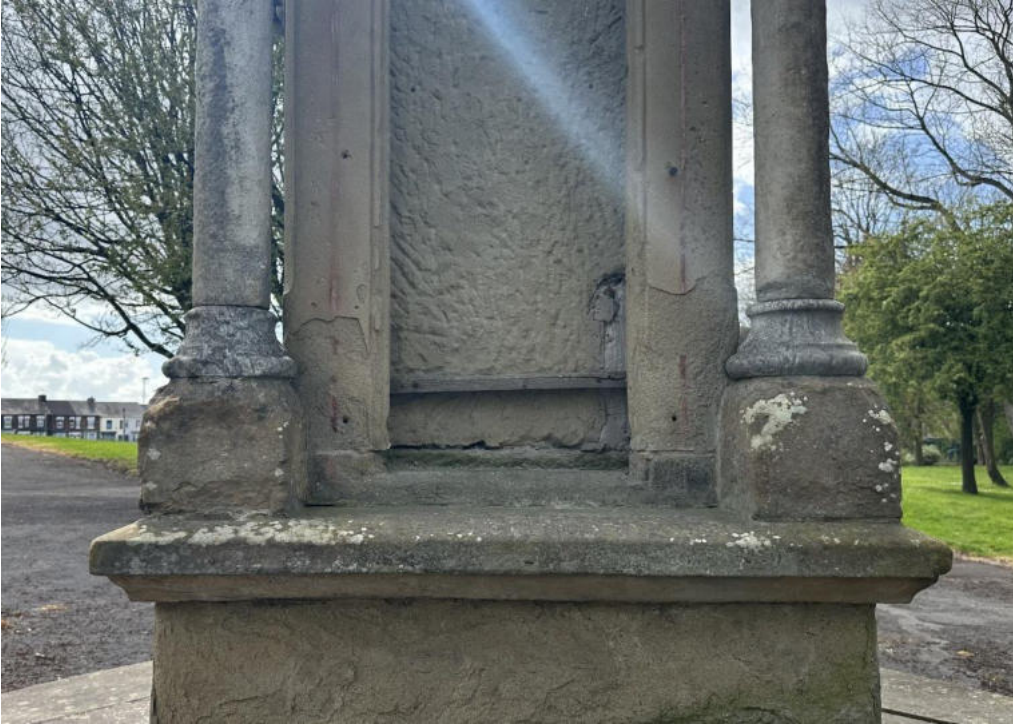
| 4.18 | <p>The recess originally had a Wedgwood Jasper panel insert that is now lost. If evidence of the original panel exists a replacement could be made and refitted. <b>RESTORE JASPER PANEL</b></p> | 5 |

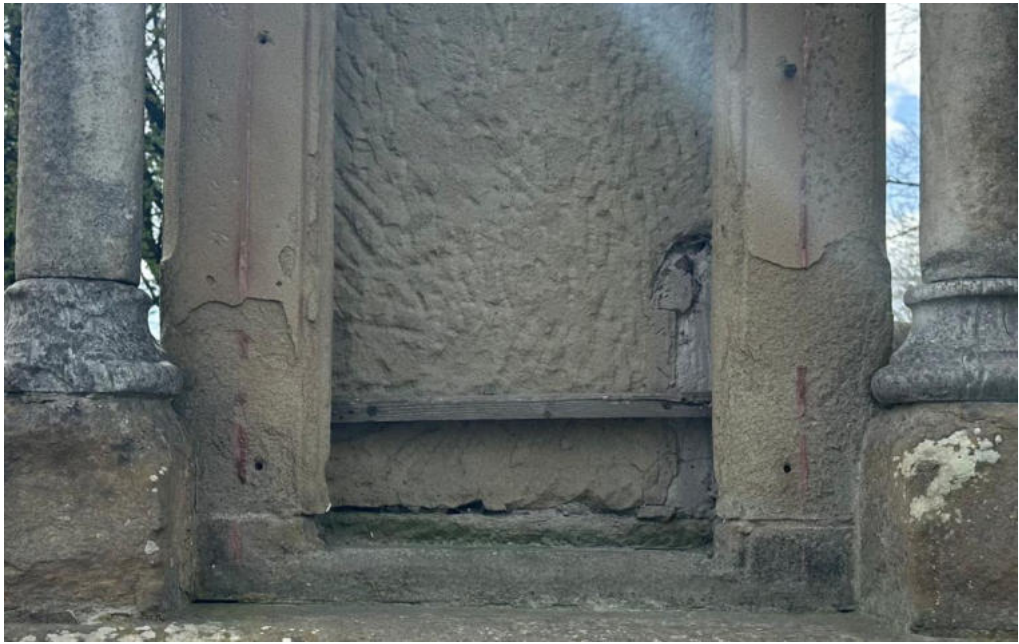
| <p><b>4.19</b></p> | <p>Stone at the base of the jambs has delaminated and should be gently dressed off or better still, indent with new <b>STONE REPAIR</b></p> | <p><b>3</b></p> |

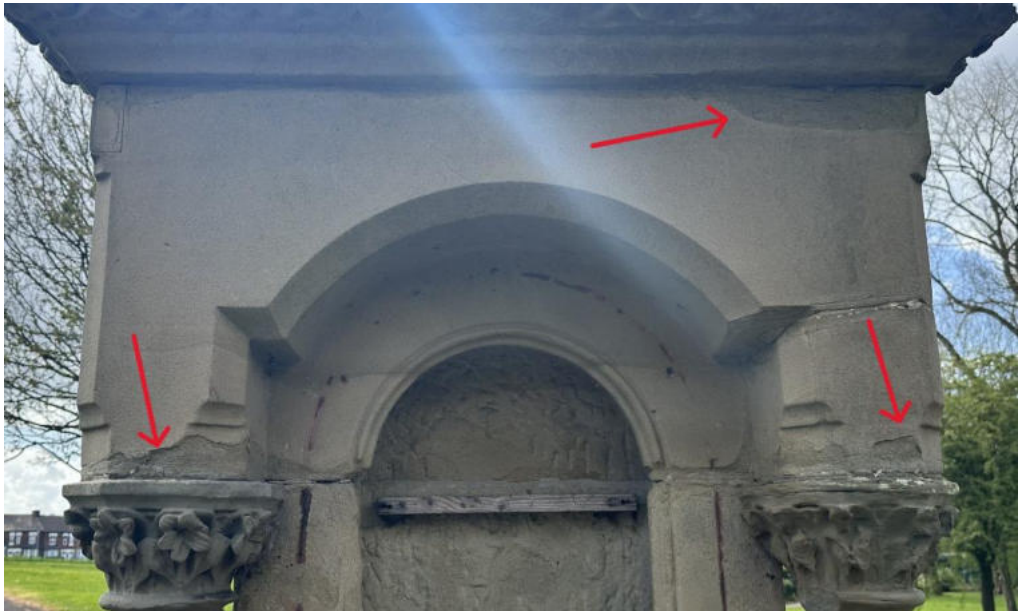
| <p><b>4.20</b></p> | <p>There have been previous repairs to the arch stone. Stone is delaminating and should be repaired with new indents. <b>STONE REPAIR</b></p> | <p><b>3</b></p> |

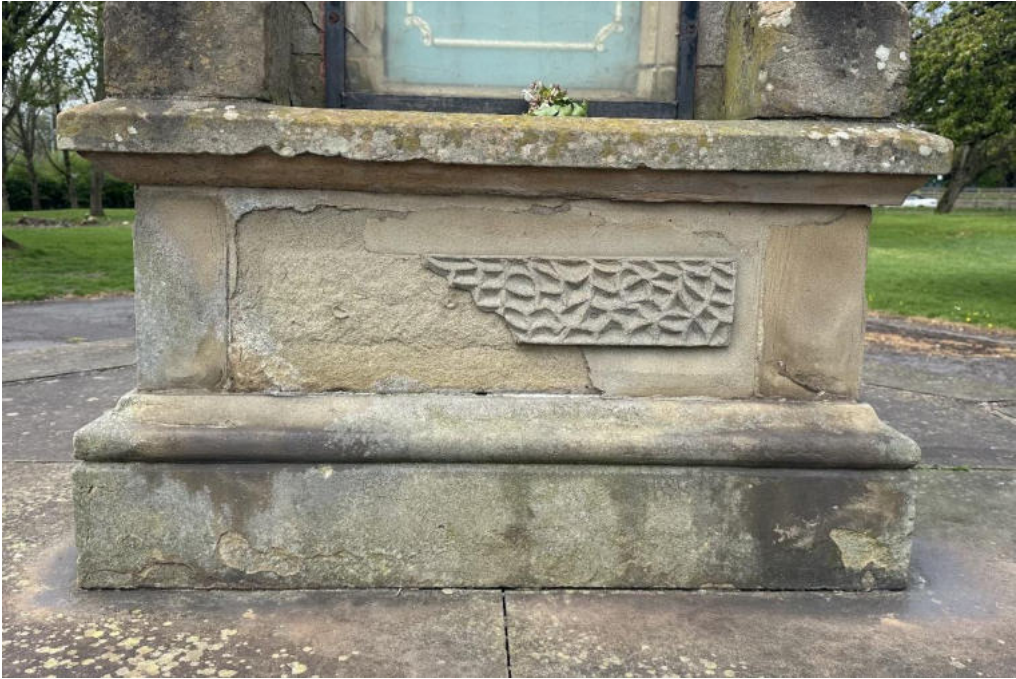
| <p><b>4.21</b></p> | <p>On the east side the carved detail on the base has delaminated and detached from the stone face leaving half missing. A new stone could be carved using details from the other side and indented in place. <b>STONE REPAIR</b></p> | <p><b>3</b></p> |

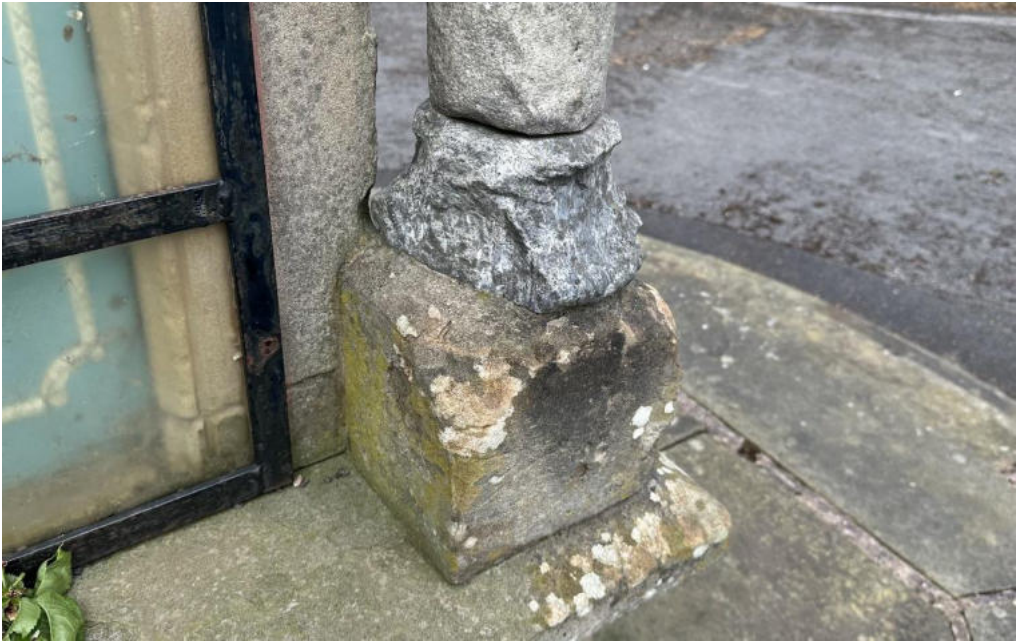
| <p><b>4.22</b></p> | <p>There is damage to the northeast column base that should be repaired with matching stone. <b>STONE REPAIR</b></p> | <p><b>3</b></p> |

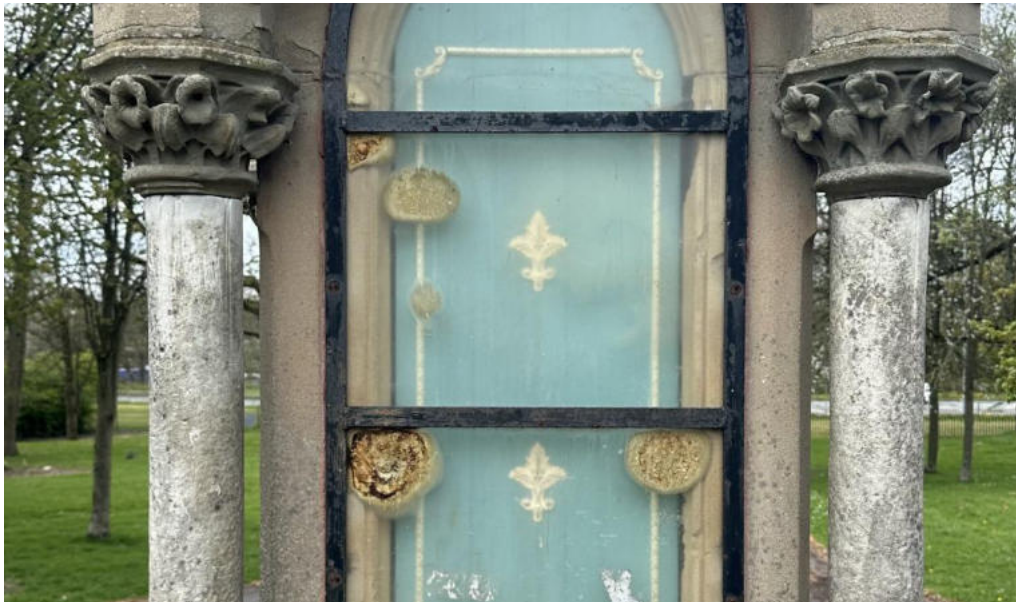
| | <p>A Jasper panel remains on the east side. The panel is protected by acrylic in a steel frame but has suffered vandalism from burning. Acrylic could be replaced to improve appearance. <b>REPLACE ACRYLIC</b></p> | 5 |

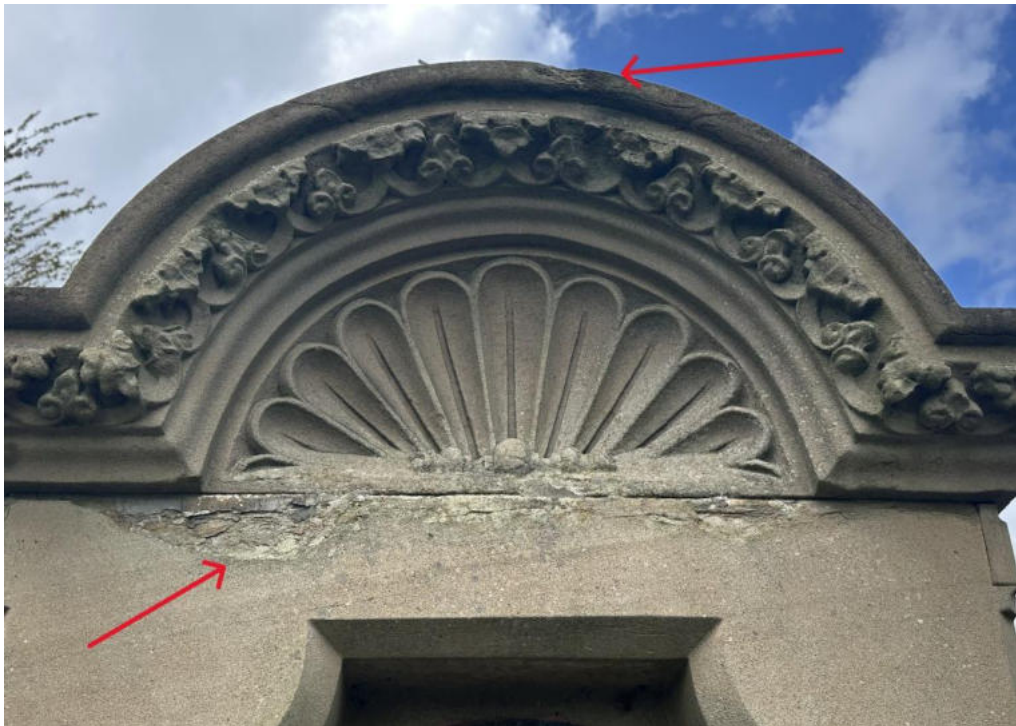
| 4.23 | <p>The upper stone arch has had previous repairs. There is stone delamination below the scalloped decoration and over the hood that should be gently dressed off. <b>DRESS OFF STONE</b></p> | 3 |

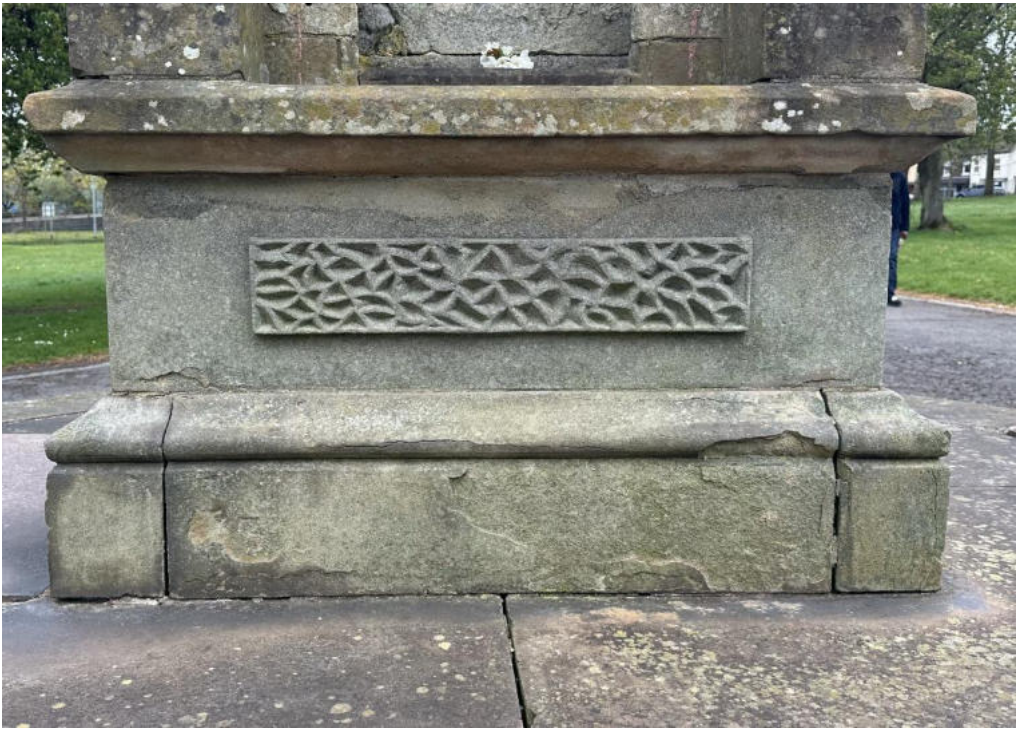
| <p><b>4.24</b></p> | <p>The south side has open joints in the base that need repointing. <b>REPOINTING</b></p> | <p><b>3</b></p> |

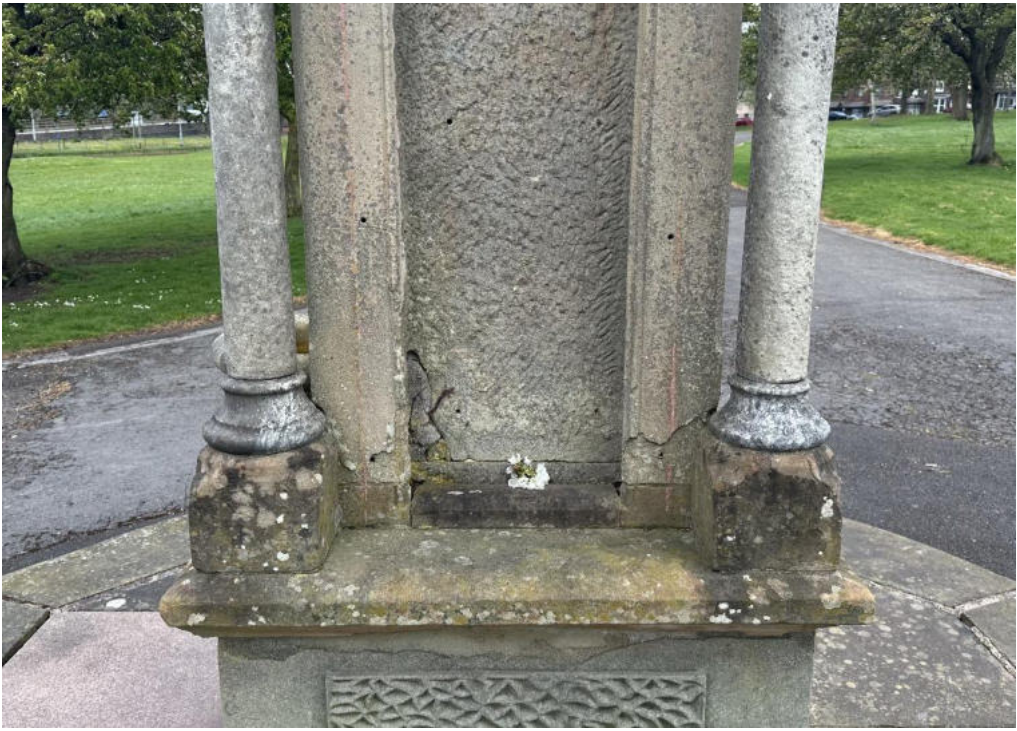
| <p><b>4.25</b></p> | <p>The recess originally had a Wedgwood Jasper panel insert that is now lost. If evidence of the original panel exists a replacement could be made and refitted. <b>RESTORE JASPER PANEL</b></p> | <p><b>5</b></p> |

| 14 | REFIT RECESSED PANELS | 4.17, 4.25, | |

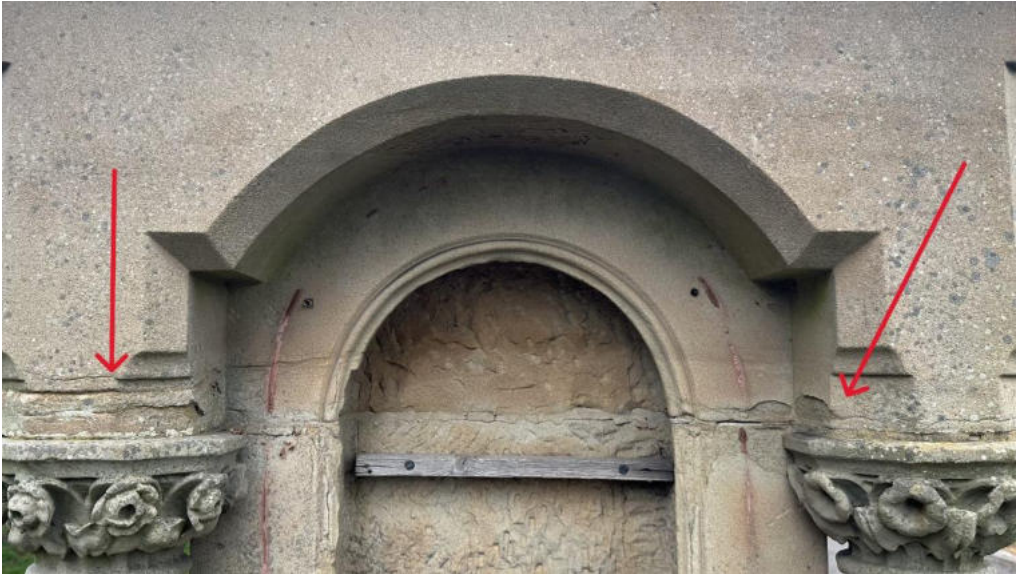
| 4.27 | <p>There is some delamination of the stone to the tops of the columns that needs gently dressing off. <b>DRESS OFF STONE</b></p> | 3 |

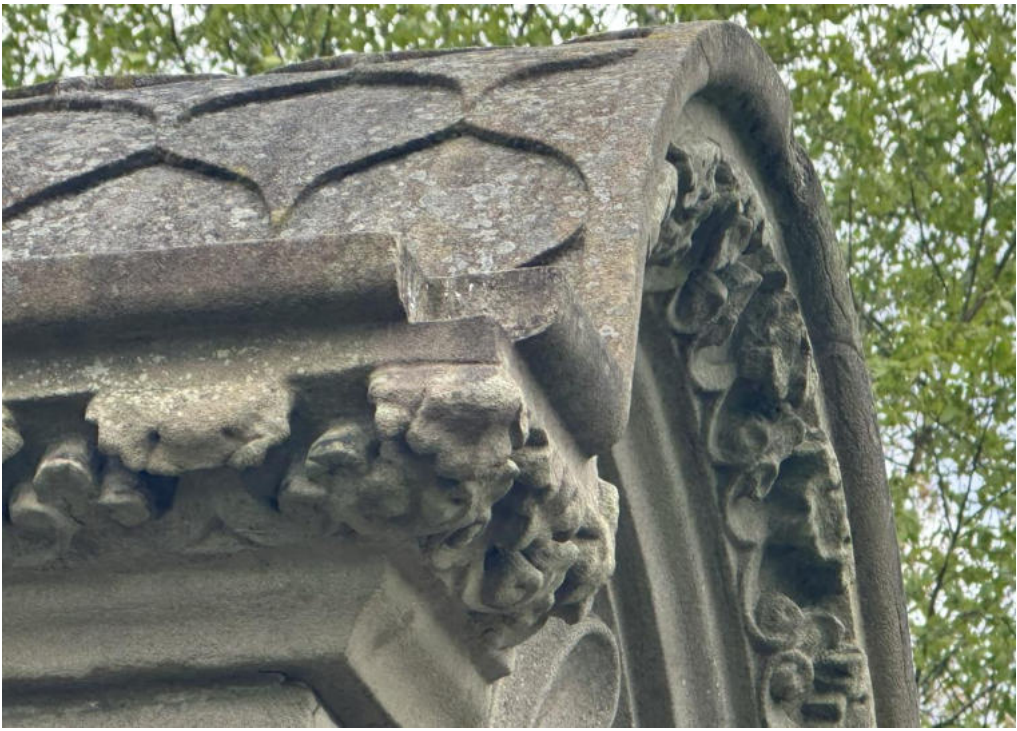
| 4.28 | <p>There is stone missing from the southeast corner of the canopy that could have a stone indent. <b>STONE REPAIR</b></p> | 3 |

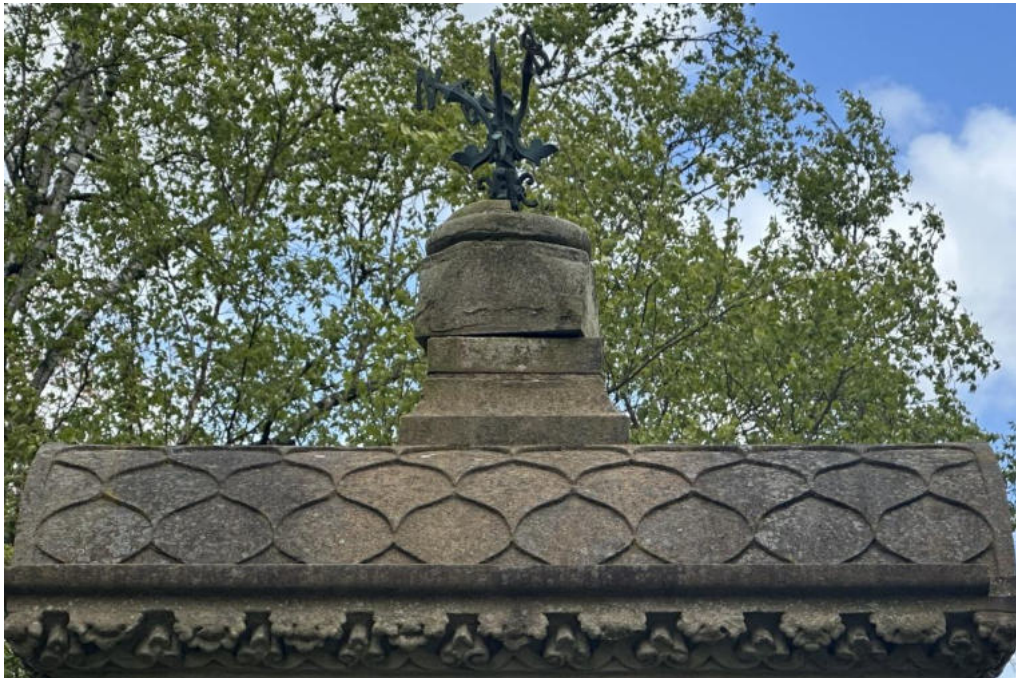
| <p><b>4.29</b></p> | <p>There is a wrought iron direction indicator fixed to stone at the top of the roof. Directions are not correct as the stone base is rotated and presumably loose. Stone should be refixed and directions corrected. <b>RE-BED STONE</b></p> | <p><b>1</b></p> |

| 1 | CHECK LOOSE HIGH LEVEL STONE AND RE-FIX | 4.29 | |

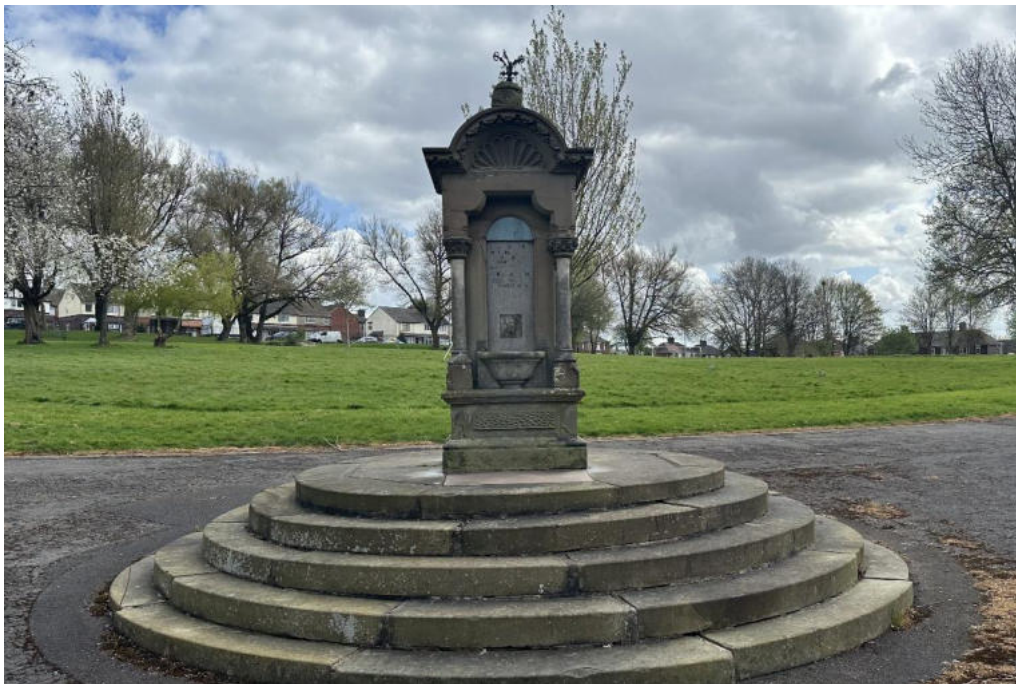
| <p><b>4.30</b></p> | <p>Stone to the fountain as a whole should be cleaned. Cleaning should be considered with an appropriate biocide. If results are not satisfactory a superheated steam system could be considered. No abrasive or high-pressure methods should be employed. <b>STONE CLEANING</b></p> | <p><b>4</b></p> |
