# Statue of Colin Minton Campbell

## Condition Report

Date: 20.03.2026

Document ID: 140-05-CR20

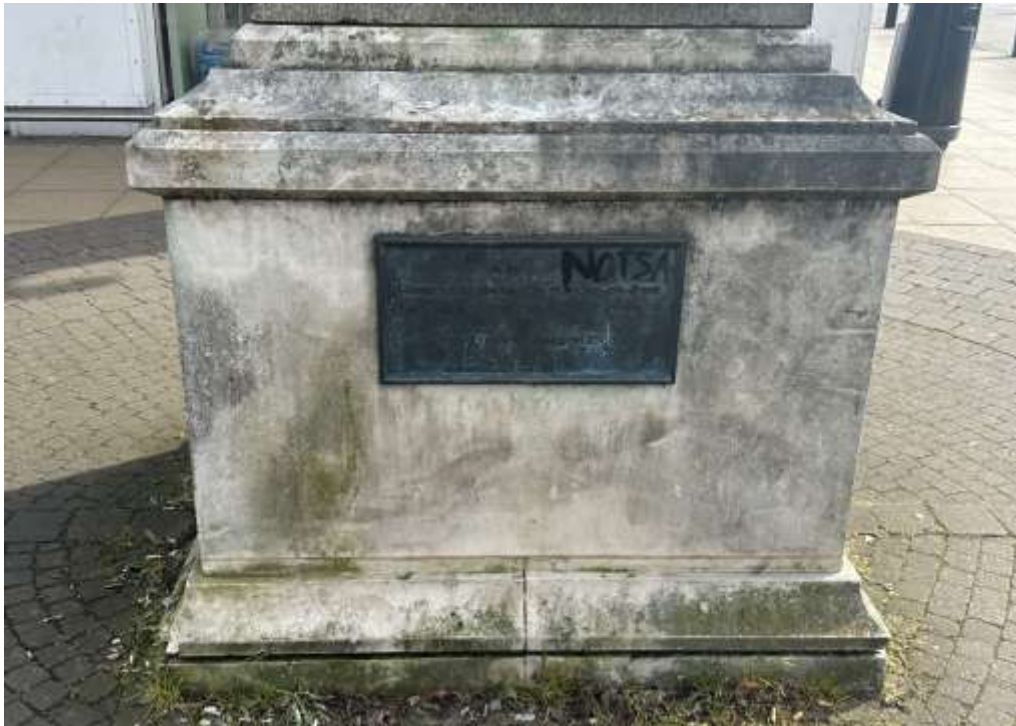
| <b>4.3</b> | <p>The stone is very dirty and scuffed and has green algae at the base. Cleaning should be considered with an appropriate biocide. If results are not satisfactory a superheated steam system could be considered. No abrasive or high-pressure methods should be employed. <b>STONE CLEANING</b></p> | <b>4</b> |

| | STONE CLEANING | 4.3, 4.6, | |

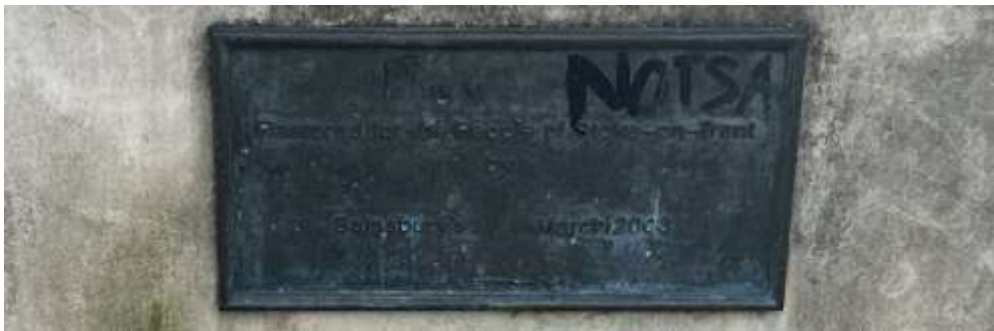
| <b>4.4</b> | <p>The bronze plaque has some graffiti that should be cleaned off. A hot or cold wax coating could be considered following cleaning. <b>CONSIDER WAX COATING OF BRONZE</b></p> | <b>5</b> |

| | REMOVE GUM/GRAFFITI | 4.4, 4.10, | V |
| | BRONZE WAXING | 4.4, 4.11, | |

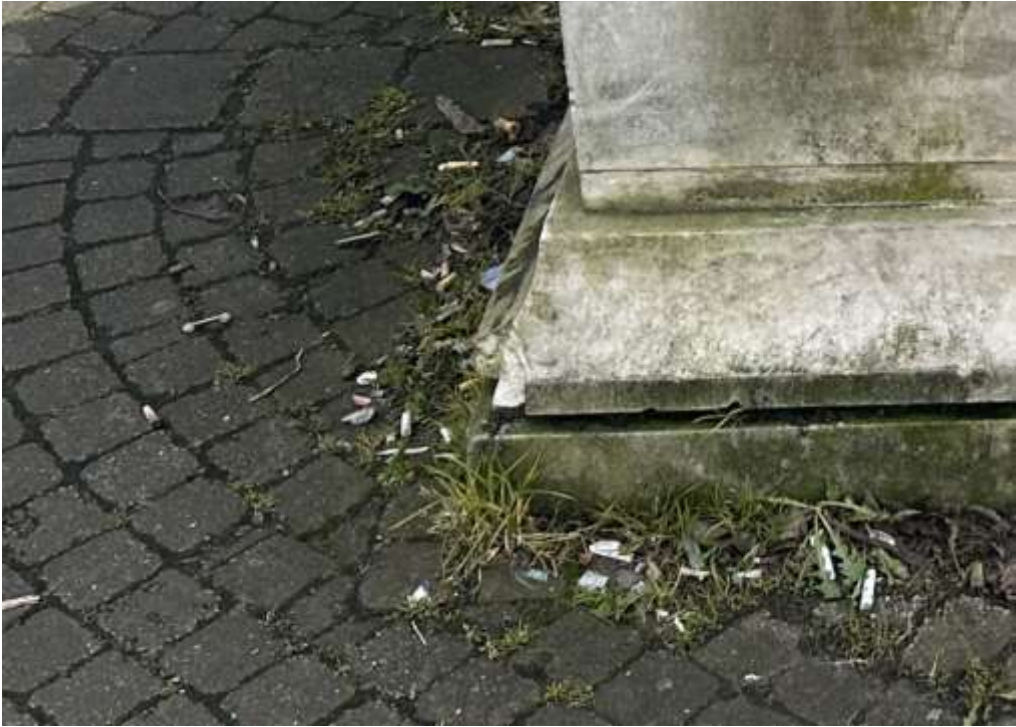
| <p><b>4.5</b></p> | <p>The base of the plinth is chipped on the northwest corner. A stone lime mortar repair could be applied. <b>STONE MORTAR REPAIR</b></p> | <p><b>4</b></p> |

| | STONE MORTAR REPAIR | 4.5, | |

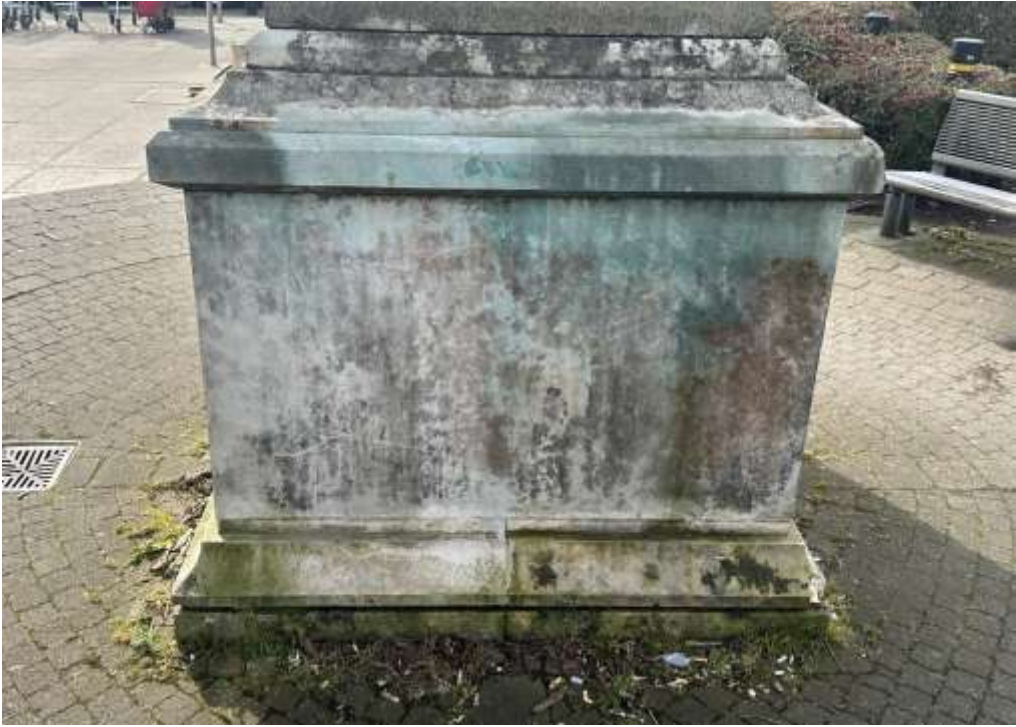
| <p><b>4.6</b></p> | <p>There is further graffiti on the north side that should be cleaned off. <b>STONE CLEANING</b></p> | <p><b>4</b></p> |

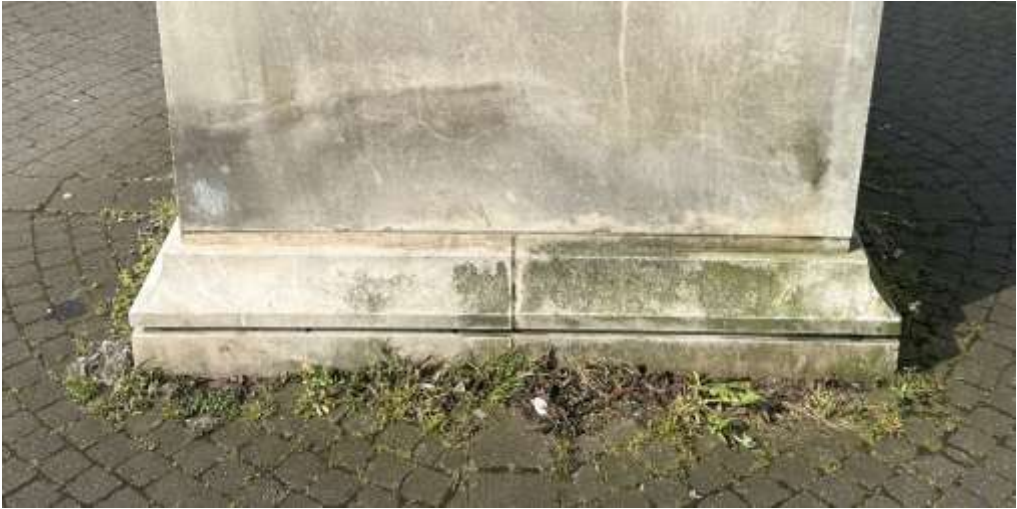
| 4.7 | <p>There is grass and vegetation growth around all sides of the base that should be removed, a herbicide should be applied to reduce regrowth. <b>REMOVE VEGETATION</b></p> | 4 |

| | REMOVE VEGETATION | 4.7, | C,V |

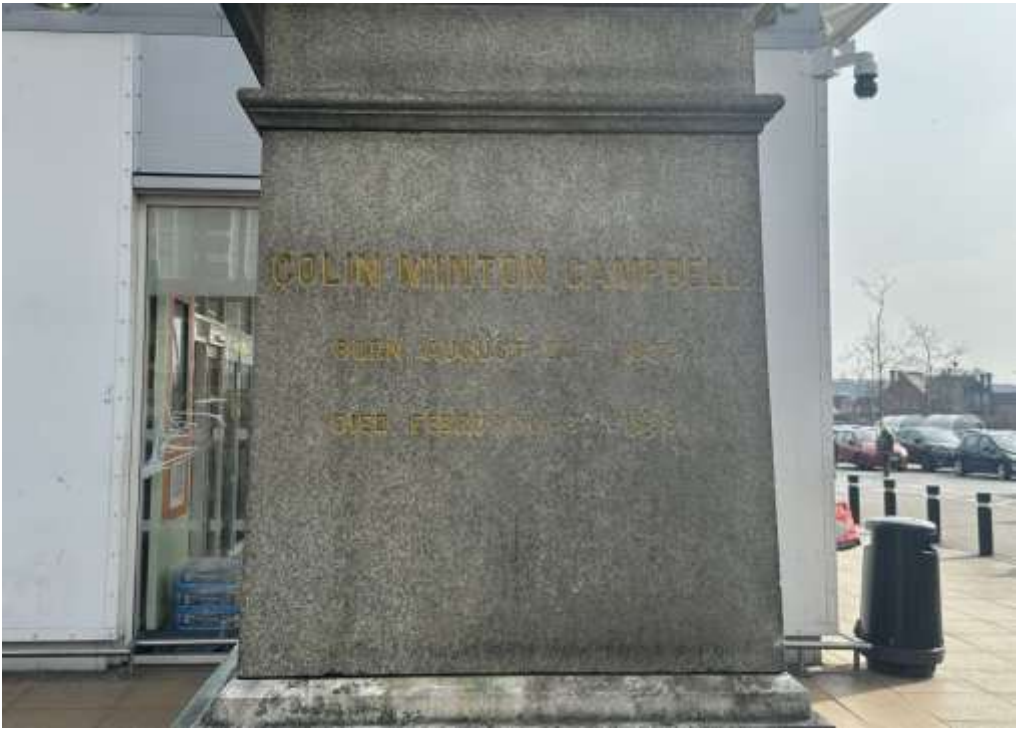
| 4.8 | <p>The upper grey granite has inscriptions to all sides. The lettering is inlaid with colour. On the west side the colouring has worn and should be reinstated. <b>REPAINT INLAY</b></p> | 4 |
| 4.9 | <p>Lettering is in a similar condition to all sides and should be re-coloured. <b>REPAINT INLAY</b></p> | 4 |

| | REPAINT INLAY | 4.8, 4.9, | |

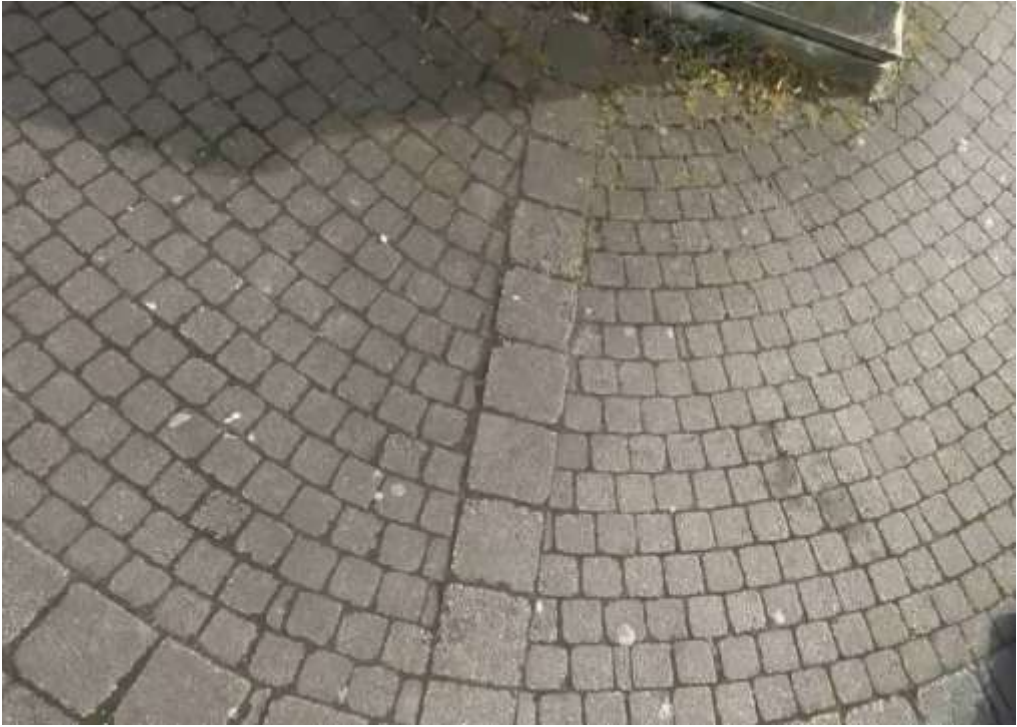
| <b>4.10</b> | <p>The statue is located in a hardstanding of granite setts laid in concentric circles. There is some gum on the surface that should be removed. <b><i>REMOVE GUM</i></b></p> | <b>4</b> |

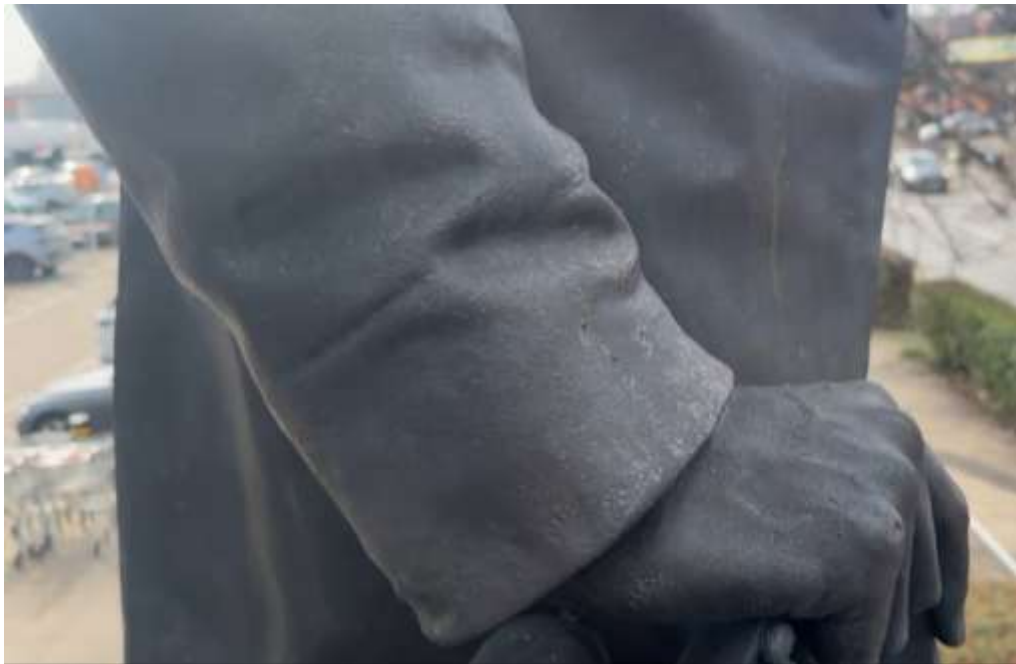
| <b>4.11</b> | <p>The bronze of the statute remains a dark brown colour and may have previously received a protective wax coating. A hot or cold wax coating could be considered following cleaning. <b>CONSIDER WAX COATING OF BRONZE</b></p> | <b>5</b> |

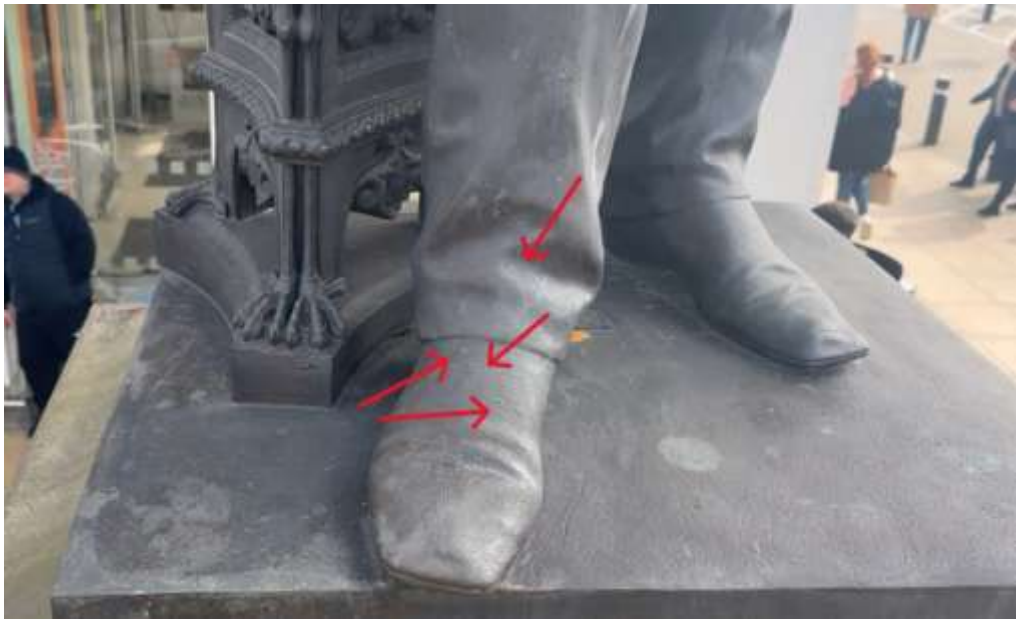
| <b>4.12</b> | <p>There are several pin holes in the bronze particularly on the shoes. These are likely to be a casting feature and the size of the holes is not likely to give rise to disproportionate corrosion, but should be monitored. <b>MONITOR BRONZE HOLLING</b></p> | <b>4</b> |

| | REPAIR BRONZE HOLING | 4.12, 4.13, 4.14, | |

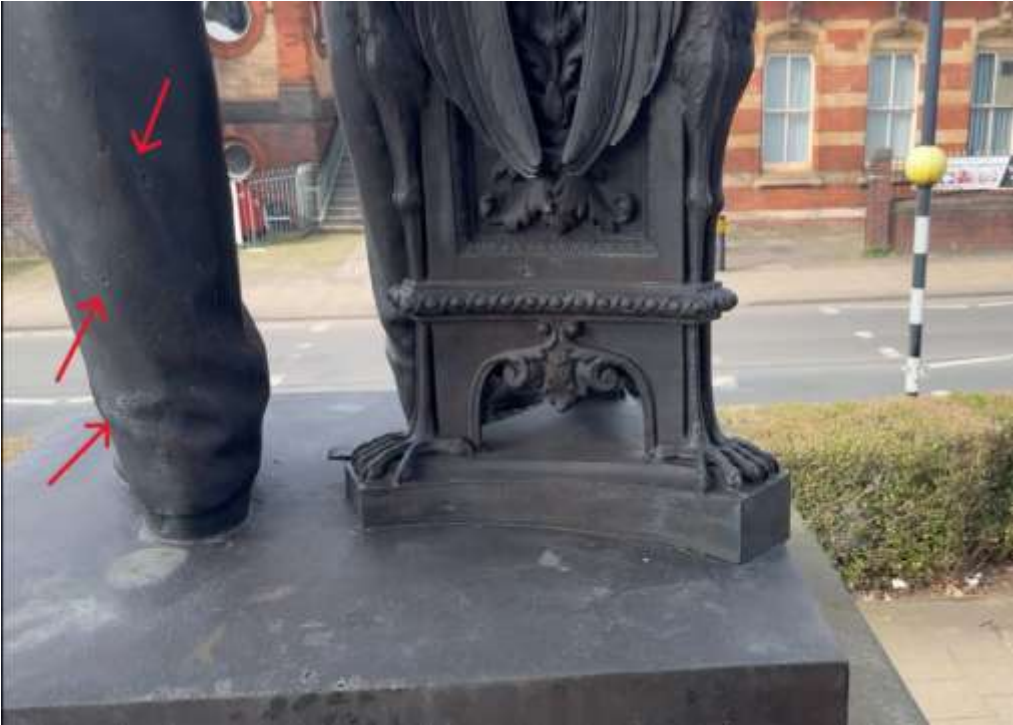
| <p><b>4.13</b></p> | <p>There is further pin holing on the rear of the leg but could be more accurately characterized as 'pitting' as the holes do not appear to be full depth. Wax coating would help to fill these and prevent water trapping <b>MONITOR BRONZE HOLING</b></p> | <p><b>4</b></p> |

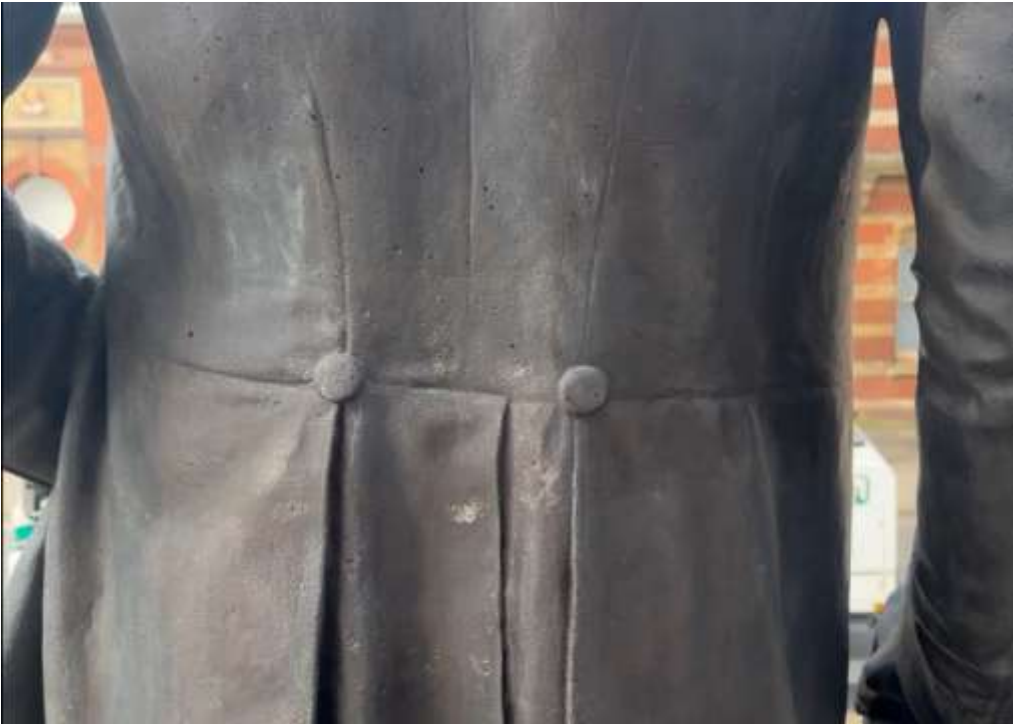
| <p><b>4.14</b></p> | <p>There are a number of pin holes at the waist on the rear. <b>MONITOR BRONZE HOLING</b></p> | <p><b>4</b></p> |

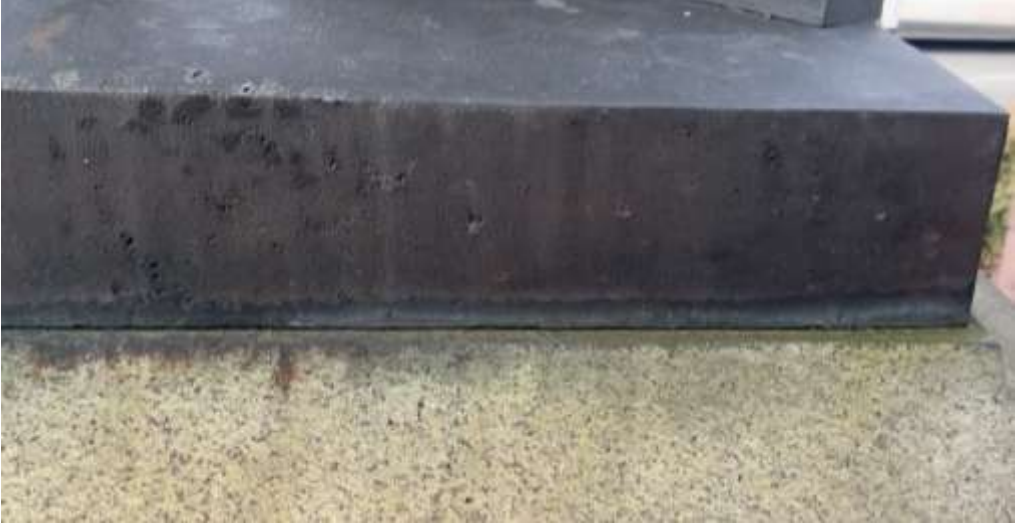
| <b>4.15</b> | <p>The base has a damp tide mark at the join with the granite and the joint is not sealed allowing water ingress under the metal base. A discreet and carefully applied flexible sealant should be used to seal the joint. <b><i>REPLACE FLEXIBLE SEALANT TO METAL JOINT</i></b></p> | <b>3</b> |

| | FLEXIBLE SEALANT TO METAL JOINT | 4.15, | |
